# Mechanical Damage FINAL REPORT

U.S. Department of Transportation  
Pipeline and Hazardous Materials Safety Administration  
Office of Pipeline Safety

Integrity Management Program  
Under Delivery Order DTRS56-02-D-70036  
(Technical Task Order 16)

Michael Baker Jr., Inc.

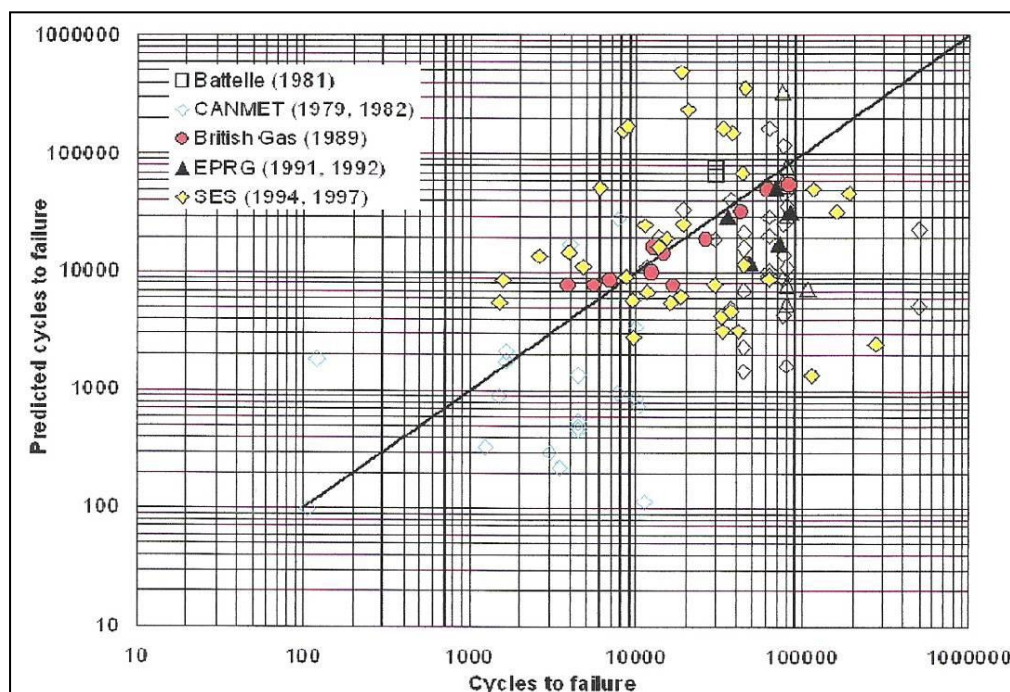
**Figure 7.18** – Comparison of Full-Scale Fatigue Test Results on Combined Dents and Gouges, with the British Gas Model (Leis and Hopkins, 2003)

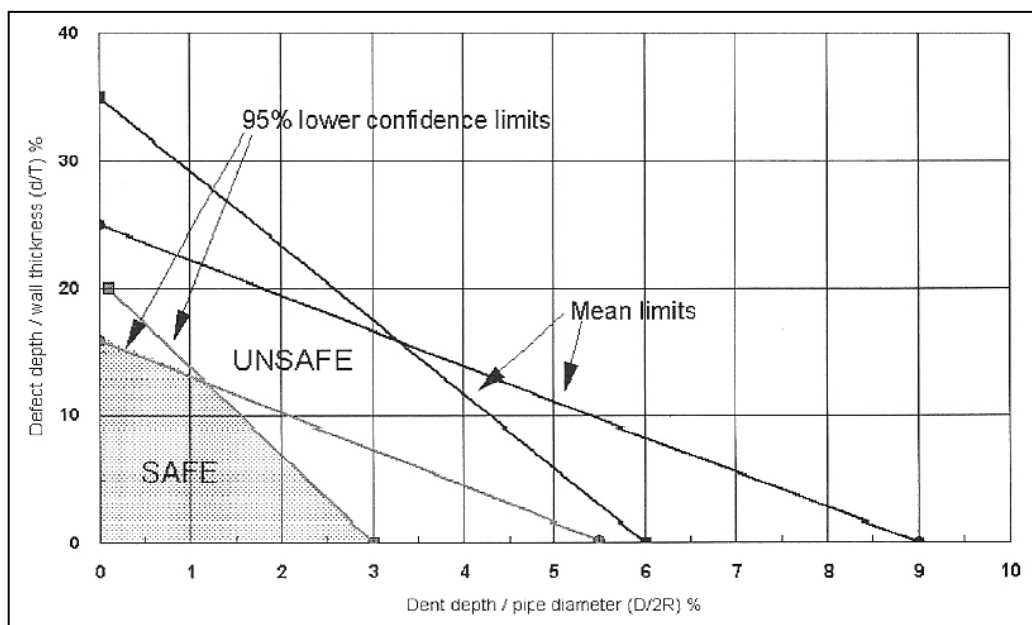
**Figure 7.19** – Illustration of the Simplified Representation of Safe Limits for Combined Dents and Gouges (Bood et al., 1999)

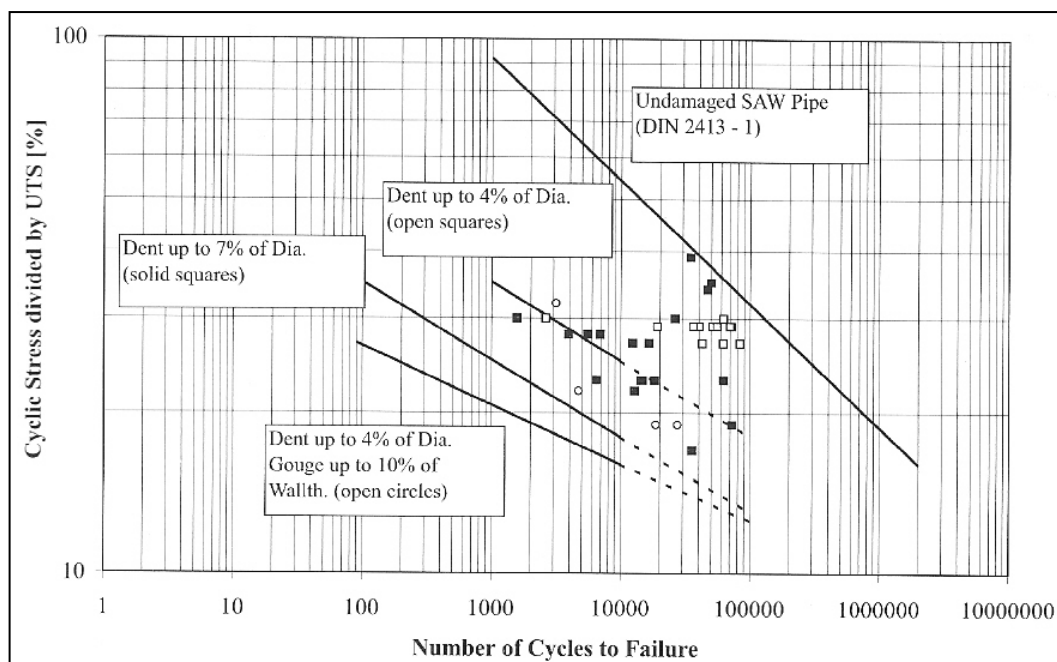
**Figure 7.20** – Fatigue Limits for Dents and Combined Dents and Gouges, Related to DIN 2413-1, Including an Adjustment Factor of Ten on Life (Bood et al., 1999)

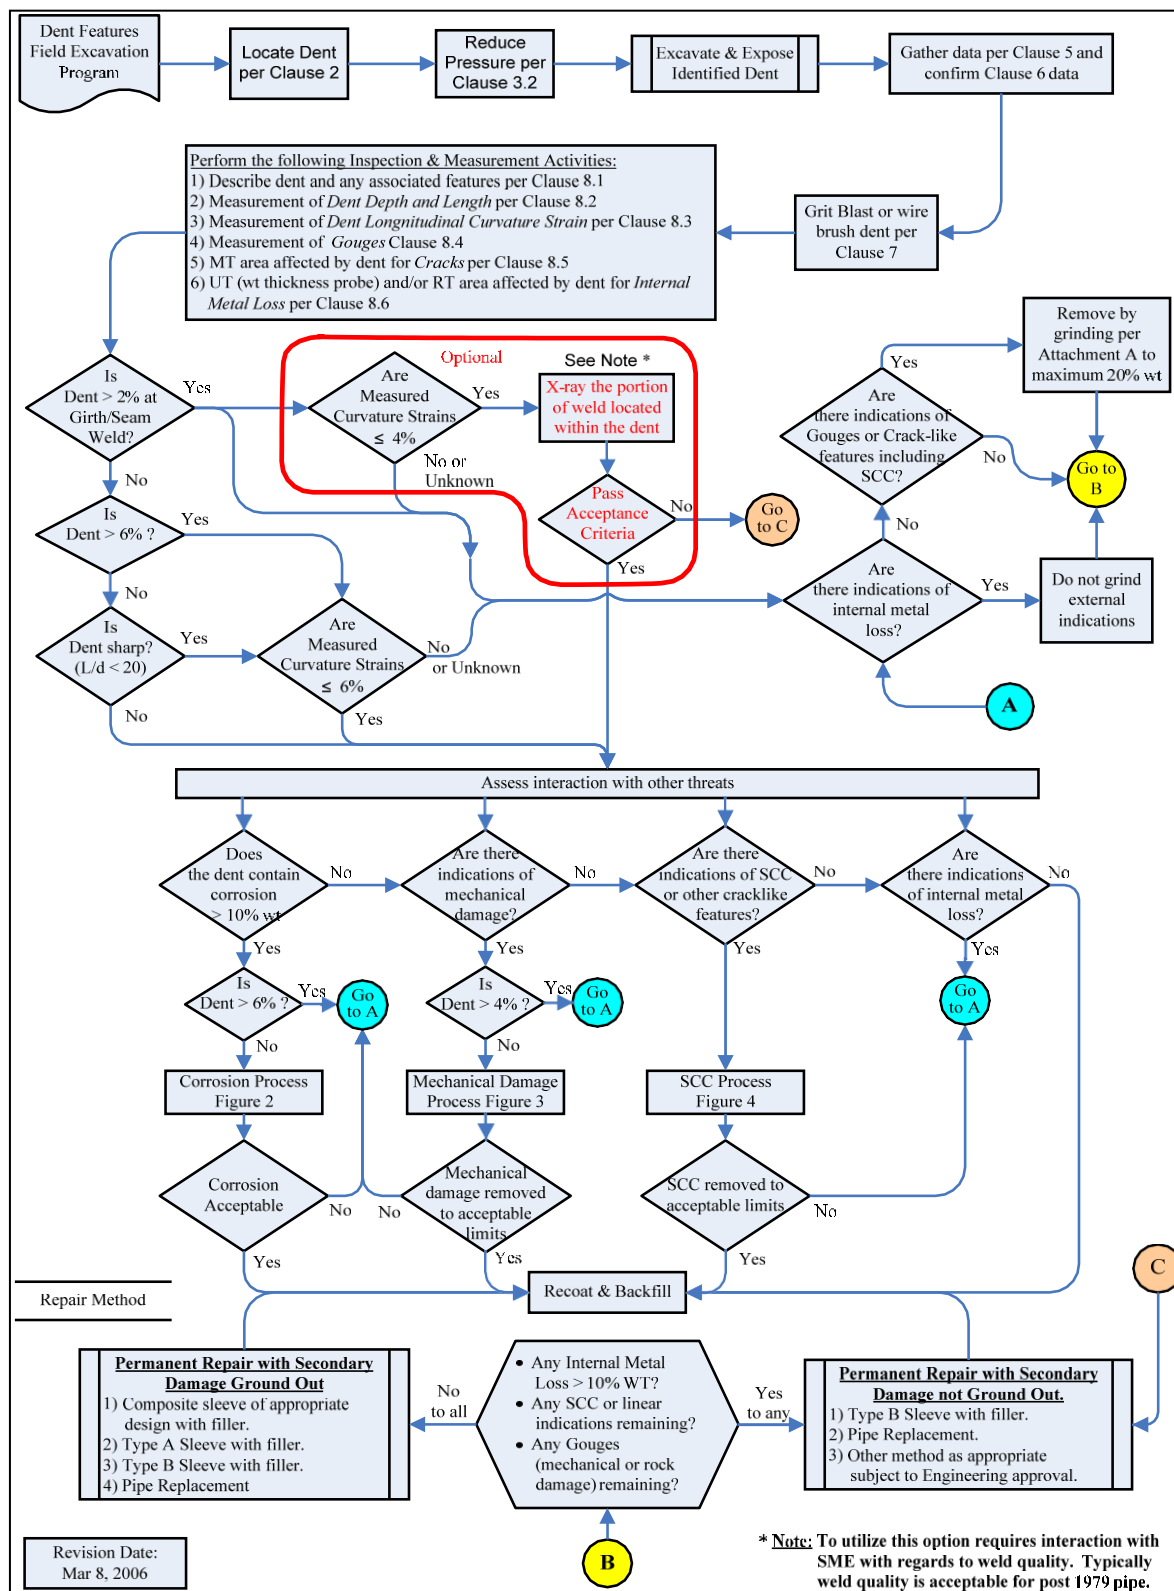
Figure 7.21 – Example of a Flow Chart for Assessing Damage Discovered Following Excavation (Warman et al., 2006)

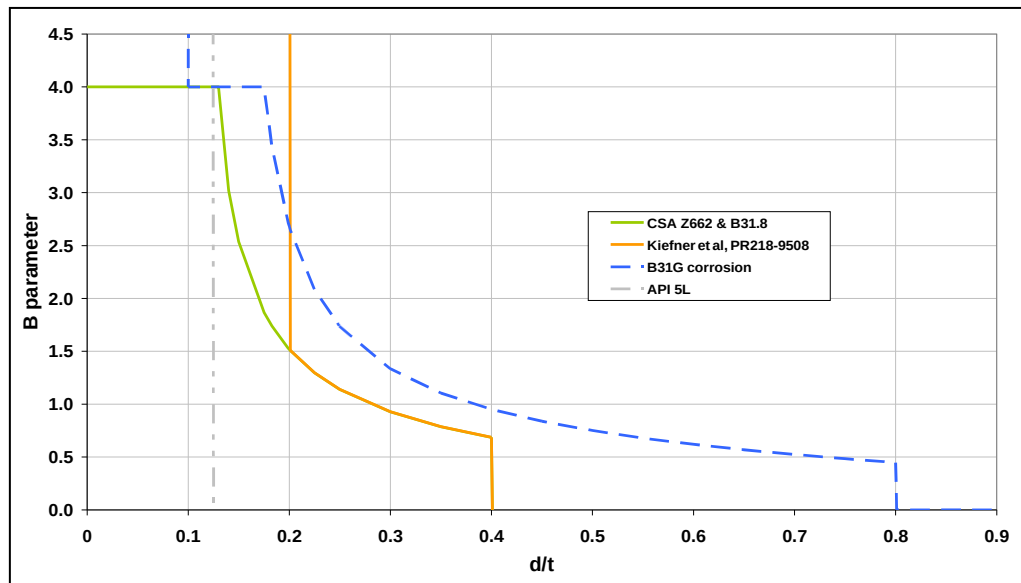
Figure 8.1 – Comparisons of Grind Criteria (Kiefner and Alexander, 1999)

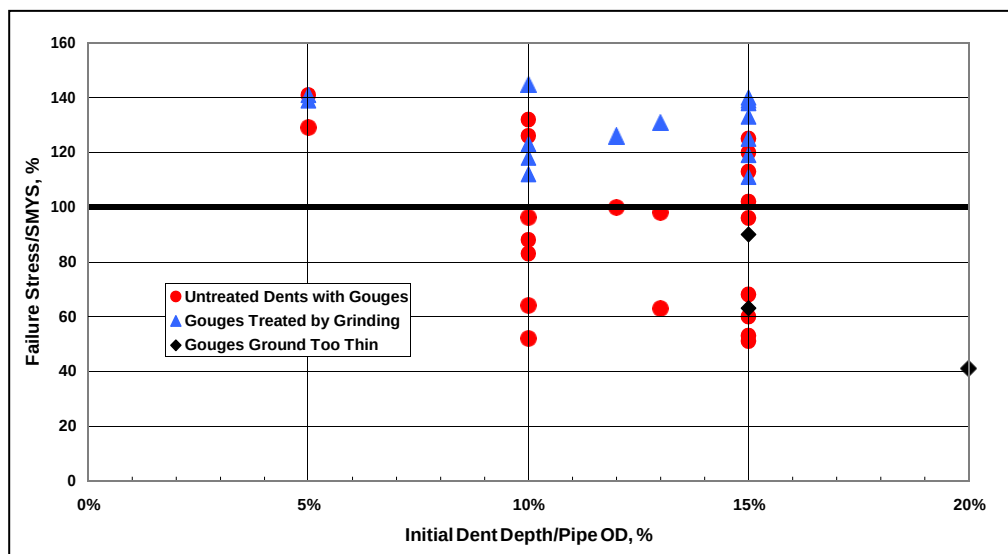
Figure 8.2 – Effectiveness of Grinding for Restoring Failure Stress (Kiefner and Alexander, 1999)

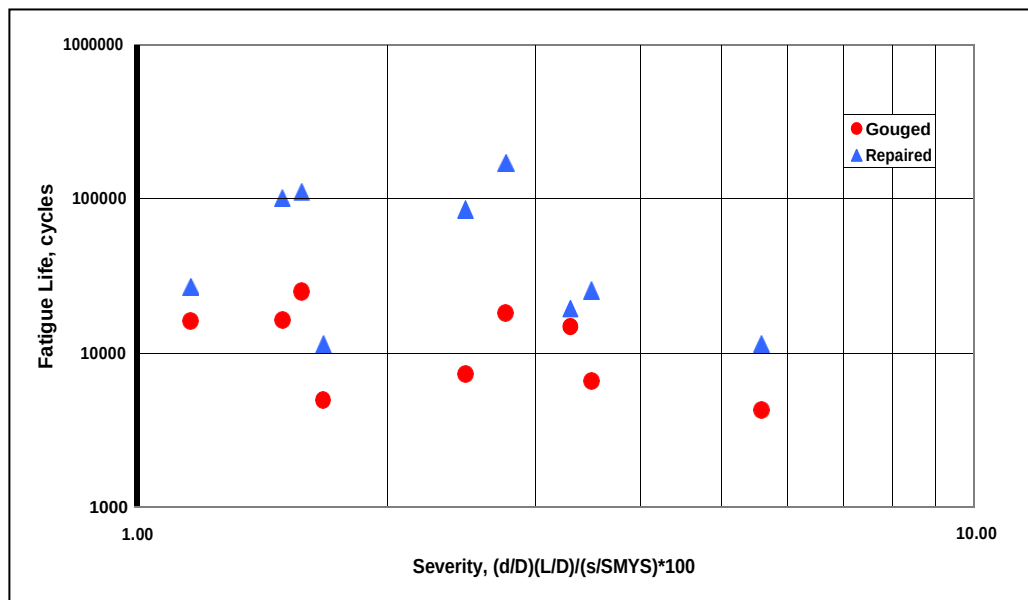
Figure 8.3 – Effectiveness of Grinding in Improving Fatigue Resistance (Kiefner, 1999)

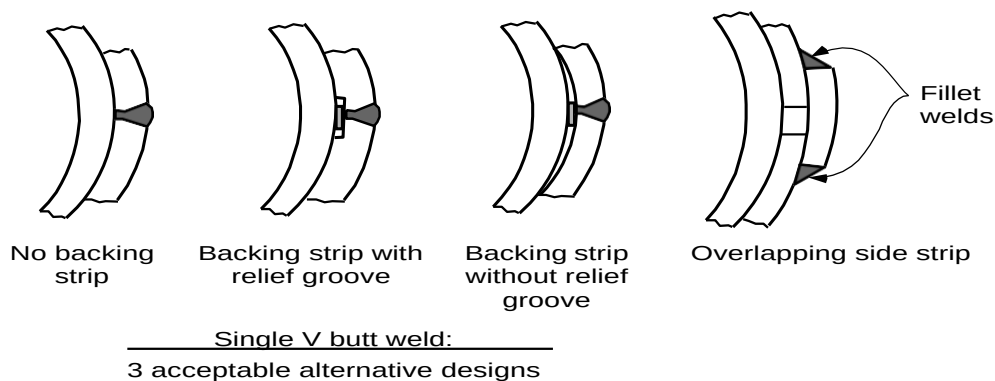
**Figure 8.4 – Weld Details for Type A Sleeve (Jaske, 2006)**

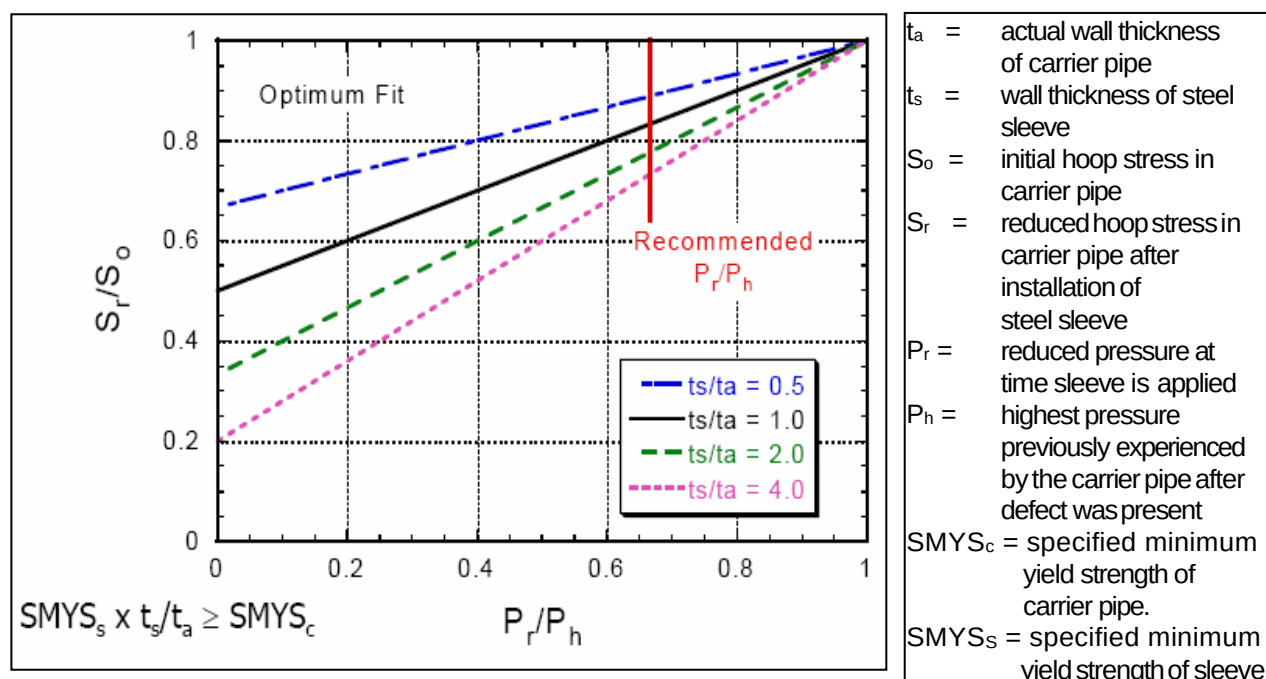
Figure 8.5 – Theoretical Relationships between Carrier Pipe Stress, Repair Pressure, and Wall Thickness. (Jaske, 2006)

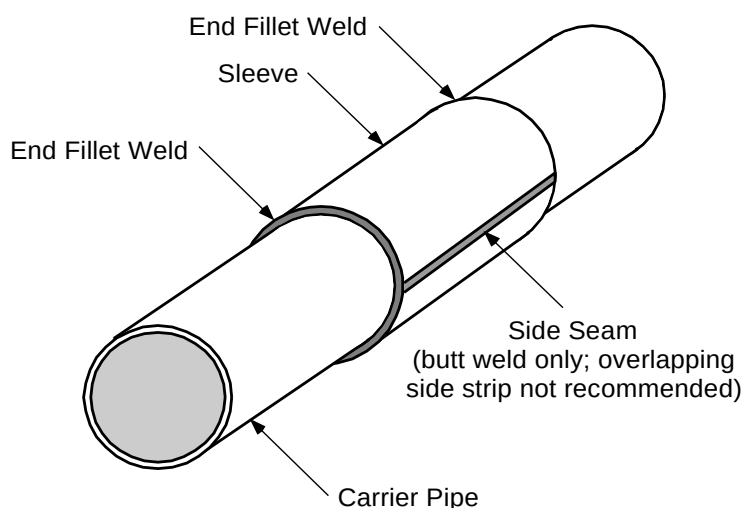
Figure 8.6 – Type B (Pressure Containing) Sleeve Illustration

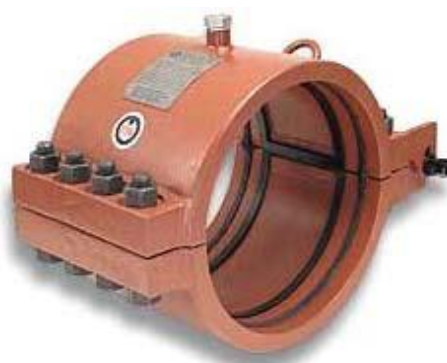
**Figure 8.7** – Typical Mechanical Bolt-On Clamp (courtesy of T. D. Williamson, Inc.).

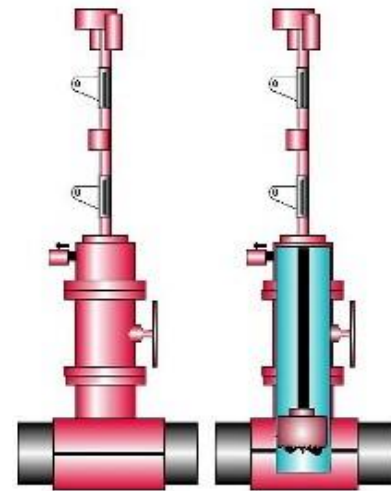
**Figure 8.8 – Hot Tap Equipment Connected to Pipe** (courtesy: <http://www.rafe1914.com>)
