**CENTRAL REGION OFFICE
Construction Inspection Report**

Project: Alberta Clipper Superior Station work

Location: Superior WI

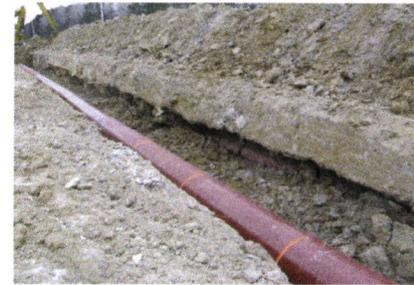
Met with Don French (Pipe Lowering Inspector). Pipe bags were on the ROW in preparation to be used in lieu of concrete pipe. As shown in Photo 4, observed location that the 20" and 36" pipe in the ditch was located no more than 6' apart.

Photograph Description
Photo 4: 20" and 36" in ditch

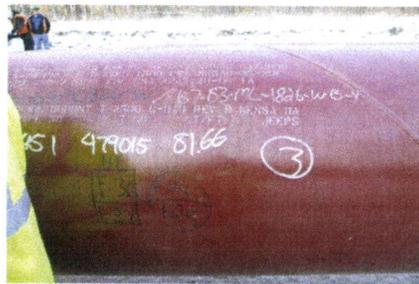
The inspection prompted a knife test to be performed at station 10600+00 (MP973) to see if any disbondment of the coating from the pipe would occur at the areas of cracking. Upon conclusion of the test, no signs of coating disbondment were noted. Enbridge stated that they would investigate the depth of the spider cracking in follow up.

Photograph Description
Weld identification number of joint where knife test was performed.

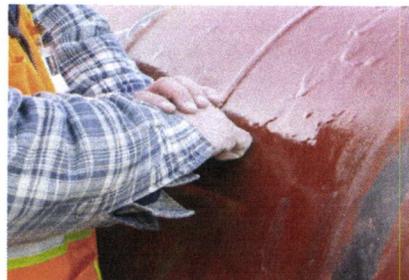
Photograph Description
Coating Foreman performing knife test.

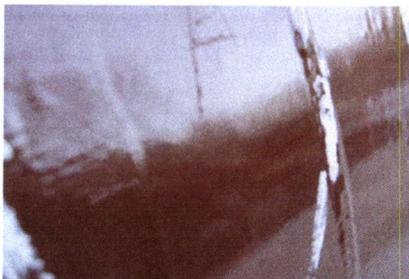
Station 10590+00 to 10610+00: The 36" diameter line FBE coating was inspected. During the inspection, areas of circumferential cracking was noted in the coating over the girth welds. The cracking was noted in the overlap of field applied coating over factory applied coating as well as the field applied coating over the girth weld areas. Longitudinal lines in the coating were also noted due to the pipe being jeeped over hot coating.

Photograph Description
Cut in coating after knife test and view of cracks in coating.

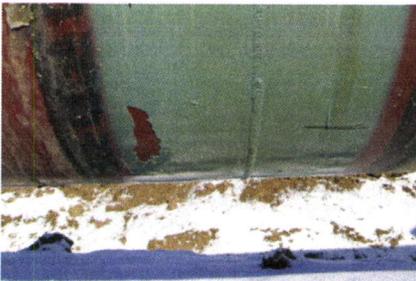
MNOPS / PHMSA observed fusion bond epoxy coating of the girth weld areas. Disbonding of the FBE coating from the factory applied coating was noted as illustrated below.

Disbonding of FBE coating from factory applied coating.

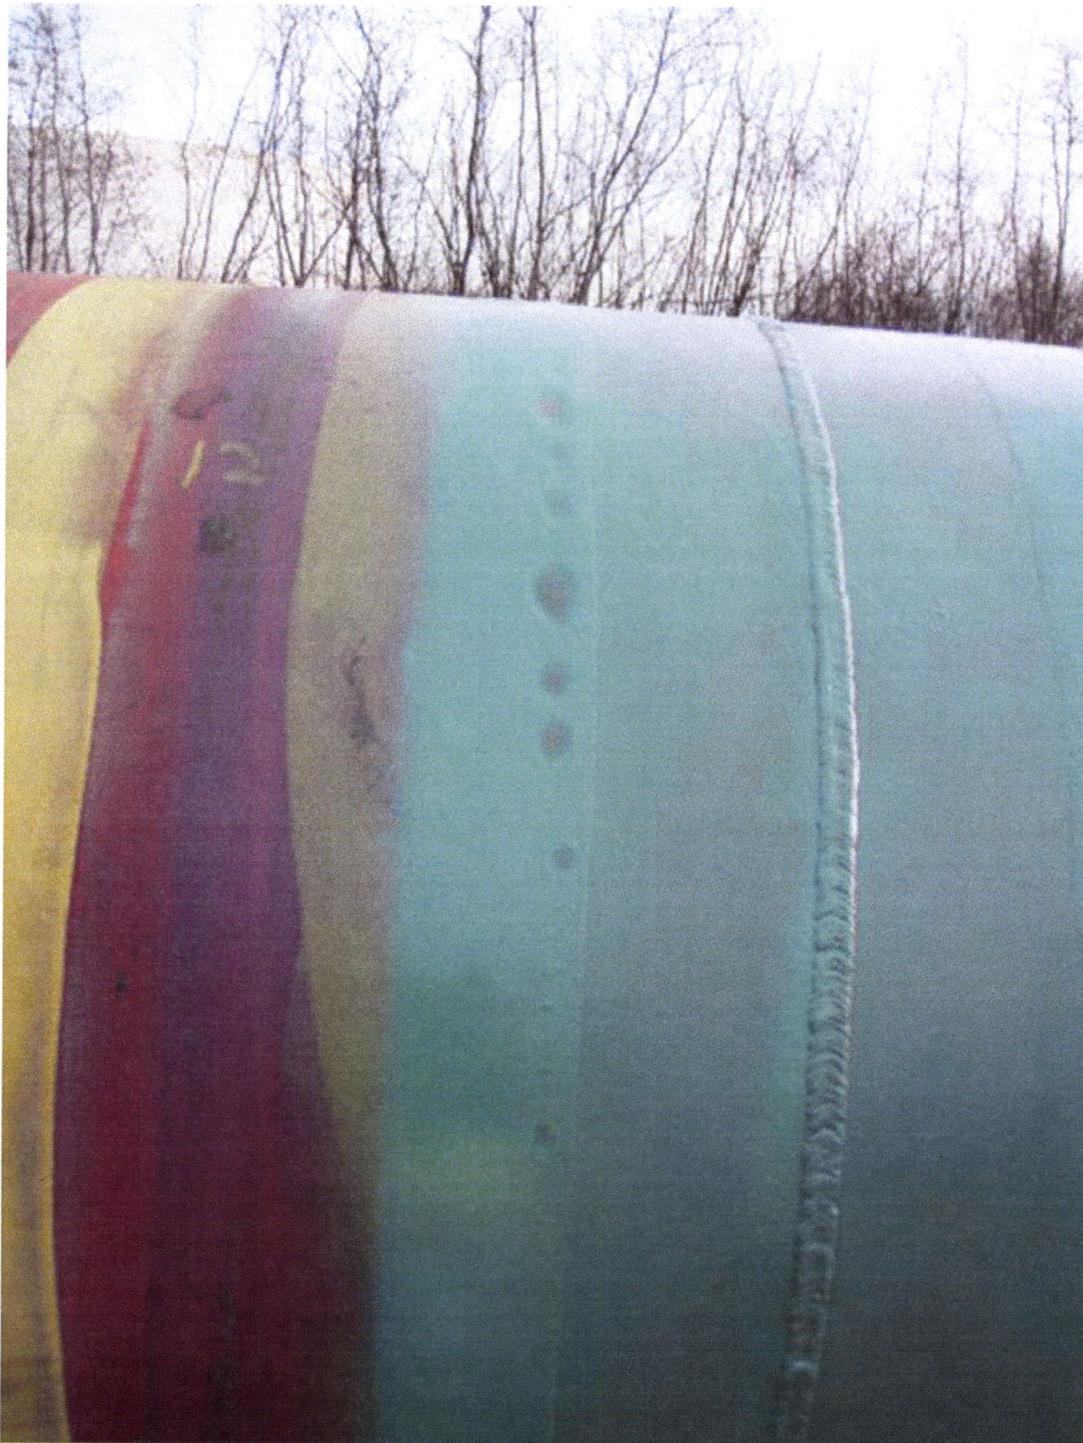
3. Coating blisters were identified on a number of coated welds, and the coating at these blisters was not adhered to the pipe. Project personnel performed an inspection the next day of 138 welds and identified a total of 29 in which this occurred, and these areas were to be sand blasted and re-coated. Personnel have been informed to watch for this during the coating operation.

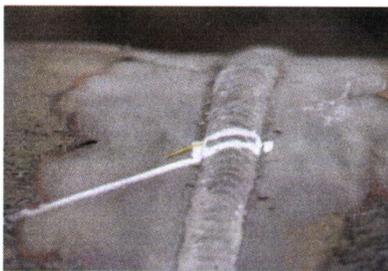
Photograph Description
 Location of defect identified on weld

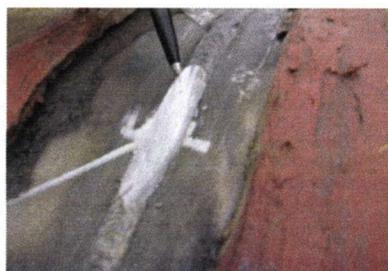
Photograph Description
 Partially ground out weld showing porosity and weld blanket with cut out area for repairs

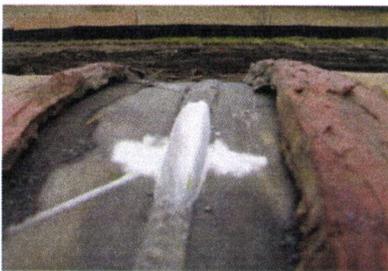
Photograph Description
 Fully ground out weld

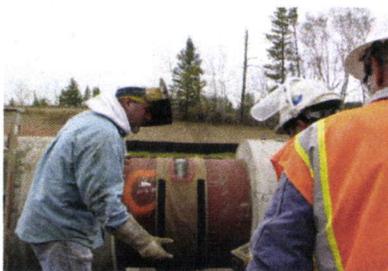
Photograph Description
 Repaired weld showing cutout repair blanket.

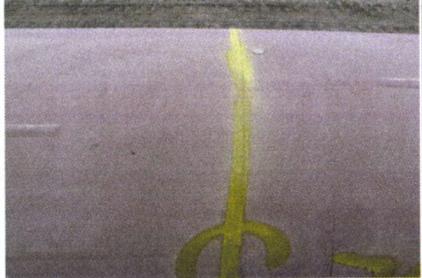
Intercept Bore. - Set up both sides.
 Pipe at 41' under river.
 75' casing added at west side to alleviate frac out. Verified by return.
 * Jeoped pipe, indications were not all patched. This on pull back pipe.

Photograph Description
 Pull Back pipe

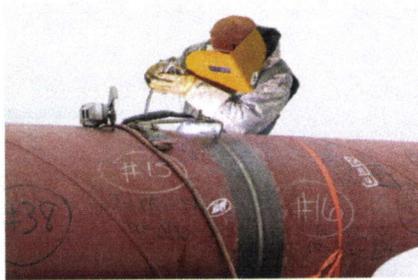
Repair Weld...
 UT is used on repair to verify.
 Single chance to repair weld, if still no good it is a cut out.

Photograph Description
 Welding a repair

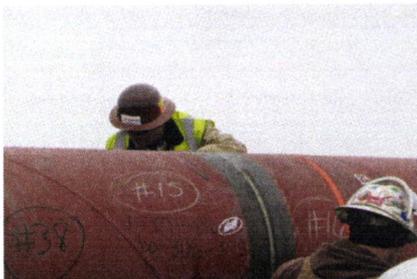
Photograph Description
 welding inspector looking at repair

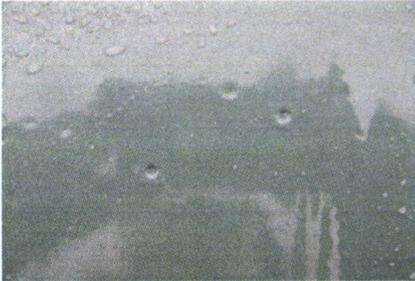
Flocking pipe...
 300 F heat with propane and final heat with clamp to 463 F.
 8 passes = 25 to 35 mils
 * unevenly applied coating
 * heat effected mill coating
 * Applied coating defects due to suspected atmospheric conditions.

Photograph Description
 Dimples in applied coating.

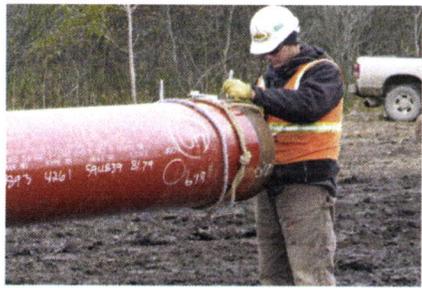
Photograph Description
 Marking top of pipe prior to bend

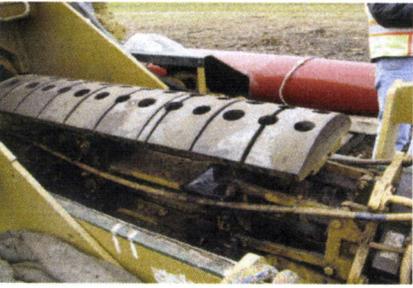
Photograph Description
 Mandrel - pre bend

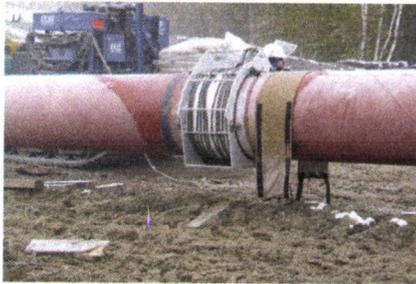
Photograph Description
Pre Heat

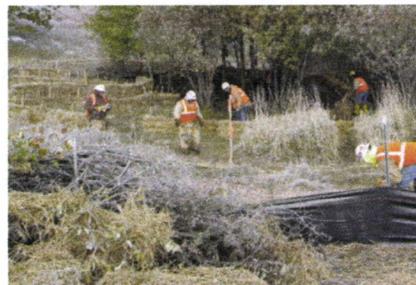
Observed 1/2 mile long HDD project.
 Clean up was progressing on a reported frac. out in a wetland area directly in front of the boring machinery.
 Observed the pull back pipe set up on west side. This pipe had previously been identified as having coating inadequacies. It appeared that re-coating had been completed.

Photograph Description
 frac spill on HDD Hwy 2 & Bemidji

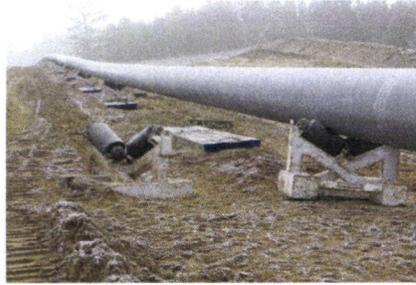
Photograph Description
 AR FBE Coating, prepped for pull through.

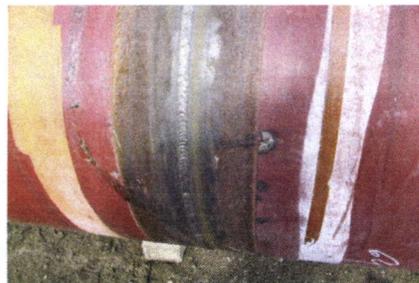
* Weld Splatter on coating and melted substance (tape?) on pipe

Photograph Description
Completed weld - Splatter onto coating. Fi

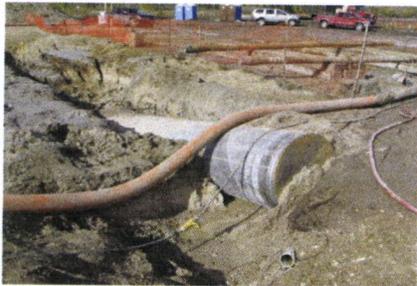
Photograph Description
 Pull back end of 36". Pulled in prior to arrival.

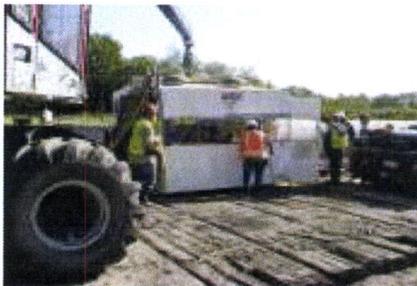
Photograph Description
Auto weld shack positioned.

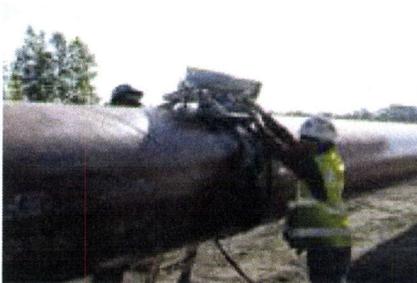
- Observed the ultrasonic testing on the 36" auto welds. There appears to be a change in the "burn through" assessment procedure. Their ECA allows a 3 dimensional volume criteria for "burn through's" according to Appendix A of the API 1104 20th edition for AUT examination of anomalies.

Photograph Description
Running the ultrasonic scan on 36" pipe.

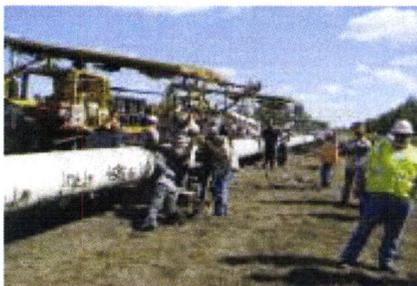
Photograph Description
Welding/firing gang crew.

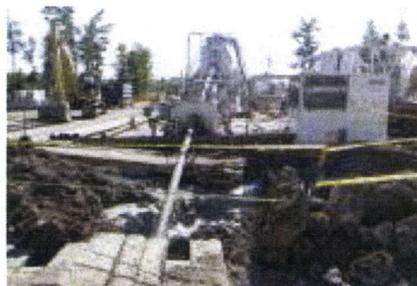
- Observed an HDD under the Prairie River. Bore run - approximately 55ft under river bottom, approximately 2,000ft total length.
- Looked at some fusion bond epoxy coating, 20" dia. pipe. Coating looked good on areas that were checked.
- Observed an x-ray on 20" dia pipe. Watched procedure and film development. X-ray film showed no weld flaws.
- Observed the welding/pipe gang on 20" dia. pipe.

Photograph Description
HDD under the Prairie River.

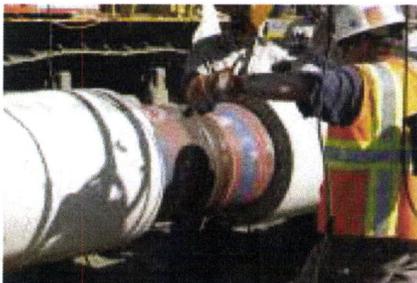
Photograph Description
Prepping for weld

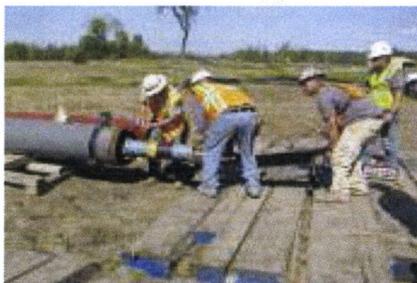
Photograph Description
Inserting internal x-ray unit.

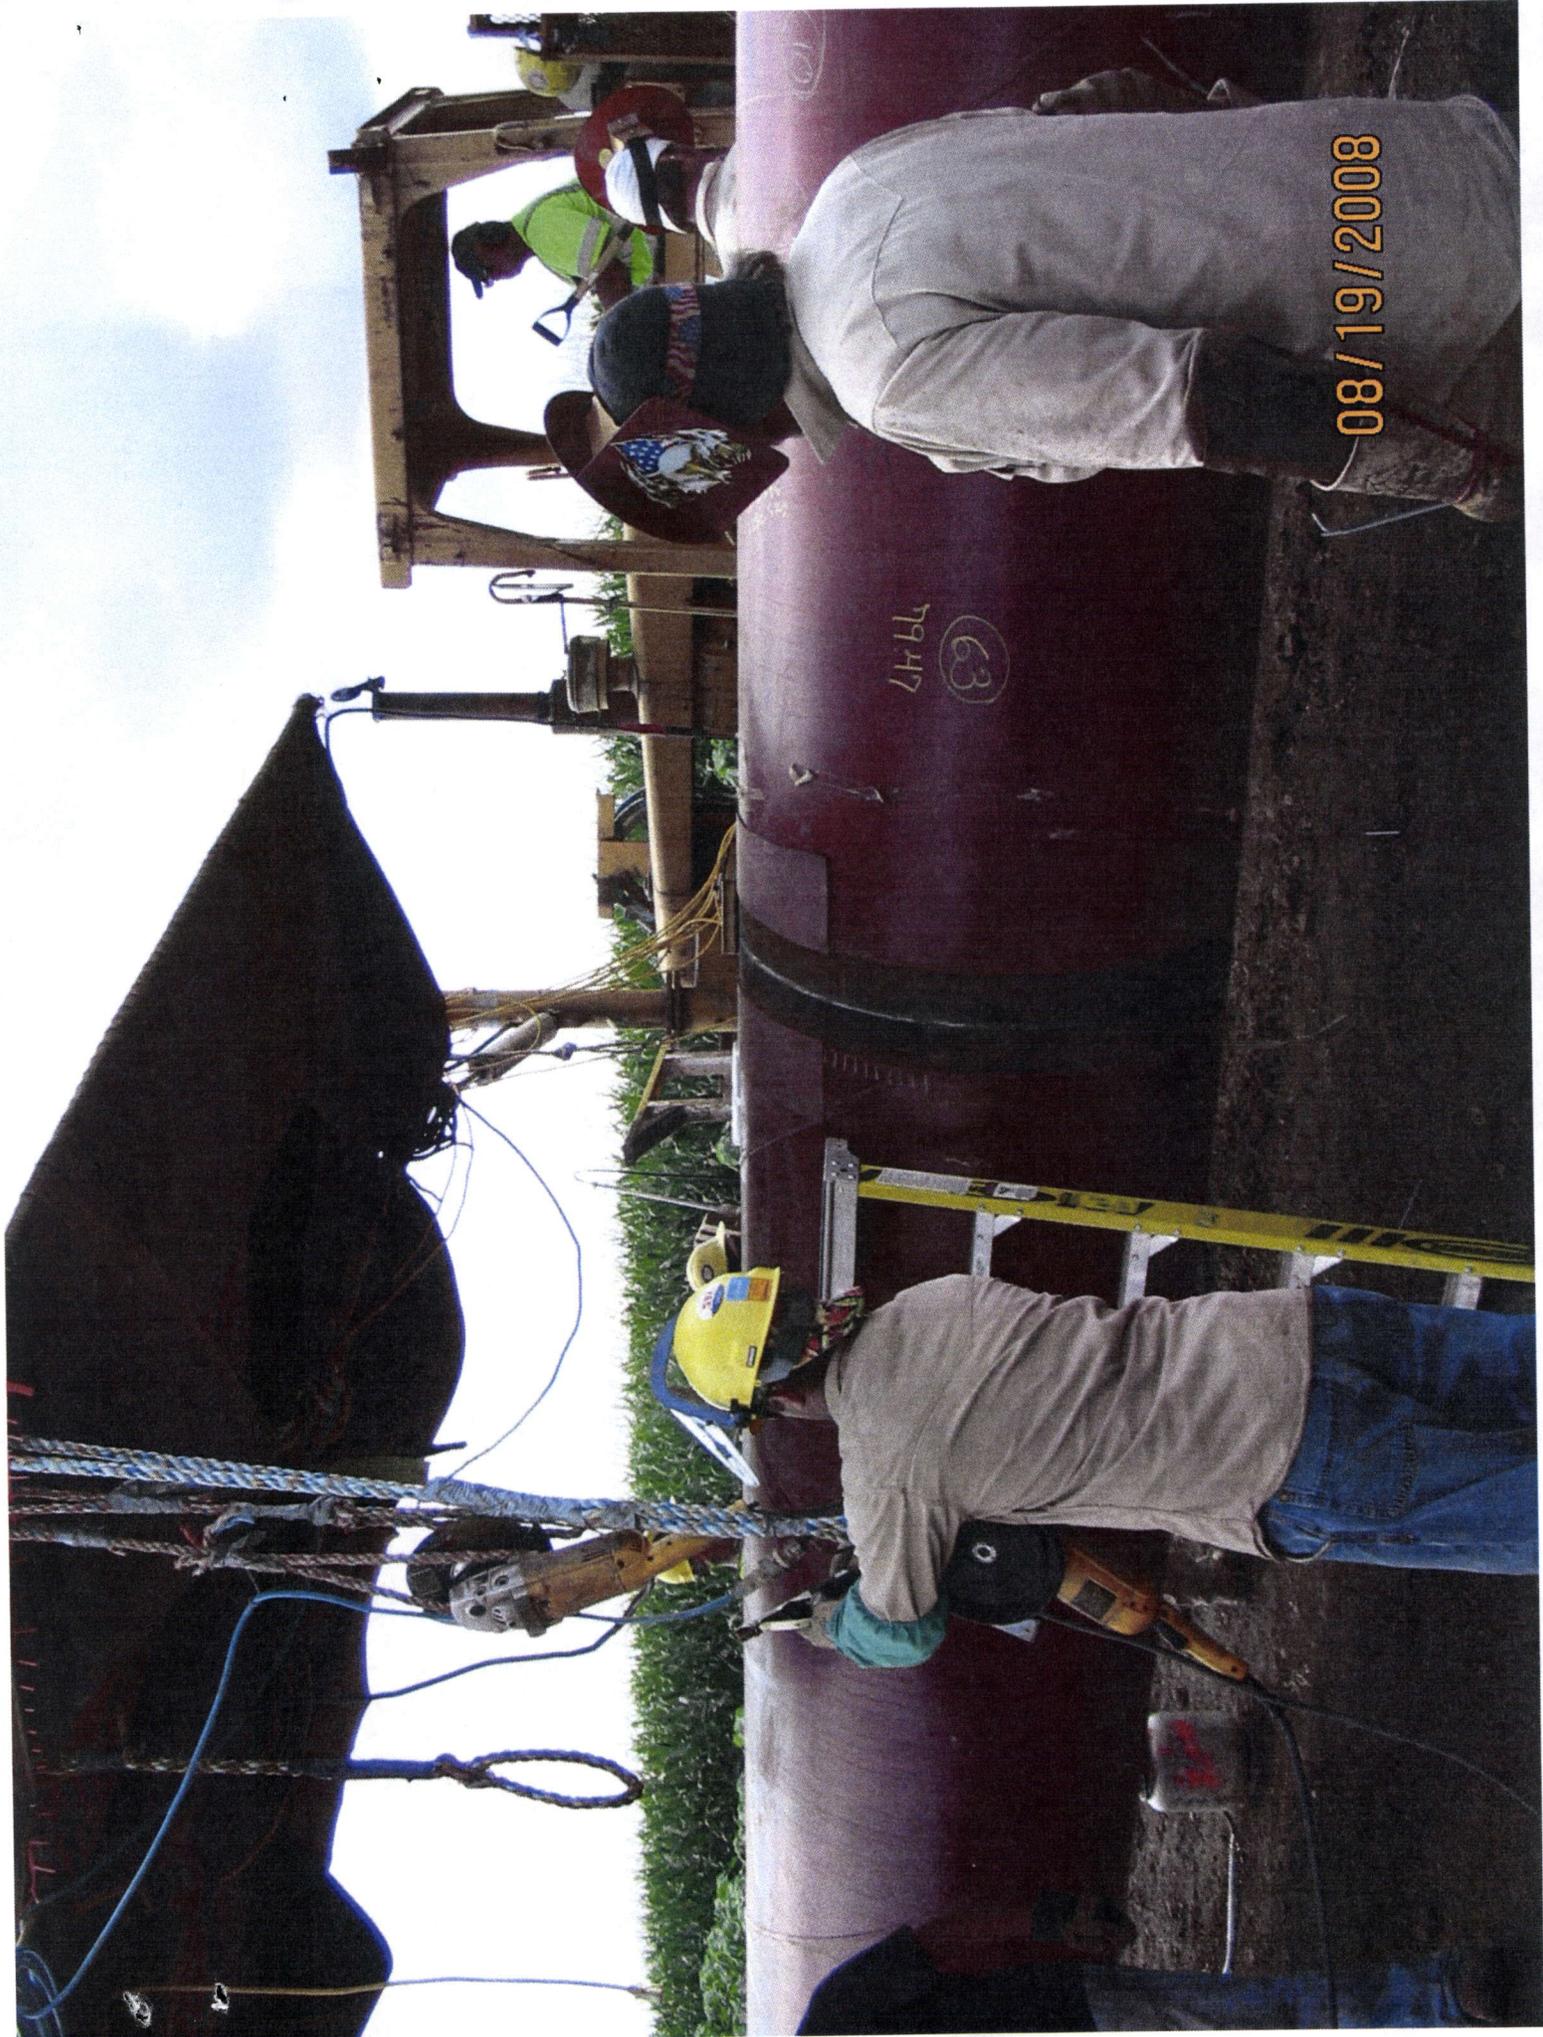
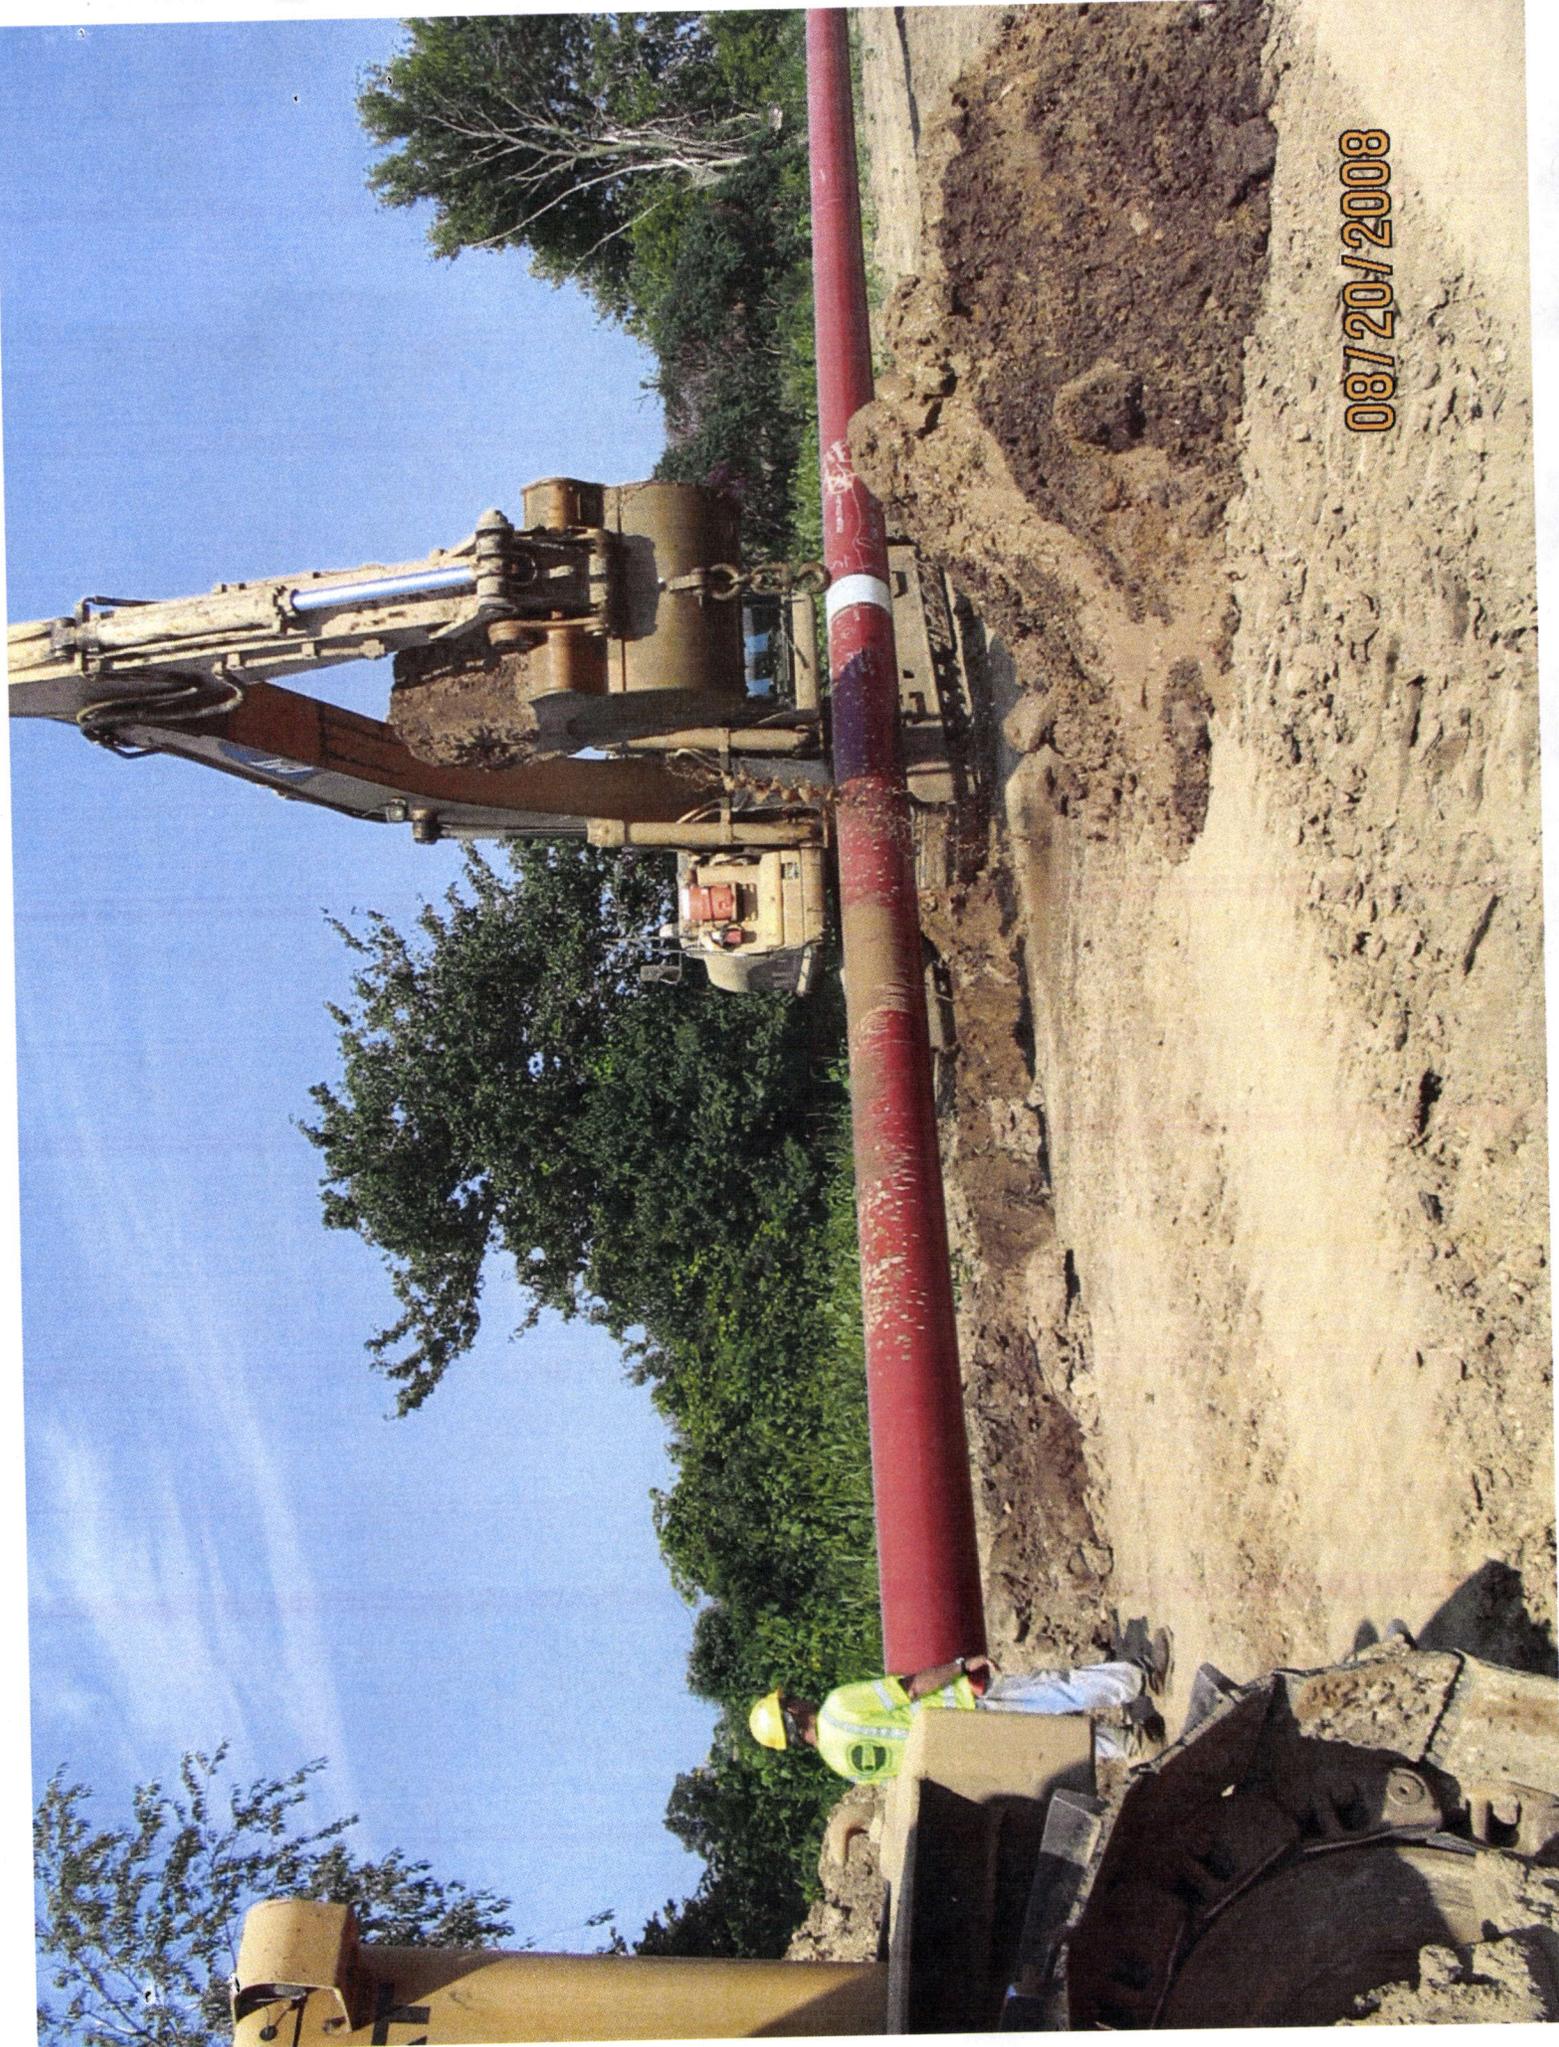
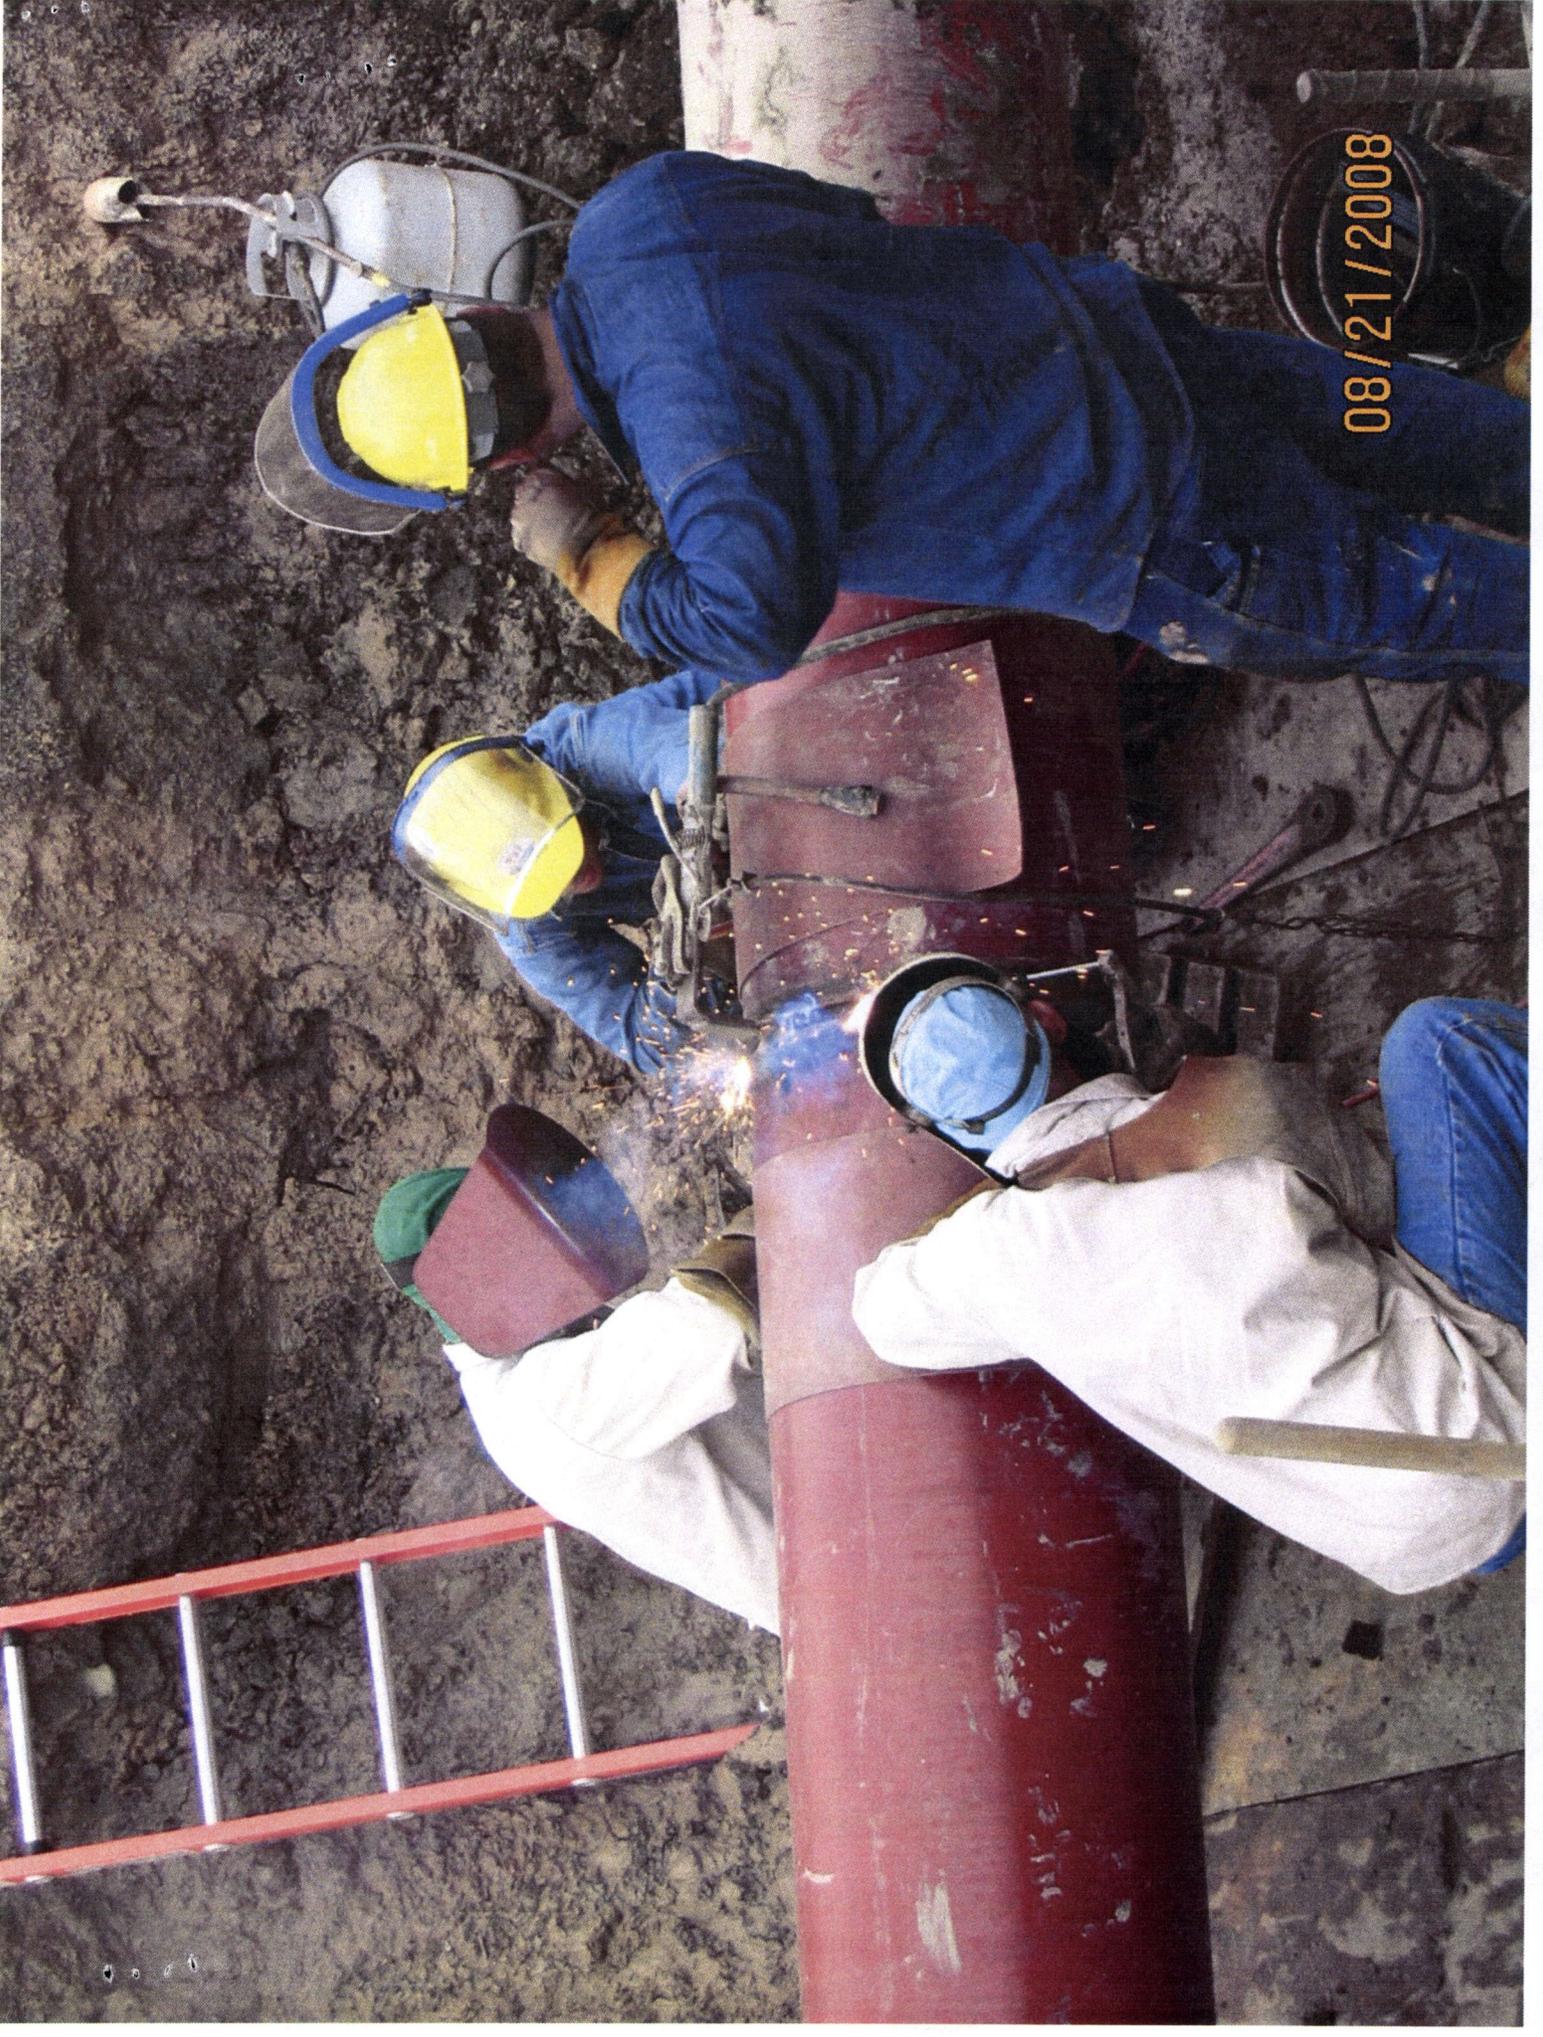
It was observed on August 20 on the pipe gang north of Highway 38 that the hot filler welders were not using splatter guards until requested to do so. The hot pass welders were using narrow splatter guards that should be wider. See pictures showing narrow and wide splatter guards
