**Digital Wave Corporation** 13760 East Arapahoe Road Centennial, CO 80112

Use of Modal Acoustic Emission (MAE) for life extension of civilian self-contained breathing apparatus (SCBA) DOT-CFFC cylinders

# FINAL REPORT

Contract DTPH56-13-P-000029

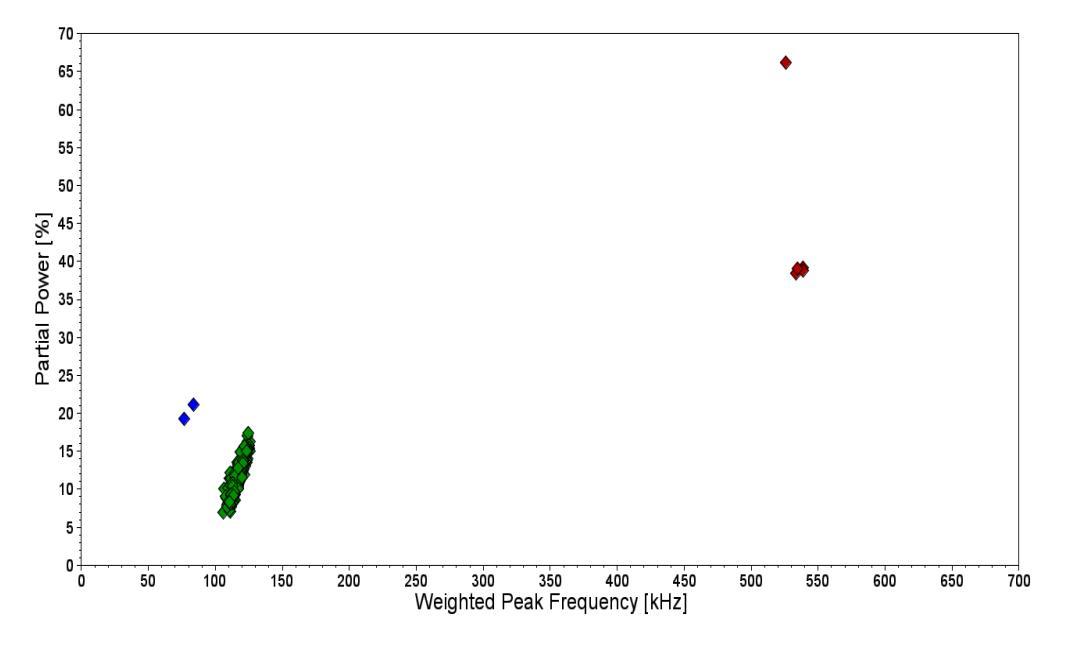
With the power of source mechanism classification recognized, the MAE data from fatigue testing of impacted cylinders may now be properly interpreted. Prior to performing source mechanism classification all events which corresponded to mechanical rubbing and flow noise were removed from the data set. Figure 6.16 presents the partial power versus weighted peak frequency plot for OM3938 during the 10,000 fatigue cycles. From Figure 6.16 it is observed that very few matrix cracking and fiber fracture events were observed, but a large number of interfacial failure events were observed. Due to the impact damage that was imparted on the cylinder, delamination between the various layers of the composite overwrapped pressure cylinder was present, and as the cylinder was cycled the delaminations were able to grow, as well as having the separated crack faces rub against one another generating frictional acoustic emission. Thus, the MAE signature during fatigue loading of a cylinder with simulated impact damage was found to be distinct and classifiable.

Figure 6.16 – Partial power versus weight peak frequency during 10,000 cycles to maximum developed pressure for OM3938.

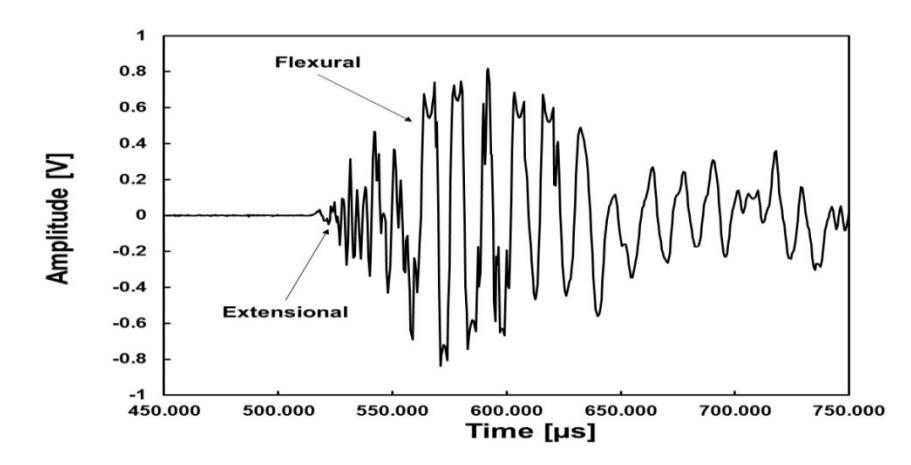
For the thirteen cylinders with simulated impact damage that were subjected to the EOL burst testing, seven of the thirteen cylinders were found to exhibit at least one large delamination event (a representative waveform is shown in Figure 6.17) on the first test pressurization cycle, while emitting nothing on the second test pressure cycle. From the waveform shown in Figure 6.17, both the extensional and flexural wave modes are clearly evident with the flexure mode dominating the relative amount of energy in the waveform. The dominant amount of flexural mode is characteristic of out-of-plane sources commonly associated with delamination. Delamination type sources are not surprising in light of the fact that a new damage state was introduced to the composite microstructure during the simulated impact. On the first test pressure cycle after the simulated impact event, several acoustic emissions were released as the damage state within the composite evolved and reestablished equilibrium. The absence of the delamination type sources on the second test pressure cycle indicates that the damage state did not significantly compromise the stability of the composite overwrap, which is confirmed in the mechanical stiffness and burst pressure data presented in Table 6.3.

Figure 6.17 – Representative delamination waveform emitted from OM3948 during the first test pressurization cycle.

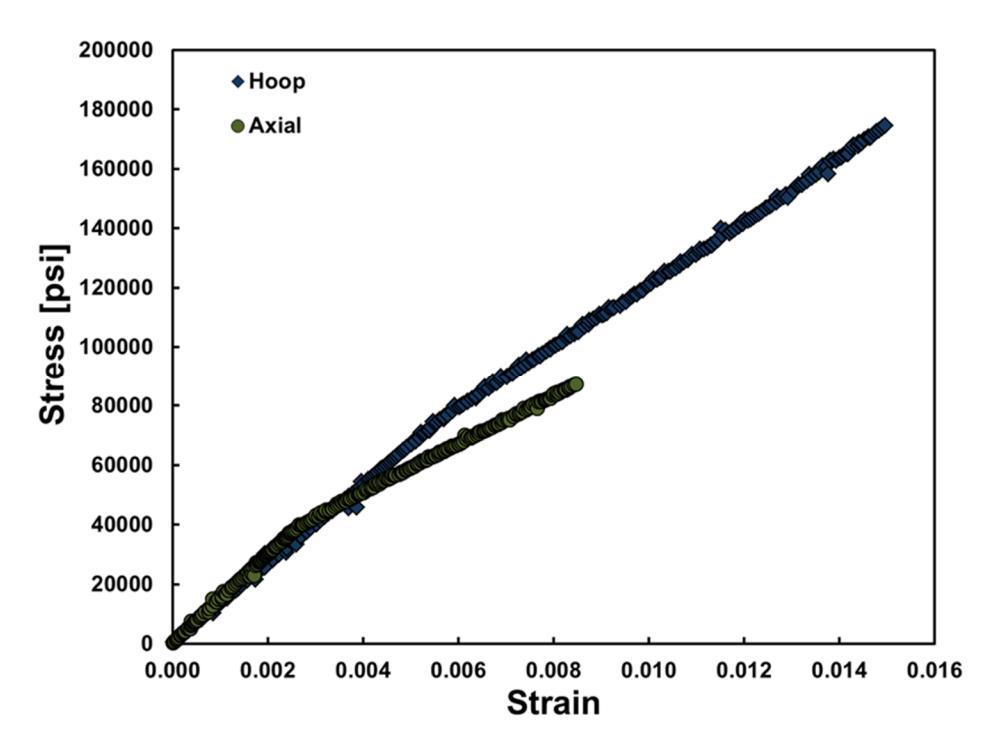
For the nine cylinders with notches that were subjected to the EOL burst testing, all cylinders were found to meet the minimum required burst strength of 10,000 psi [2], and seven of the nine cylinders were found to meet the minimum burst pressure (15,300 psi) requirements of DOT CFFC 5<sup>th</sup> revision [1]. From a stiffness response perspective, all cylinders were found to respond in a bi-modulus fashion. The typical response of a cylinder is shown in Figure 6.19, while stress-strain curves for all notched cylinders are provided in Appendix A. Due to extreme delamination of the sacrificial layer, certain stress-strain curves did not perfectly follow the clean bi-modulus response that was observed in all other cylinders subjected to an EOL burst. Table 6.4 summarizes the physical testing of all notched SCBA cylinders covered in this report.

Figure 6.19 - Stress-strain response of ALT639-17732 operated under DOT-SP 10945.

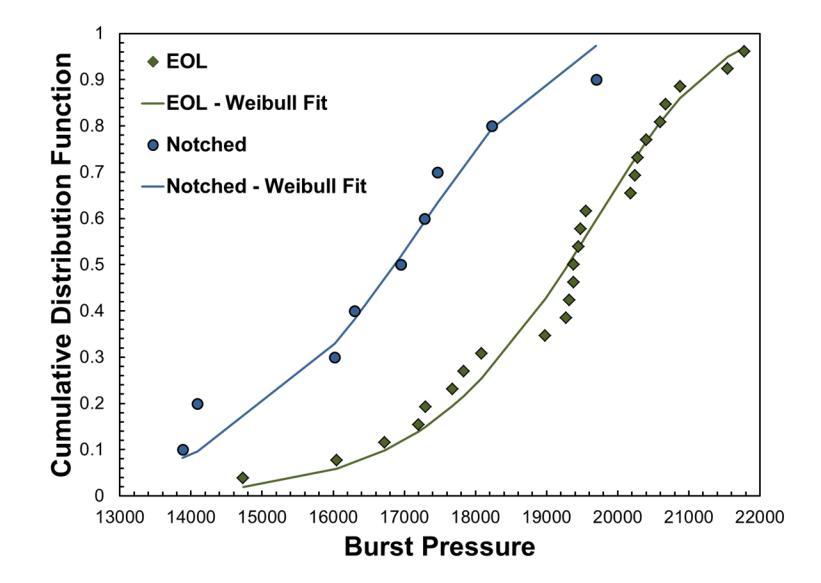
Figure 6.20 compares the two parameter Weibull distributions for cylinders which only experienced fifteen years of service life (Section 6.1.1) to the distribution of notched SCBA cylinders. From Figure 6.20 it was observed that the scale and shape parameters of the Weibull distribution for cylinders which experienced fifteen years of service life was 19,840 psi and 13.3, respectively, while the scale and shape parameters of the Weibull distribution for cylinders which experienced fifteen years of service life and were notched or notched and subjected to 5,000 cycles was 17,461 psi and 10.7, respectively. Such findings indicate that introducing two notches, which were over 50% of the depth of the composite overwrap, had a measurable effect on the burst strength of the SCBA cylinders. A 12% reduction in the scale parameter of the Weibull distribution for notched cylinders as compared to un-notched SCBA cylinder Weibull distribution, only 21.7% of SCBA cylinders with such a significant notch would burst below the minimum required burst pressure of DOT-CFFC 5<sup>th</sup> Revision [1].

Figure 6.20 - A comparison of the two parameter Weibull distributions for cylinders which experienced fifteen years of service life ( $\kappa = 19,840$  psi,  $\beta = 13.3$ ) to cylinders which experienced fifteen years of service life and subjected to the notch tolerance testing ( $\kappa = 17,461$  psi,  $\beta = 10.7$ ).

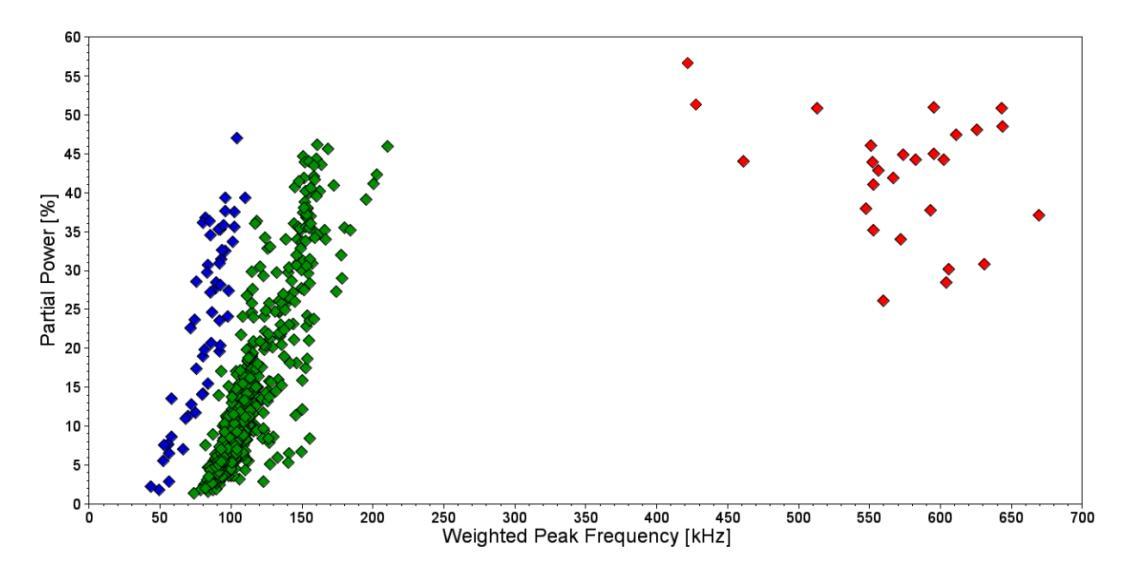
Using the power of source mechanism classification (highlighted in Section 6.3.2), the MAE data from notched cylinders could be properly interpreted. Prior to performing source mechanism classification all events which corresponded to mechanical rubbing and flow noise were removed from the data set. As a representative example, MAE data from the EOL burst test of ALT695-3929 was analyzed. Figure 6.22 presents the partial power versus weighted peak frequency for the EOL burst test of ALT695-3929, from which it was observed that a large number of interfacial failure events (particularly delaminations) were observed. Due to notching the cylinders, a free surface was created at which the hoop and helical wraps will tend to delaminate due to the extreme Poisson Ratio mismatch of the plies. As an example of this type of behavior, Figure 6.23 shows a notched SCBA cylinder that was taken to approximately 95% of its' burst strength and then de-pressurized in order to photograph the damage state. From Figure 6.23, the large amount of delamination originating from the free surfaces created at the axial notch was quite obvious, providing strong evidence that the MAE signature during pressurization of a notched cylinder was found to be distinct and classifiable.

Figure 6.22 – Partial power versus weight peak frequency during a burst test pressurization for ALT695-3929. The blue diamonds identify matrix cracking events, the green diamonds correspond to interfacial failure events, and the red diamonds signify fiber fracture events.

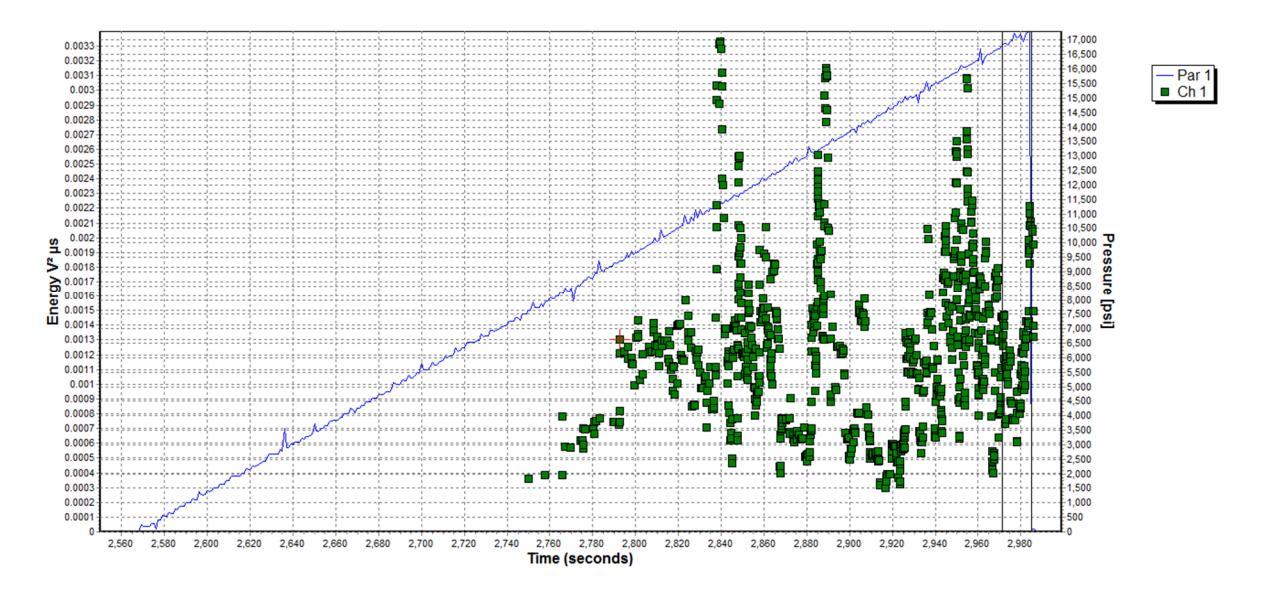
MAE life extension requirements due to background energy oscillations on both test pressure cycles, while OP11129 failed the single event energy criterion on the second test pressure cycle. Additionally, one other cylinder (IH2554) failed Digital Wave's MAE life extension due to background energy oscillation on the first test pressure cycle; however, the cylinder did burst at 16,020 psi. For IH2554 (as with all notched cylinders), the ratio of background energy oscillation pressure to burst pressure was lower as compared to un-notched cylinders, due to the extreme stress concentrator that was put into the notched SCBA cylinders. An example of the determination of the background energy oscillations for a notched cylinder is shown in Figure 6.24, while all BEO plots are presented in Appendix B.

Figure 6.24 – Background Energy Oscillation for ALT639 - 17827.

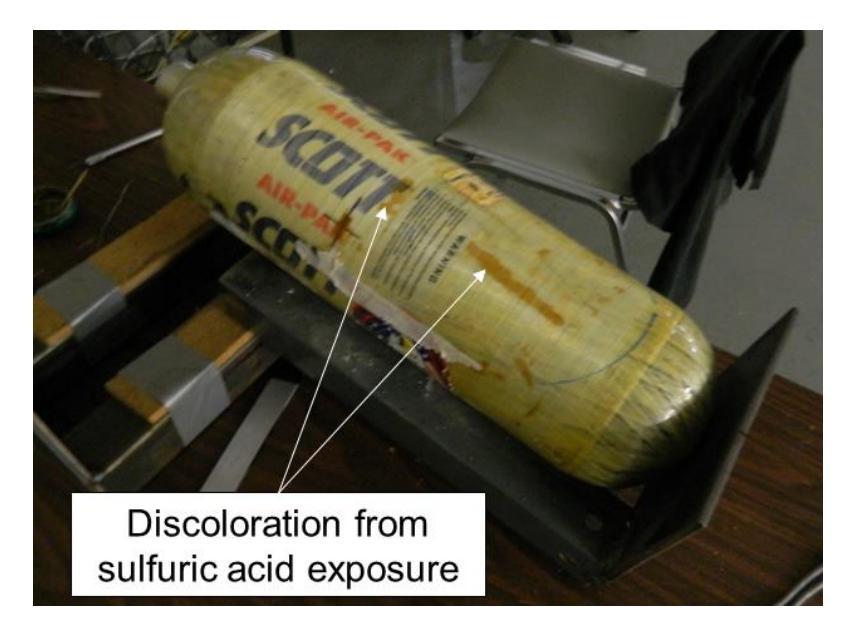
After the 100 hour hold at operating pressure with the sulfuric acid patch painted on the cylinder, the only physical sign of acid exposure were patches of discoloration of the gel coat of all DOT-SP 10945 cylinders (as shown in Figure 6.26). The DOT-SP 10915 cylinders did not show any physical signs of acid exposure.

Figure 6.26 – Typical discoloration of the gel coat of DOT-SP 10945 cylinders after 100 hours of sulfuric acid exposure while being held at operating pressure.

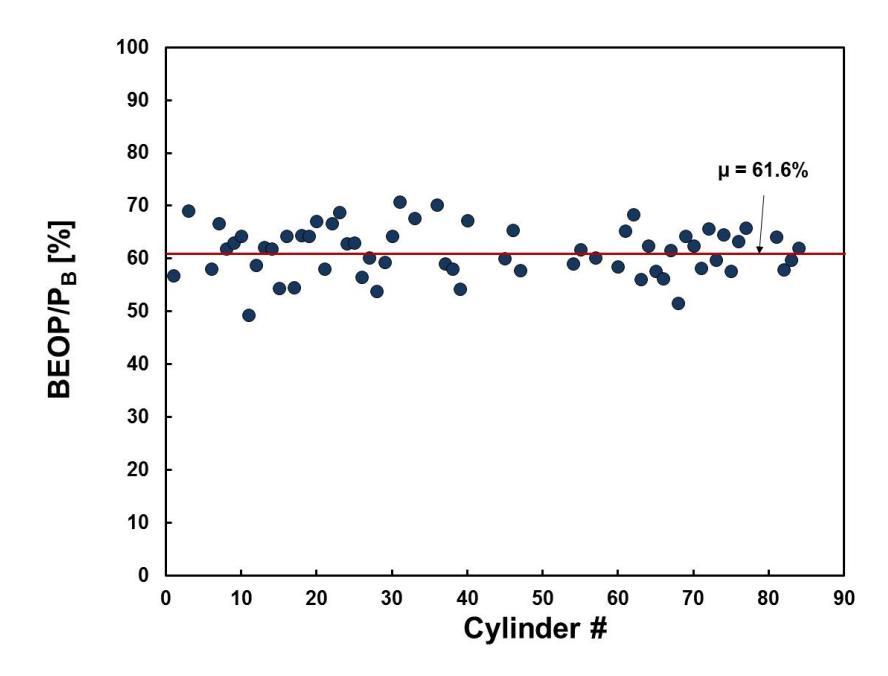
It was shown in [3] that the Background Energy began oscillating at a consistent pressure relative to the ultimate burst strength of a given cylinder. The data from [3] is represented here for completeness in Figure 6.32. From Figure 6.32, it is seen that on average a cylinder began oscillating at a pressure of 61.6% of its' respective burst pressure. Further, it was found that the distribution of normalized Background Energy Oscillation Pressures (BEOP/P<sub>B</sub>) was tightly grouped about the mean (a standard deviation of 4.6%). Hence, due to the consistent onset of BEOP, and the tight clustering of the distribution of the BEOP, it was found that the BEOP can be used as a reliable predictive metric for the burst strength of a given SCBA pressure cylinder [3].

Figure 6.32 – Background Energy Oscillation Pressure (BEOP) as a function of burst pressure (P<sub>B</sub>) for all cylinders tested in the Navy SCBA test program [1].

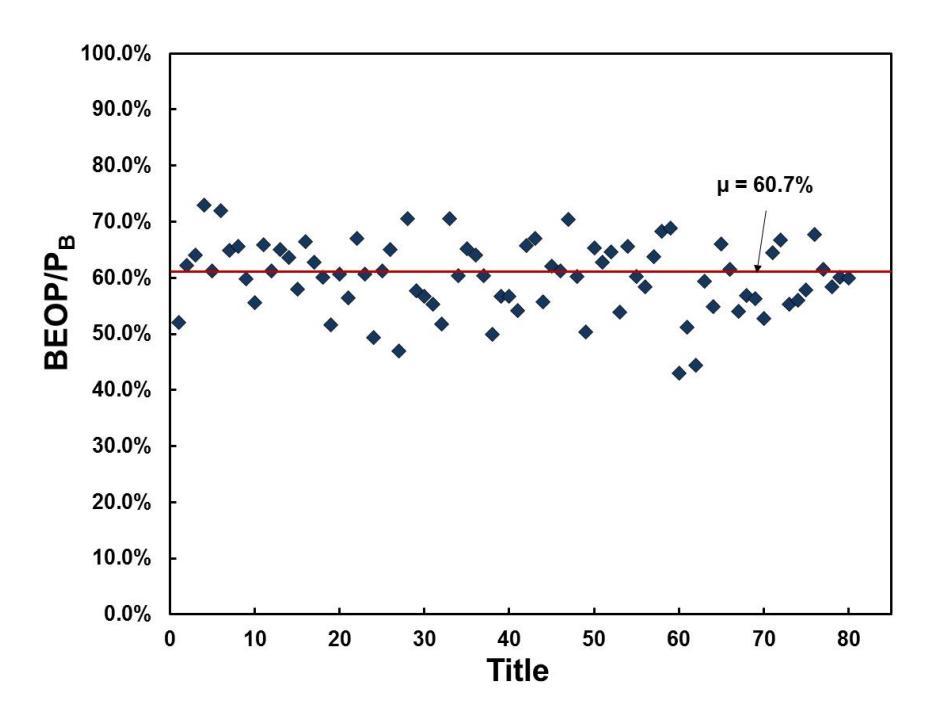
Similarly, in this study the normalized Background Energy Oscillation Pressure  $(BEOP/P_B)$  was found to occur at a consistent value (Figure 6.33). From Figure 6.33, it is seen that on average for the civilian SCBA pressure cylinders tested, a cylinder began oscillating at a pressure of 60.7% of its' respective burst pressure. Further, it was found that the distribution of normalized Background Energy Oscillation Pressures (BEOP/P<sub>B</sub>) was tightly grouped about the mean (a standard deviation of 5.7%). Thus, the predictive capability of the Background Energy Oscillations and Modal Acoustic Emission has again been shown in this study.

Figure 6.33 - Background Energy Oscillation Pressure (BEOP) as a function of burst pressure (P<sub>B</sub>) for all cylinders tested in the current study.

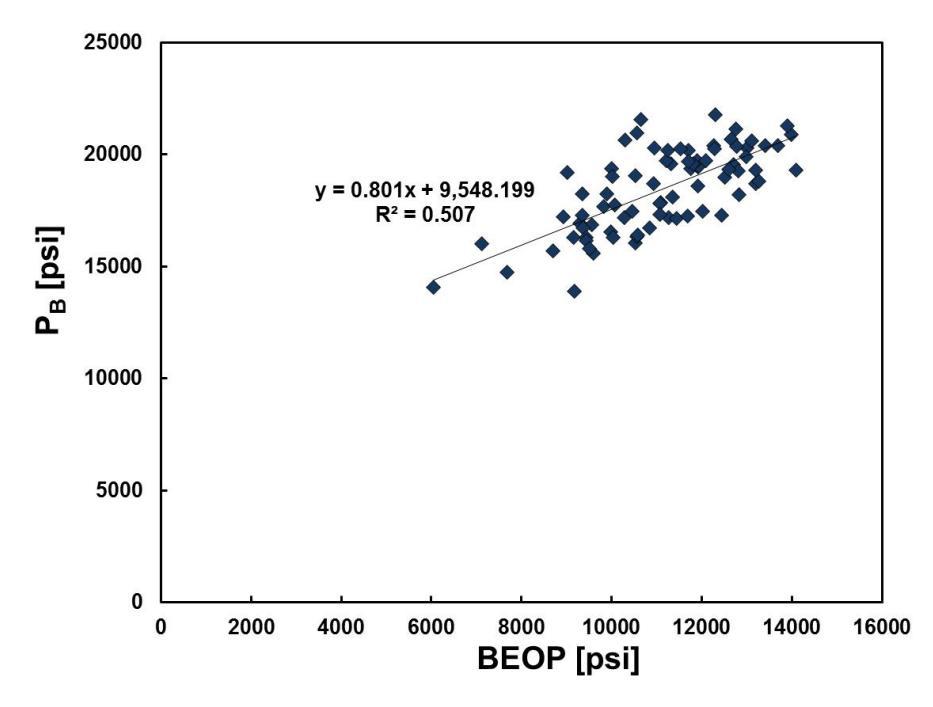
To further demonstrate the relationship between the Background Energy Oscillation Pressure and the burst pressure of an SCBA pressure cylinder, Figure 6.34 shows the burst pressure of a cylinder as a function of the Background Energy Oscillation Pressure. From Figure 6.34, it is observed that a strong correlation (goodness of fit coefficient equal to 0.51) existed between the BEOP and the burst pressure of a cylinder. Such a strong correlation further validates the predictive capability of the BEOP.

Figure 6.34 – Burst pressure of a cylinder as a function of BEOP for all civilian SCBA cylinders.

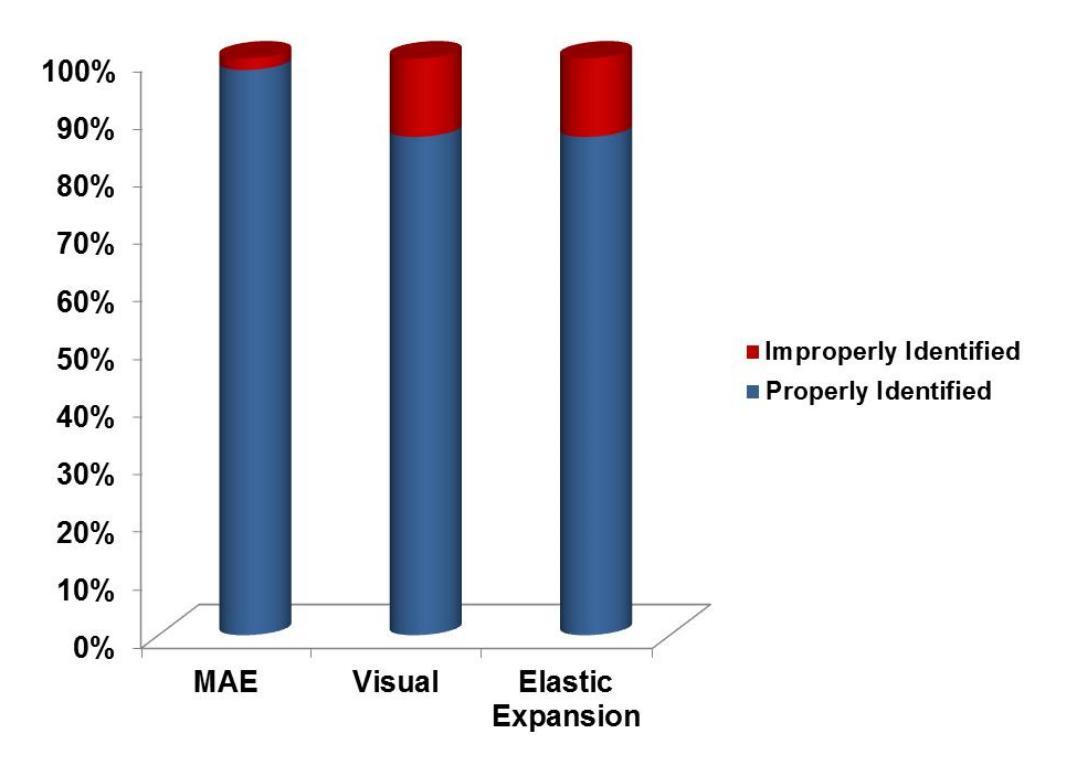
The efficacy of Modal Acoustic Emission, visual inspection, and elastic expansion for all cylinders which were burst tested in Sections 6.1 through 6.6 was compared. The percentage of the time that the respective NDE technique agreed with whether or not an SCBA pressure cylinder burst above the minimum required burst strength was compared (Figure 6.35). It was found that MAE properly identified 98.2% of the cylinders tested, while visual inspection and elastic expansion both only properly identified 86.4% of the cylinders. Of concern, the elastic expansion measurement at test pressure passed all three cylinders which burst below the minimum required burst strength. The majority of the misses for the visual inspection and elastic expansion technique were of the false-positive variety; however, false-negatives (which are far more concerning) for both visual inspection and elastic expansion occurred. ALT 604 - 3742passed the visual inspection (and hydrostatic test), but burst below the minimum required pressure of DOT CFFC 5<sup>th</sup> Revision [1]. Such an occurrence points out the lack of sensitivity of the visual inspection and elastic expansion measurement to microstructural damage, which is the controlling factor in cylinder burst strength. It is pointed out that MAE properly identified and rejected ALT604-3742 which had compromised burst strength. The one miss that MAE had was a false-positive in which Background Energy Oscillations on the second test pressure cycle caused IH2554 to fail the MAE life extension requirements, with the cylinder bursting at 16,000 psi.

Figure 6.35 – Evaluation of how often the result of the various NDE inspection technique agreed with the minimum required burst pressure of the CFFC 5<sup>th</sup> Revision [2].

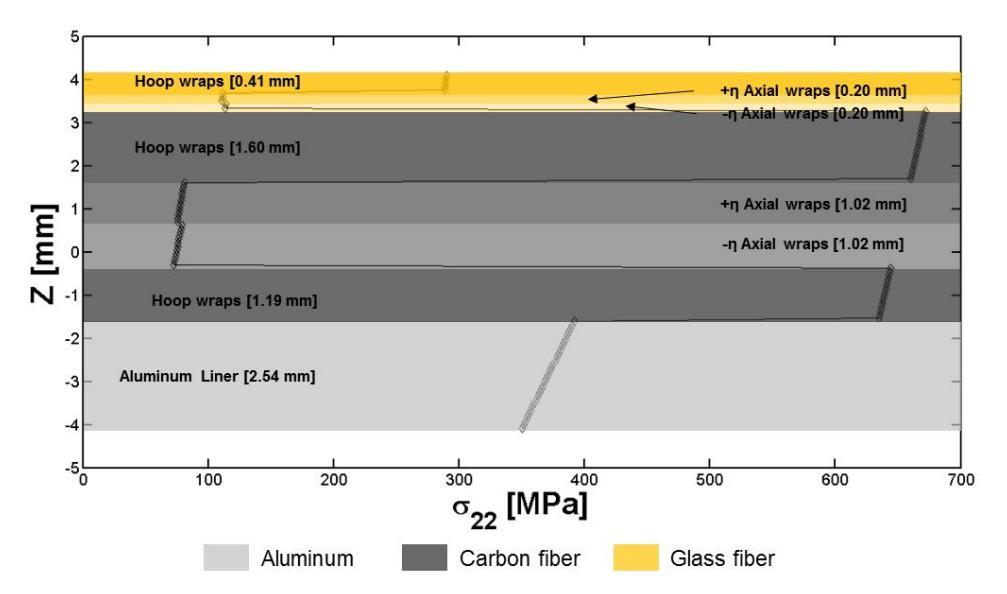
Figure 8.3 shows the first (axial) principal stress, while Figure 8.4 shows the second (hoop) principal stress. From Figure 8.4 it can be seen that the maximum hoop stress within the aluminum liner at the maximum developed pressure was found to be 391.7 MPa (56,800 ksi), which is the value for the hoop stress within the aluminum liner that will be used in all subsequent fatigue life estimation analyses. Note the yield strength of the 6061-T6 Aluminum was taken as the maximum stress within the aluminum liner when subjected to the initial autofrettage pressure of (7500 ksi), resulting in  $S_y = 82.1$  ksi.

Figure 8.4 – Distribution of hoop stress through the laminate thickness for a representative SCBA CFFC pressure cylinder at maximum developed pressure during fast fill (5,192 psi).

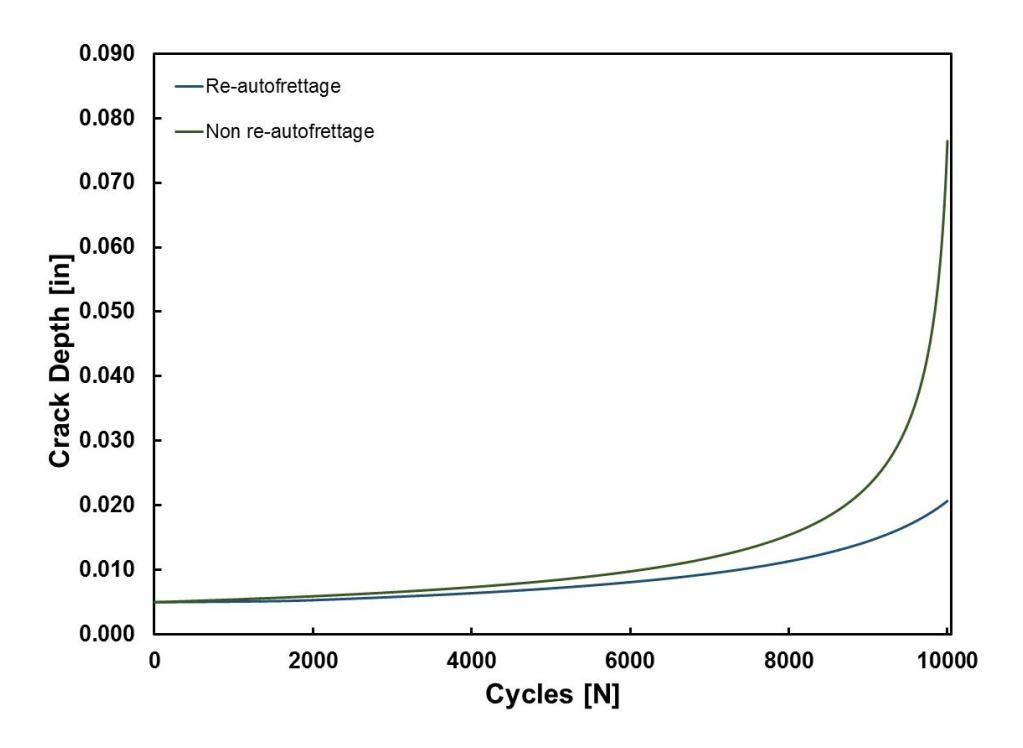
Figure 8.5 provides the crack length as a function of the number of cycles to maximum developed for the representative DOT-CFFC cylinders that were and were not reautofrettaged. The Paris law model predicts that the considered initial flaw ( $a_0 = 0.005^{\circ}$ ,  $2c_0 = 0.050^{\circ}$ ) would grow to a depth of 0.076" in 10,000 cycles. A slightly larger flaw (only one to two thousandths of an inch) would grow through the remaining 0.024" before 10,000 cycles, resulting in leakage of the aluminum liner. Also, in good agreement with the observations of Section 6.6, specifically the re-autofrettaged SCBA cylinders, the Wheeler model predicts reduced crack growth behavior (as compared to cylinders which did not experience the tensile overload). This reduced crack growth rate behavior is due to all existing cracks being blunted and put into residual compression upon the removal of the tensile overload; such behavior is what enabled 87.5% of the heavily corroded liners to achieve an additional 10,000 fatigue cycles to maximum developed pressure during fast fill (Table 6.6).

Figure 8.5 – Crack depth as a function of the number of cycles to maximum developed pressure for Aluminum liners that were and were not re-autofrettaged.

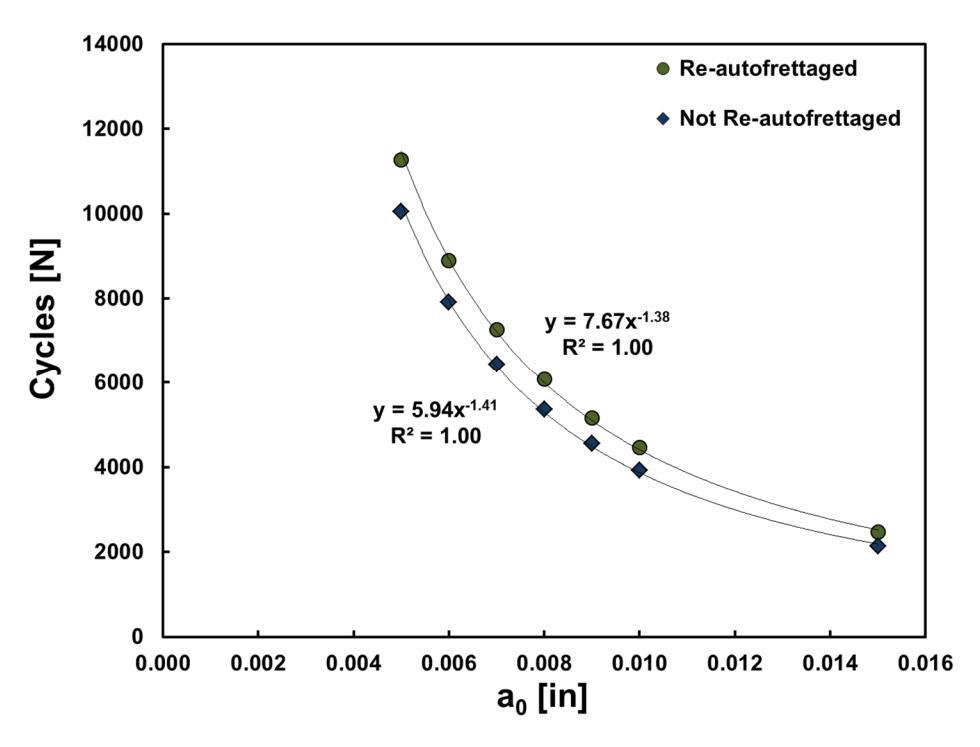
Figure 8.6 – Effect of the initial flaw depth (a<sub>0</sub>) on the total number of obtainable fatigue cycles to maximum developed pressure prior to the flaw growing through the aluminum liner.

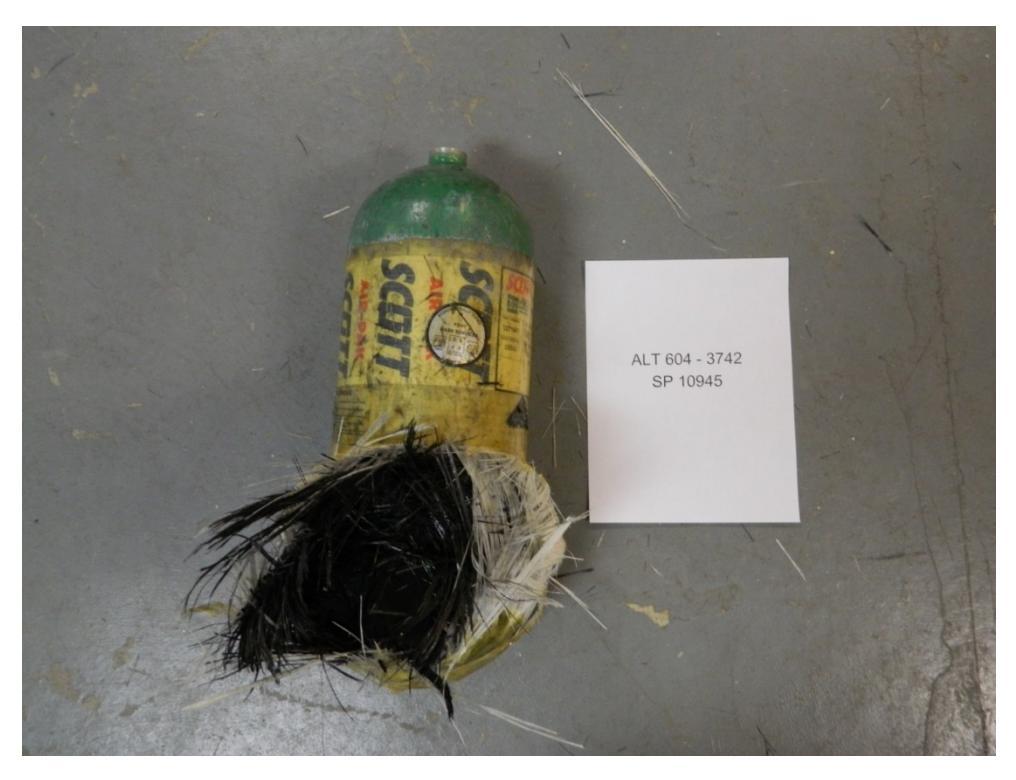
Figure 10.1 – Image of ALT604-3742 after EOL Burst testing.

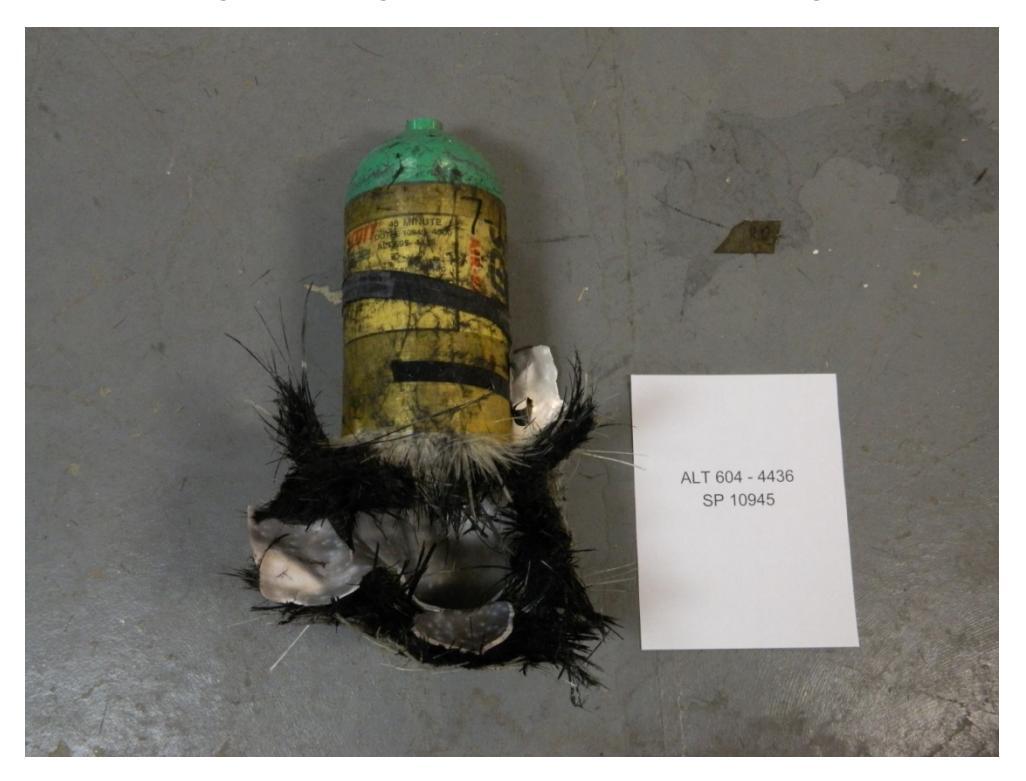
Figure 10.2 – Image of ALT604-4436 after EOL Burst testing.

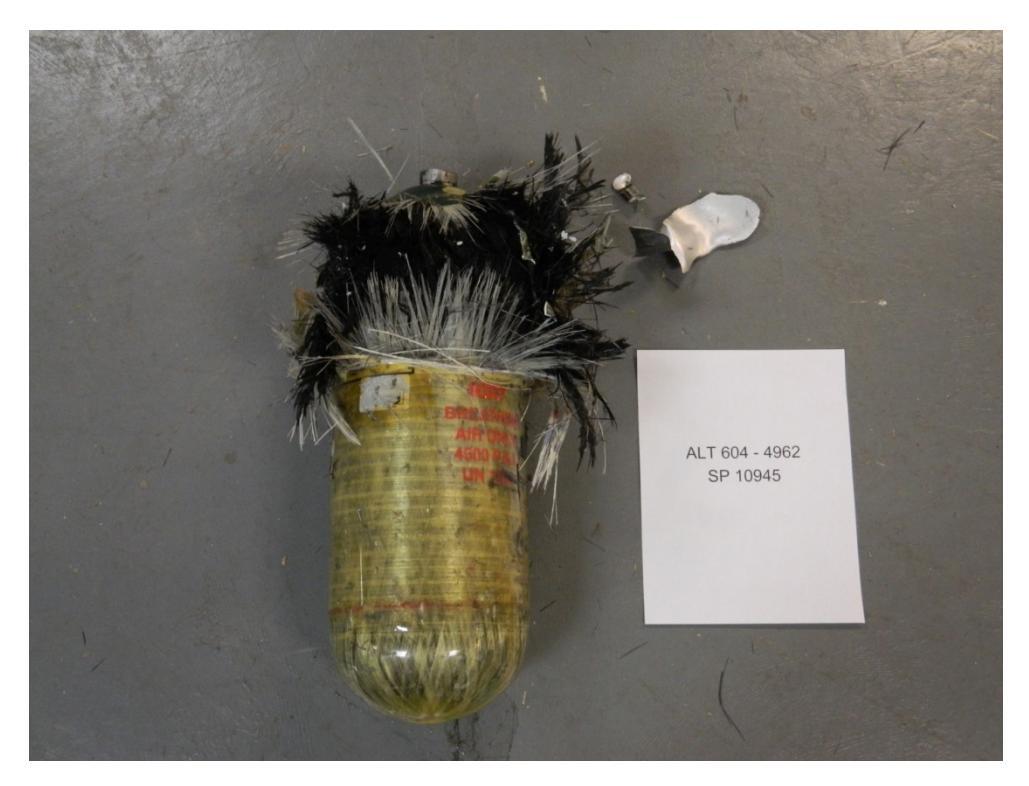
Figure 10.3 – Image of ALT604-4962 after EOL Burst testing.

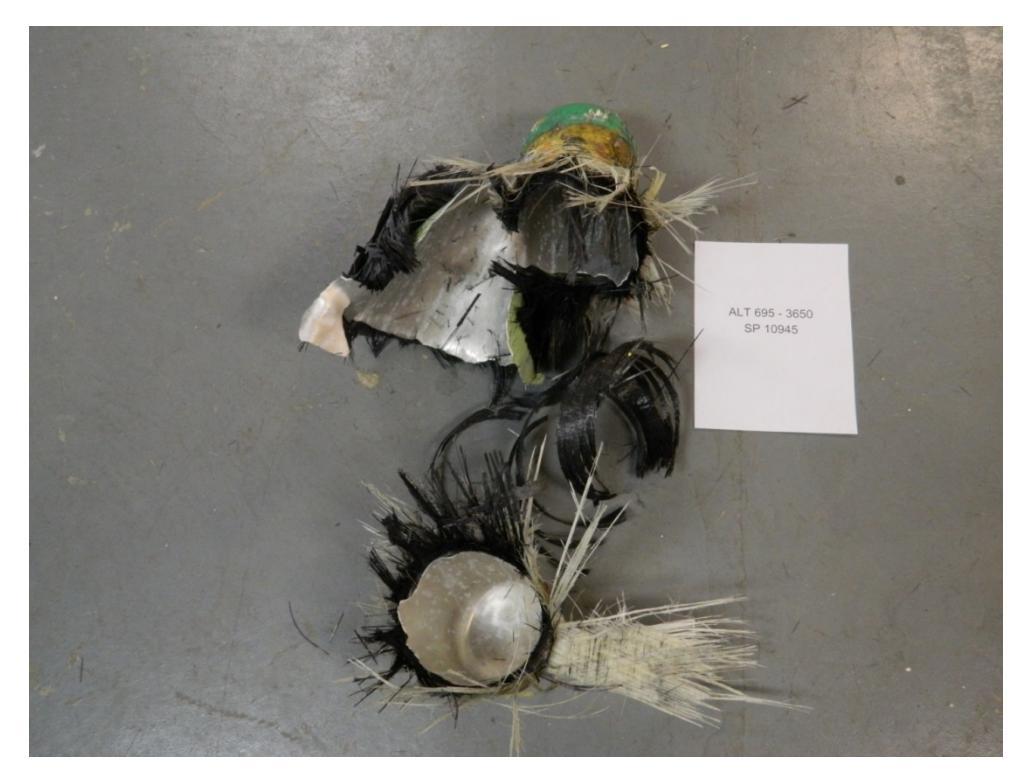
Figure 10.4 – Image of ALT604-3650 after EOL Burst testing.

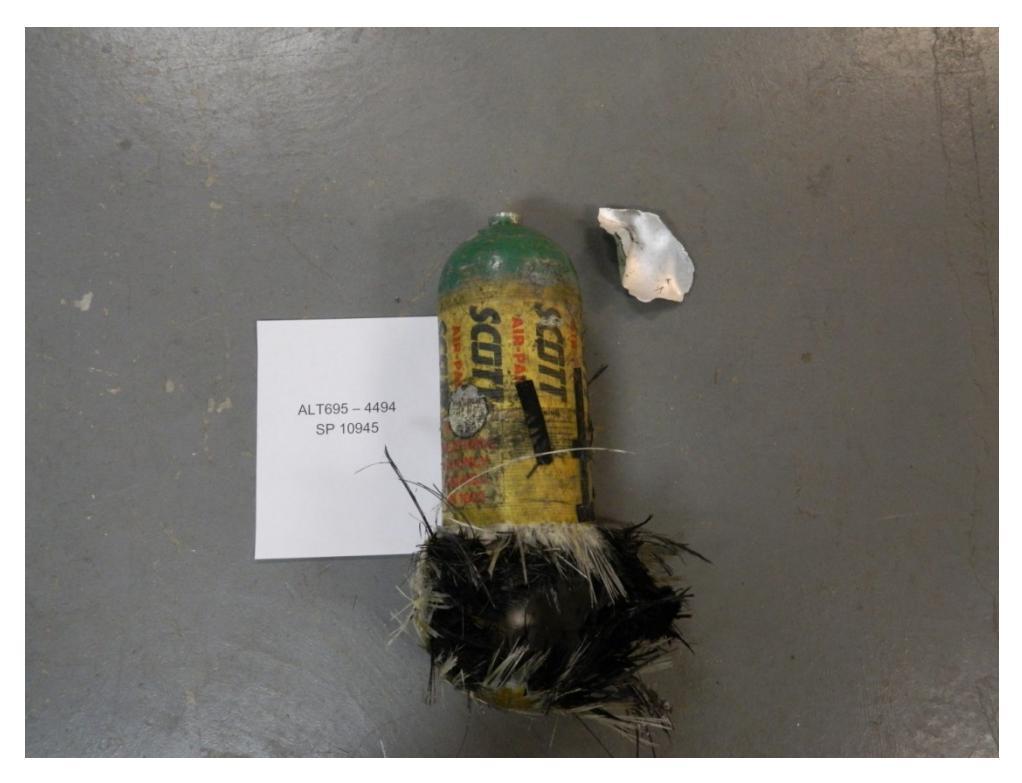
Figure 10.5 – Image of ALT604-4494 after EOL Burst testing.

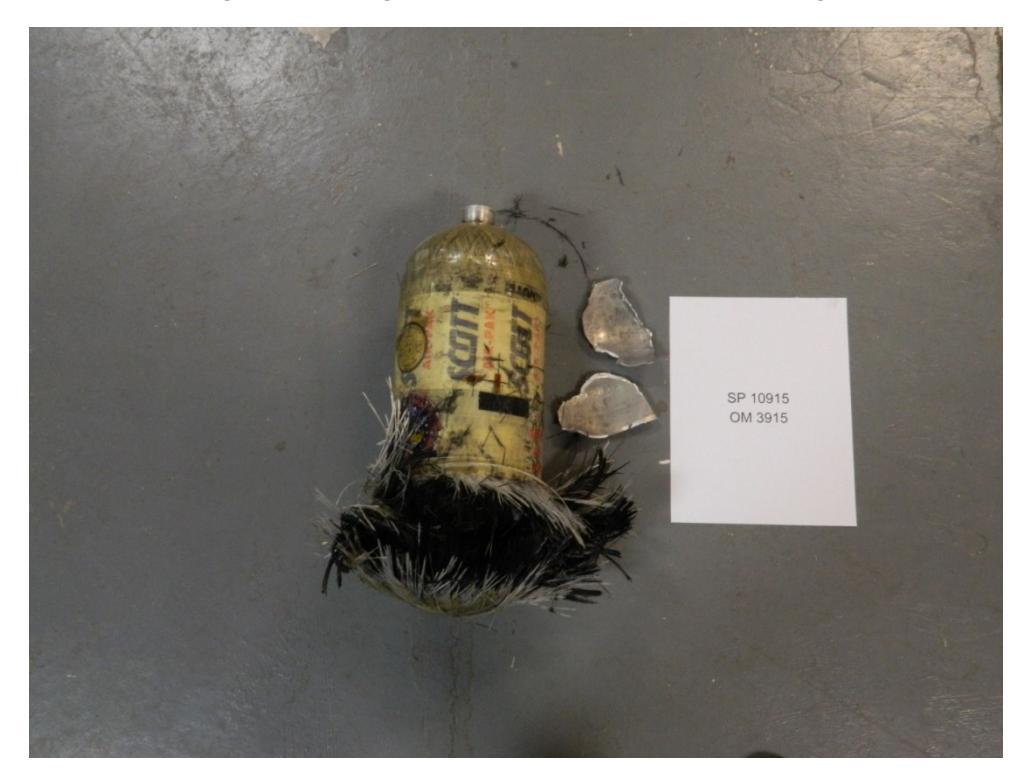
Figure 10.6 – Image of OM3915 after EOL Burst testing.

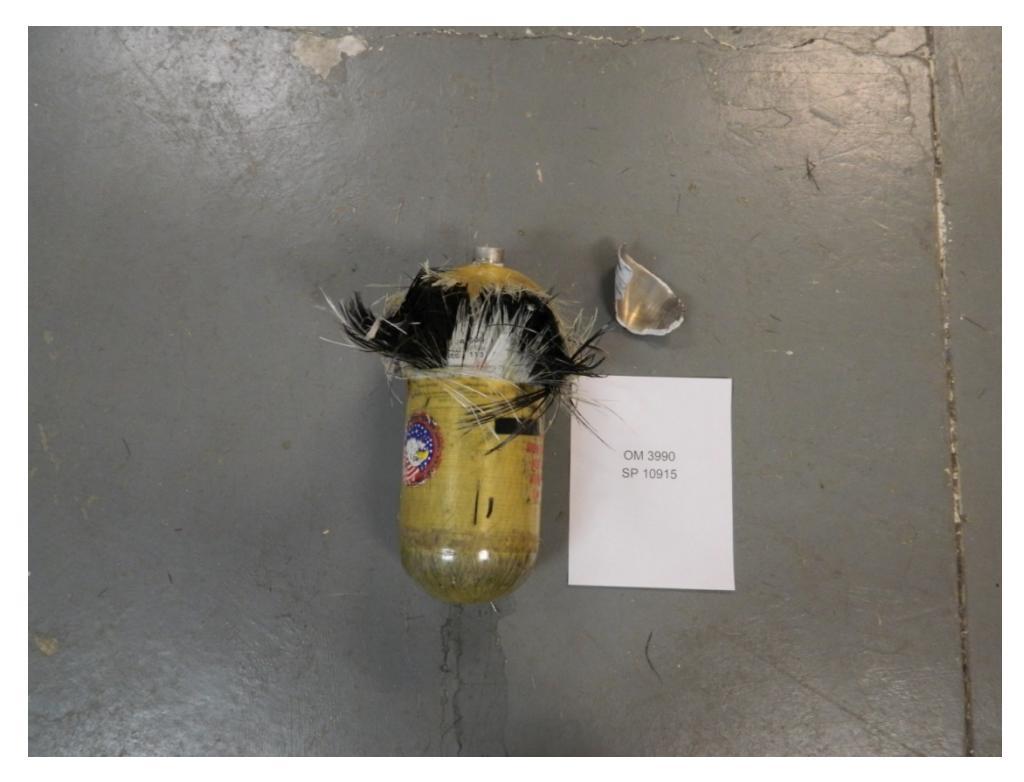
Figure 10.7 – Image of OM3990 after EOL Burst testing.

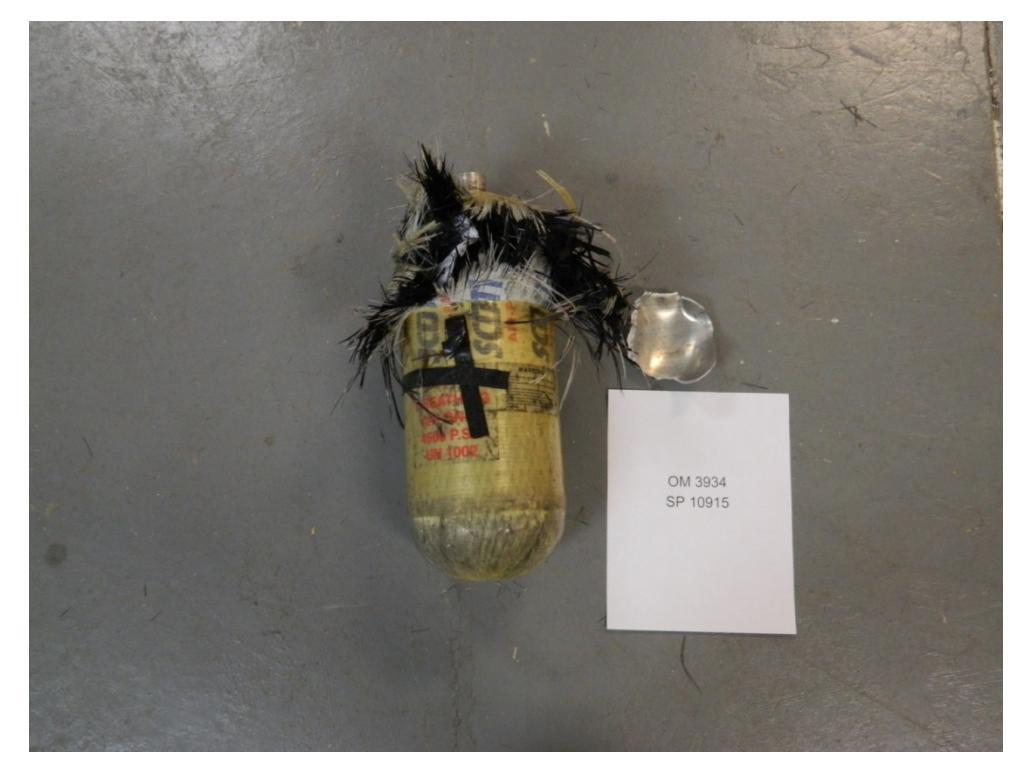
Figure 10.8 – Image of OM3934 after EOL Burst testing.

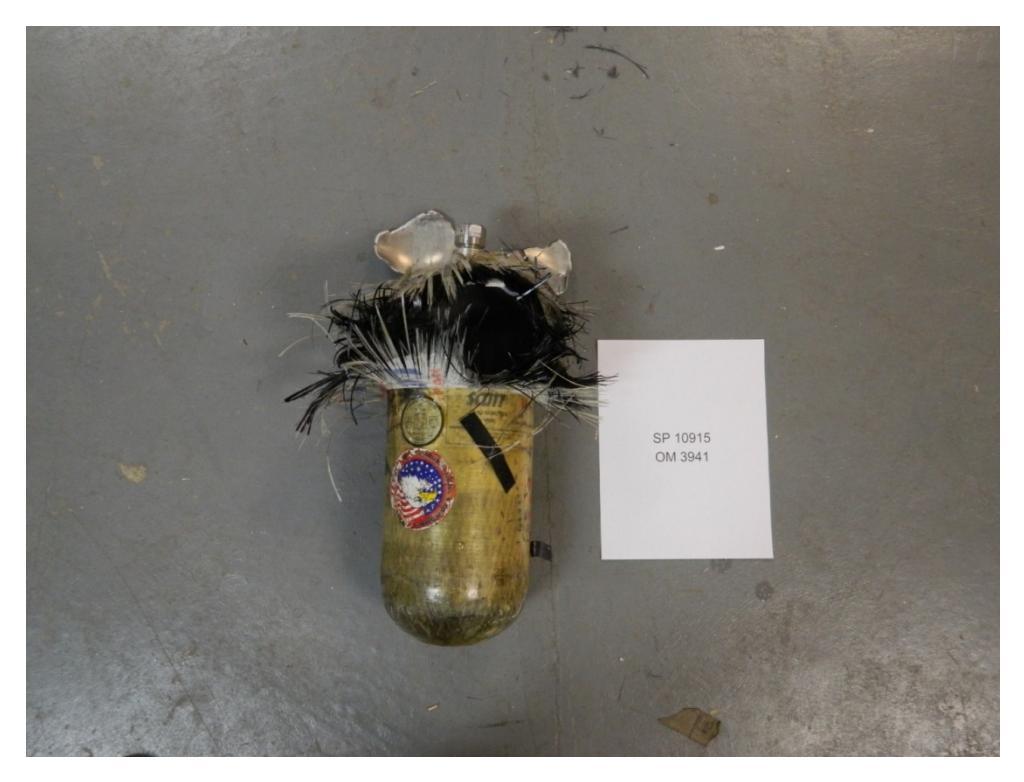
Figure 10.9 – Image of OM3941 after EOL Burst testing.

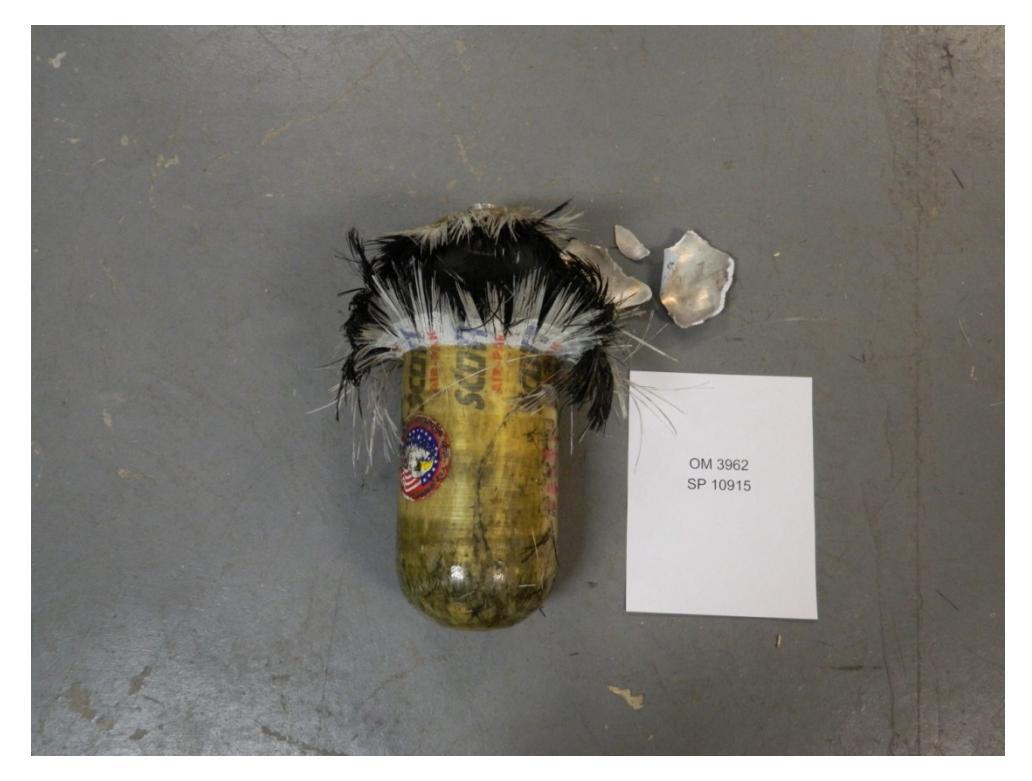
Figure 10.10 – Image of OM3962 after EOL Burst testing.

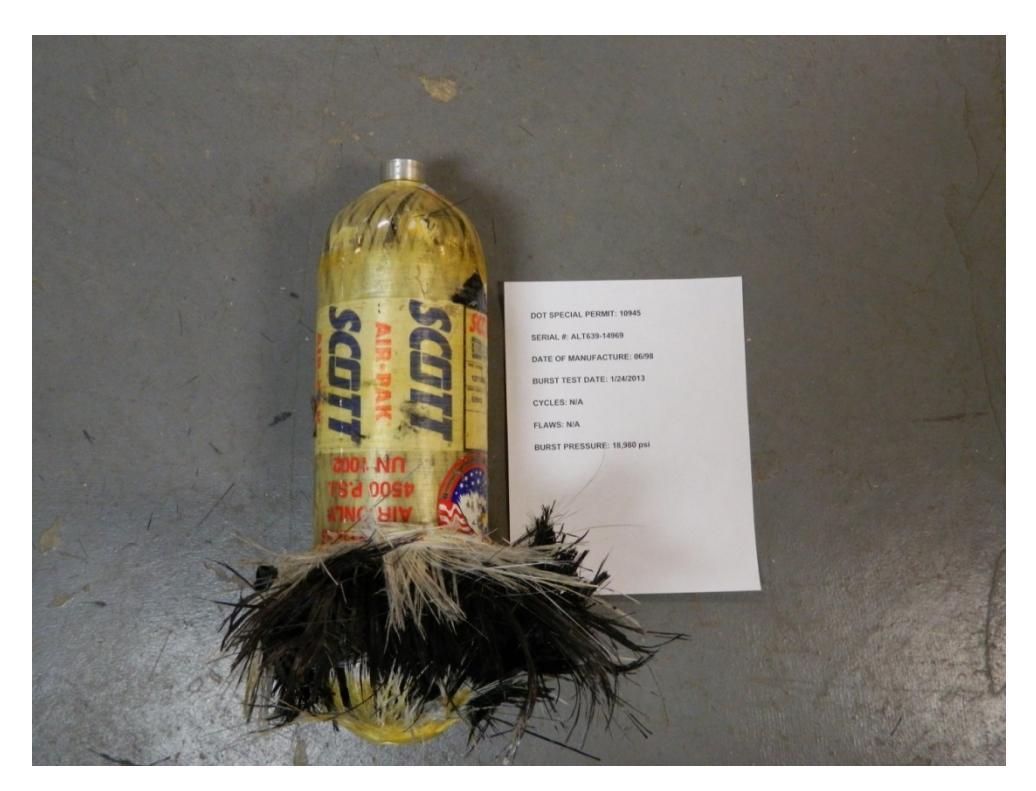
Figure 10.11 - – Image of ALT639-14969 after EOL Burst testing.
