**Digital Wave Corporation** 13760 East Arapahoe Road Centennial, CO 80112

Use of Modal Acoustic Emission (MAE) for life extension of civilian self-contained breathing apparatus (SCBA) DOT-CFFC cylinders

# FINAL REPORT

Contract DTPH56-13-P-000029

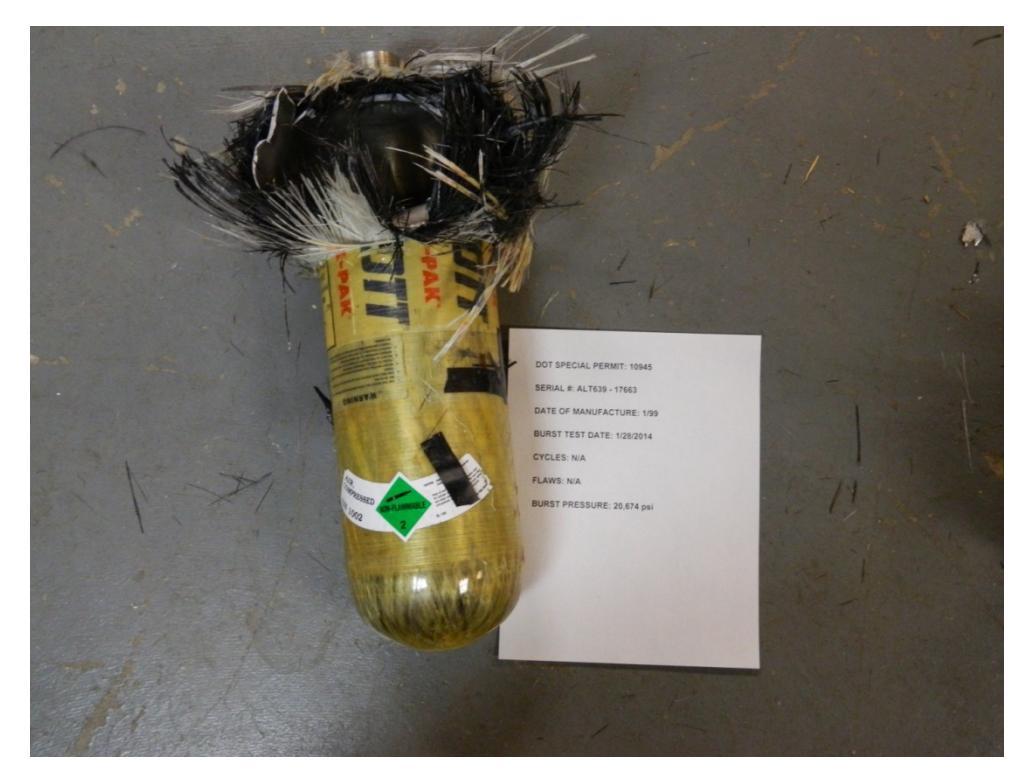
Figure 10.12 – Image of ALT639-17663 after EOL Burst testing.

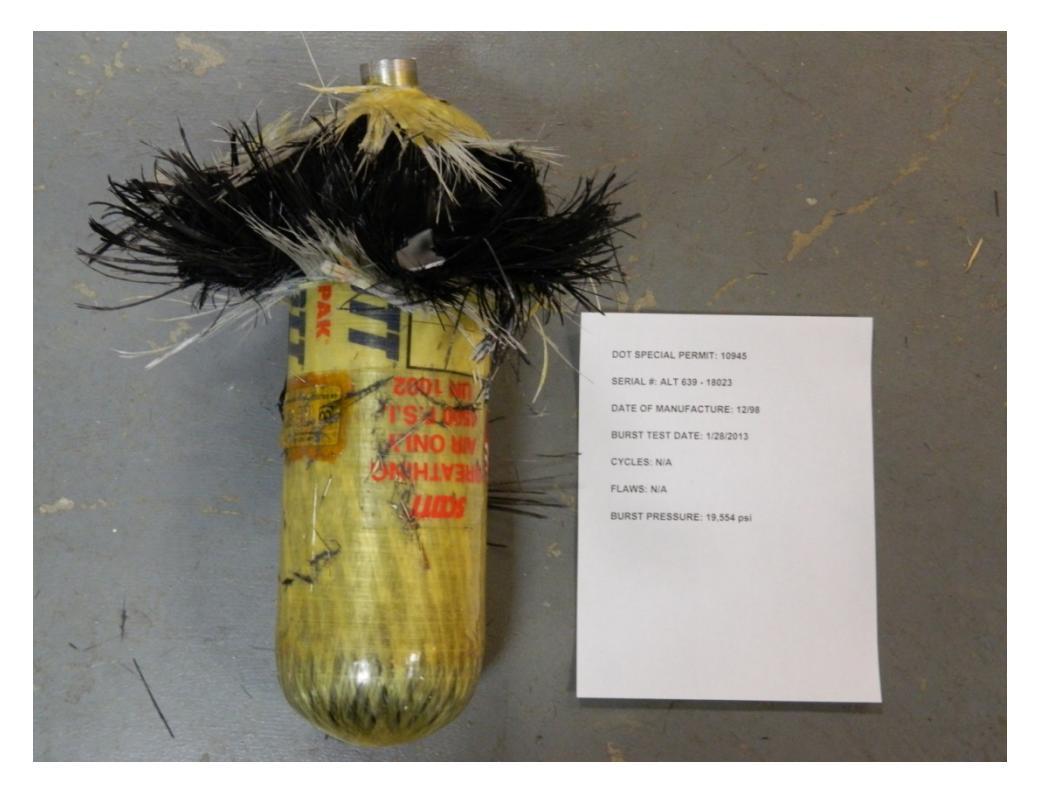
Figure 10.13 – Image of ALT639-18023 after EOL Burst testing.

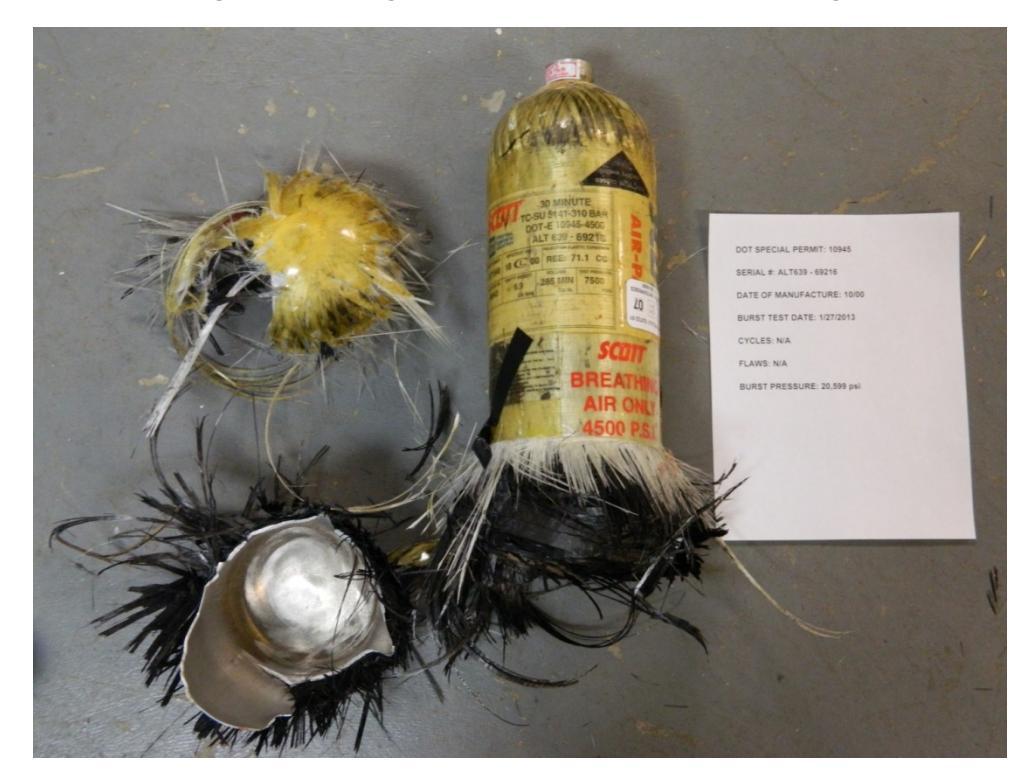
Figure 10.14 – Image of ALT639-69216 after EOL Burst testing.

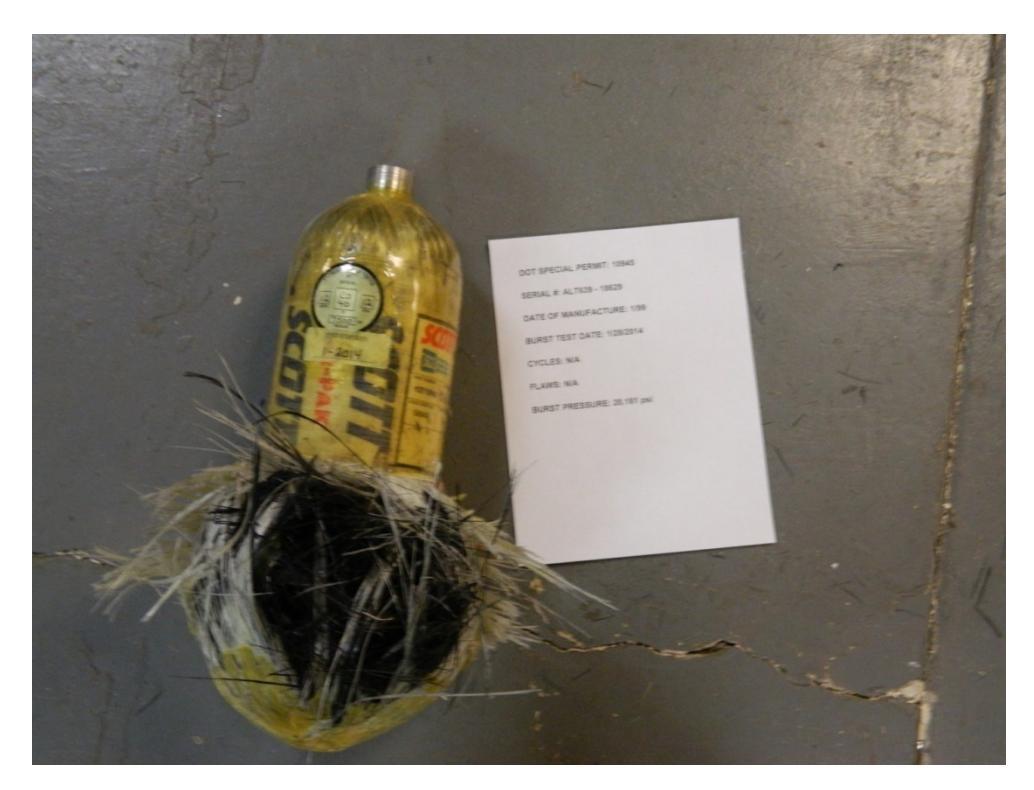
Figure 10.15 – Image of ALT639-18629 after EOL Burst testing.

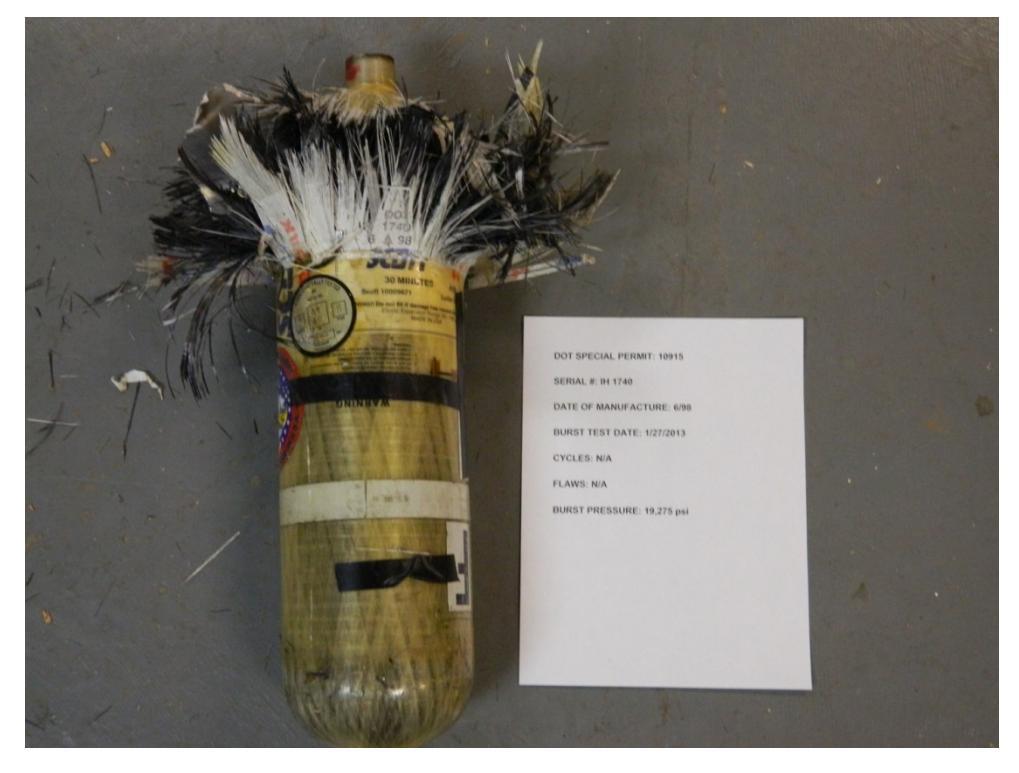
Figure 10.16 – Image of IH1740 after EOL Burst testing.

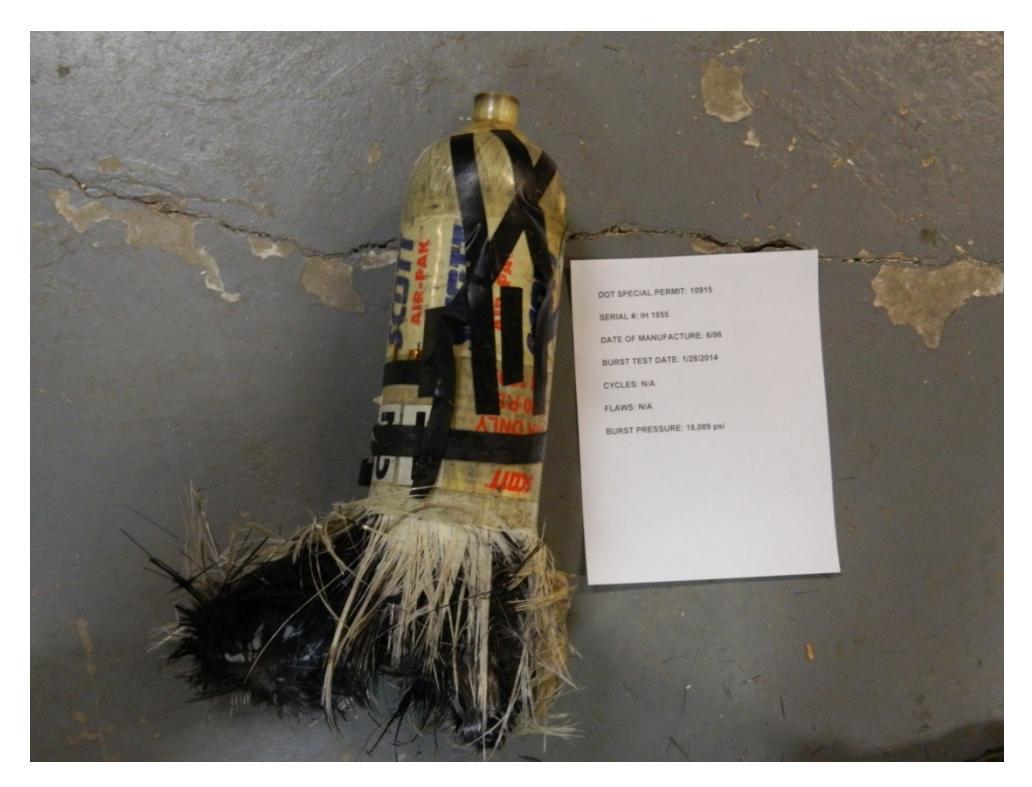
Figure 10.17 – Image of IH1855 after EOL Burst testing.

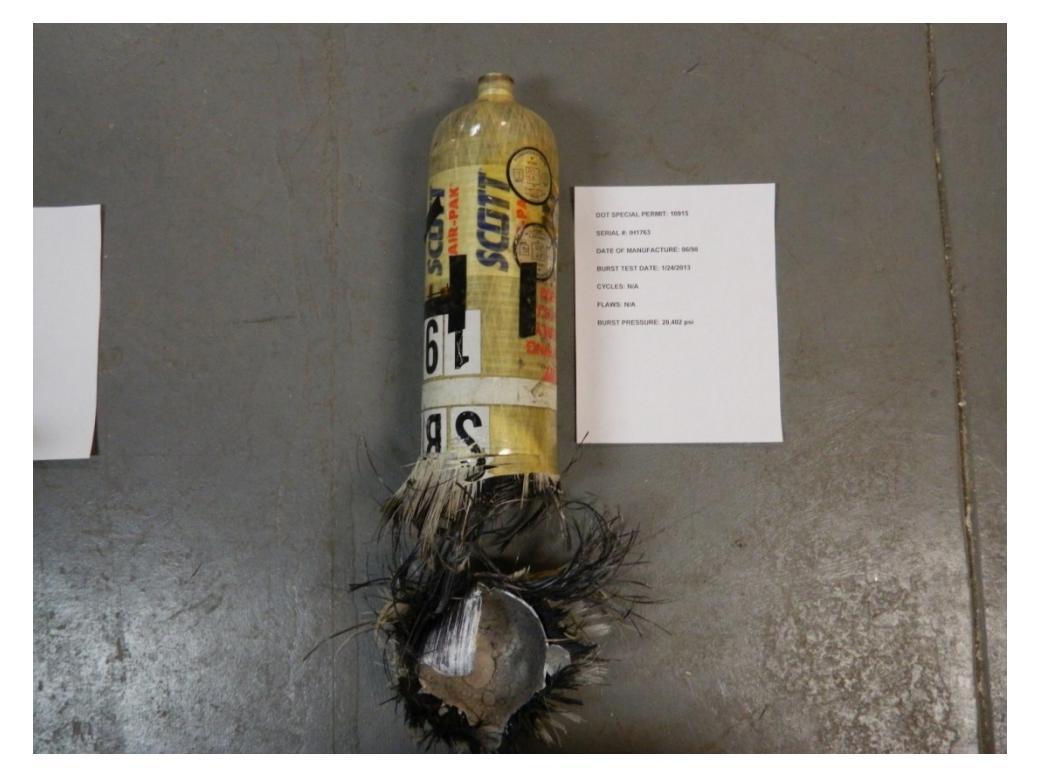
Figure 10.18 – Image of IH1763 after EOL Burst testing.

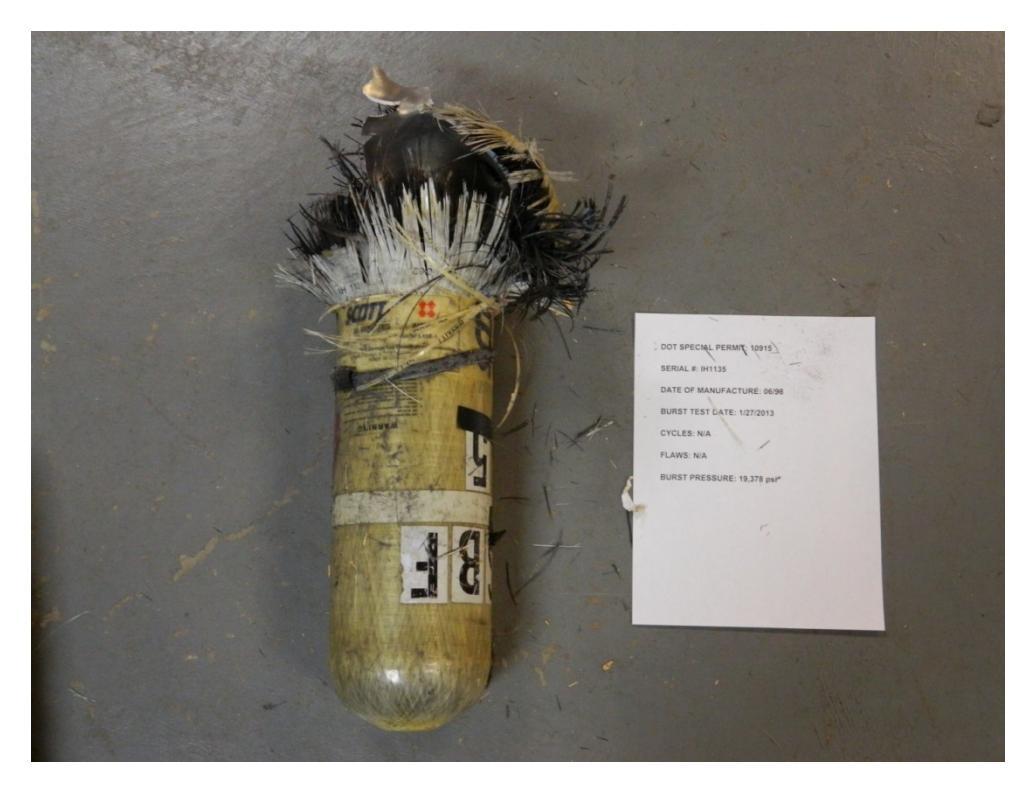
Figure 10.19 – Image of IH1135 after EOL Burst testing.

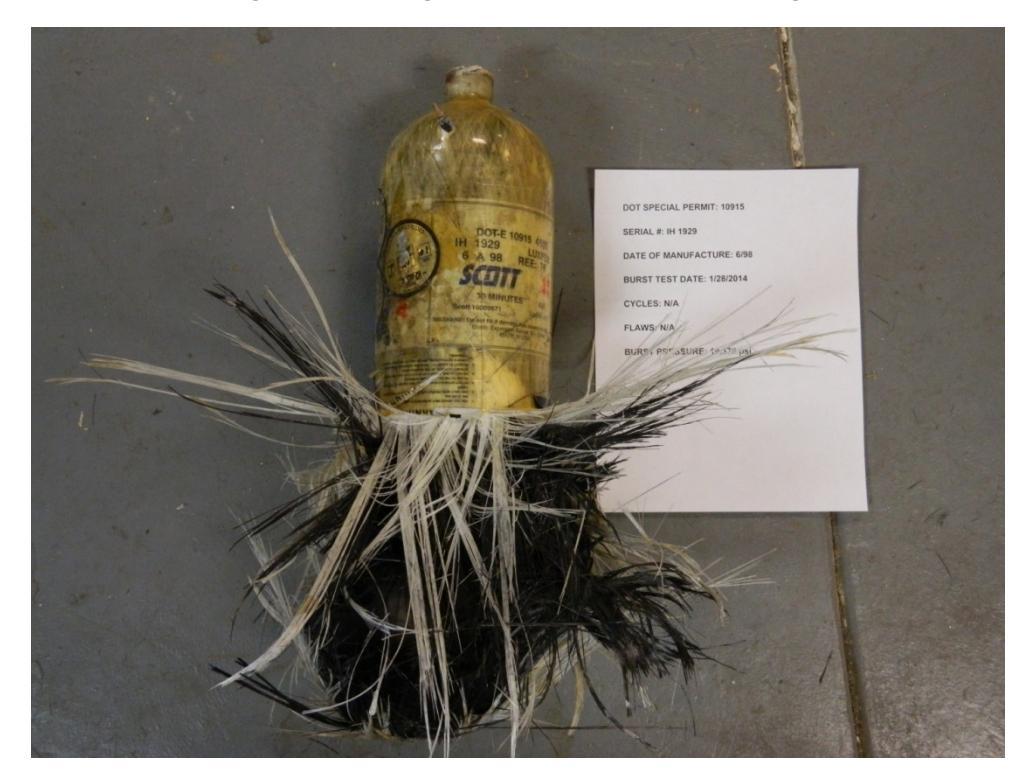
Figure 10.20 – Image of IH1929 after EOL Burst testing.

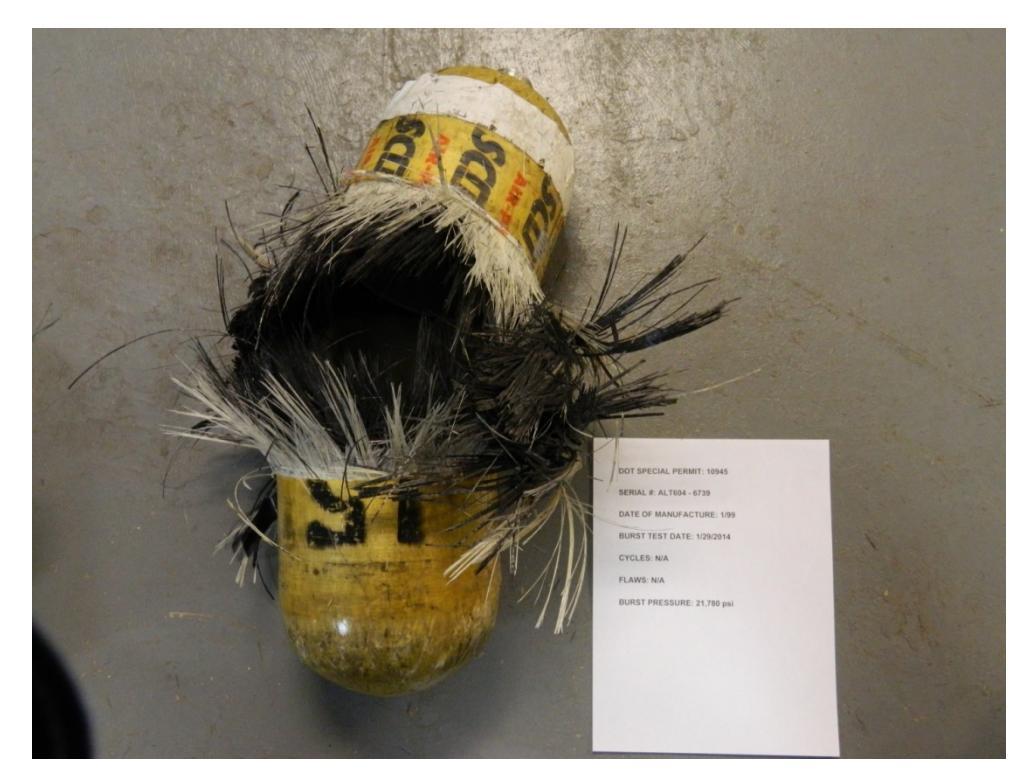
Figure 10.21 – Image of ALT604-6739 after EOL Burst testing.

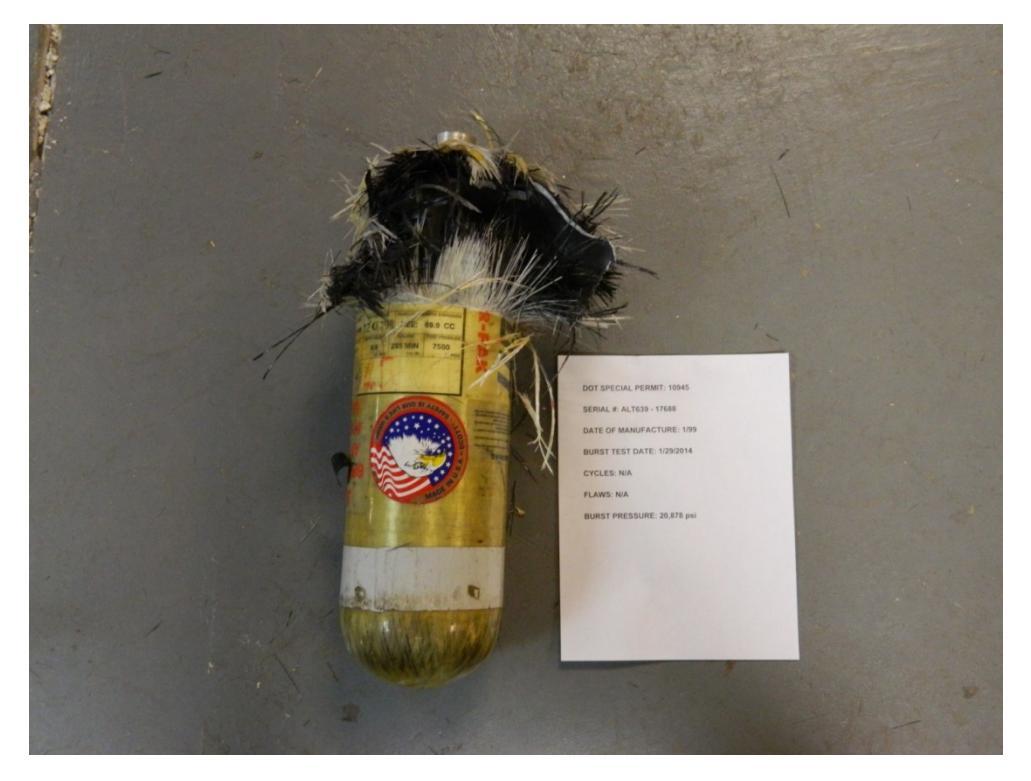
Figure 10.22 – Image of ALT639-17688 after EOL Burst testing.

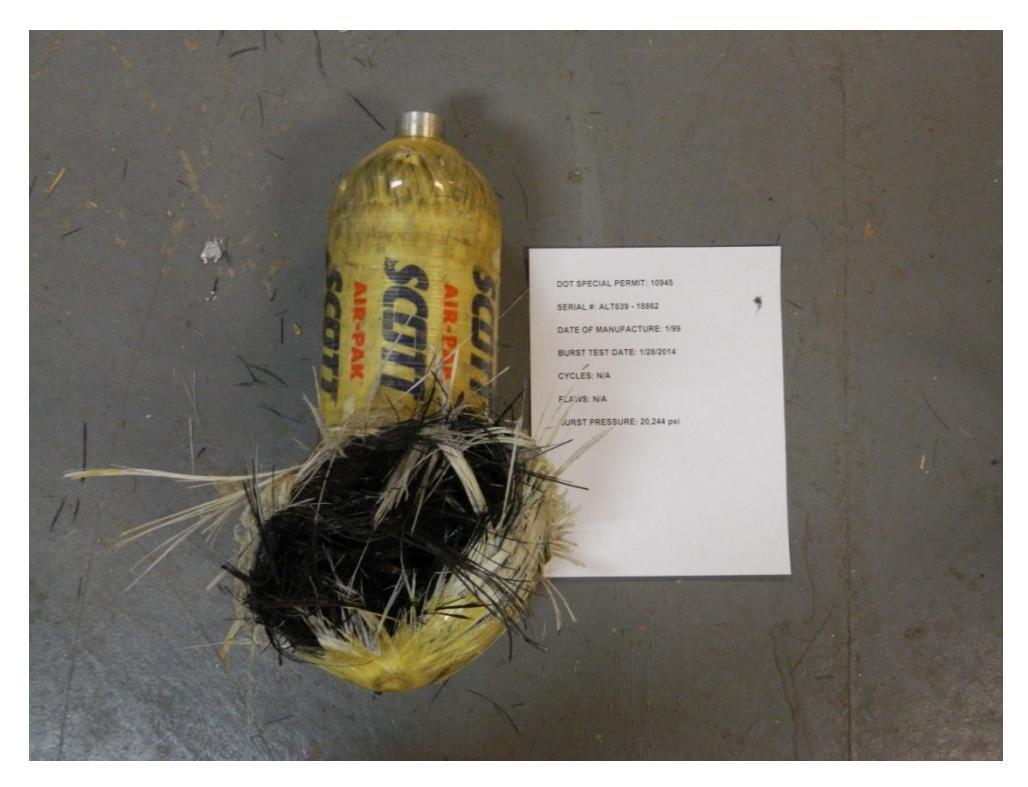
Figure 10.23 – Image of ALT639-18862 after EOL Burst testing.

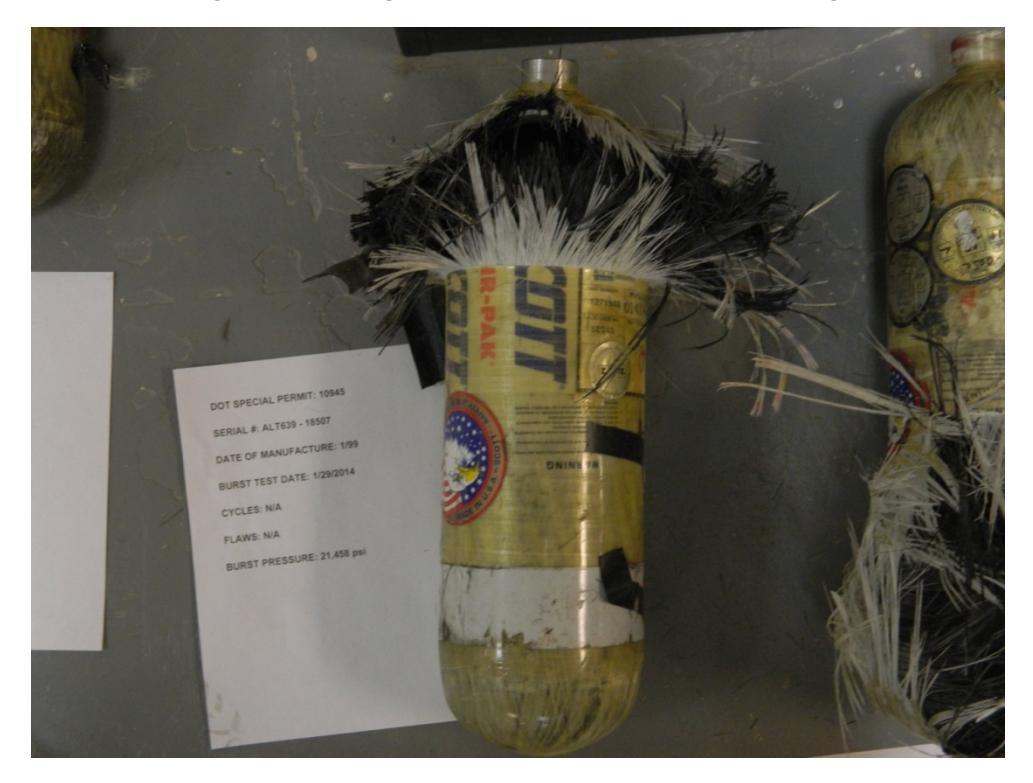
Figure 10.24 – Image of ALT639-18507 after EOL Burst testing.

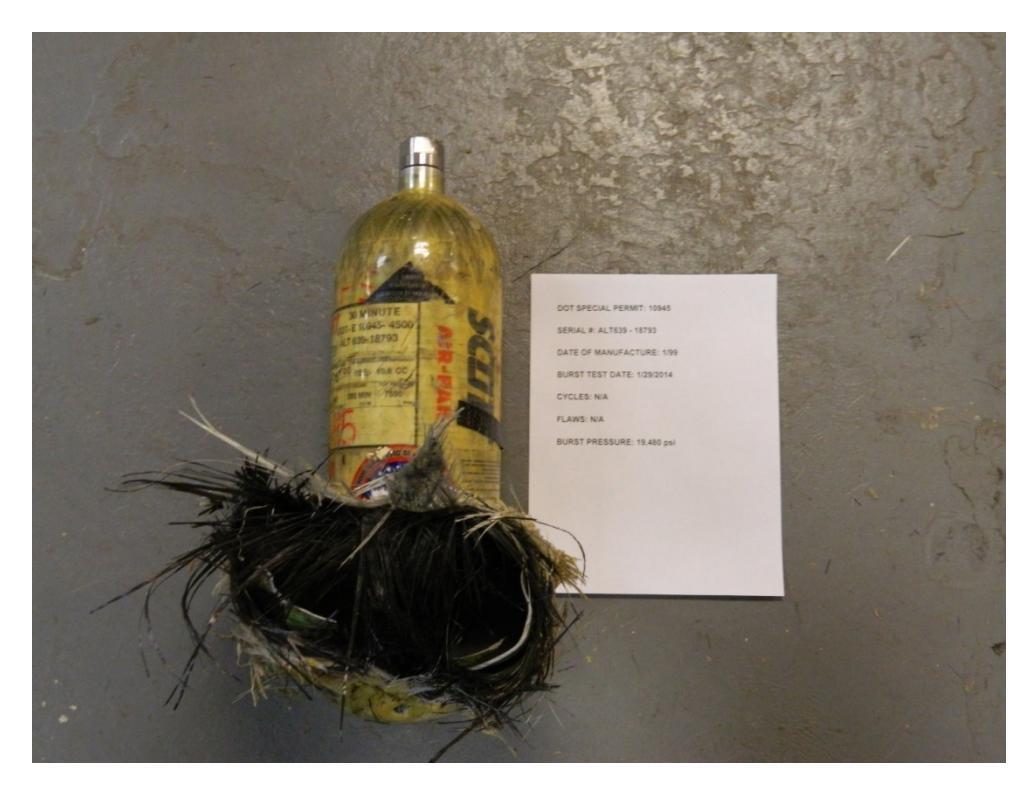
Figure 10.25 – Image of ALT639-18793 after EOL Burst testing.

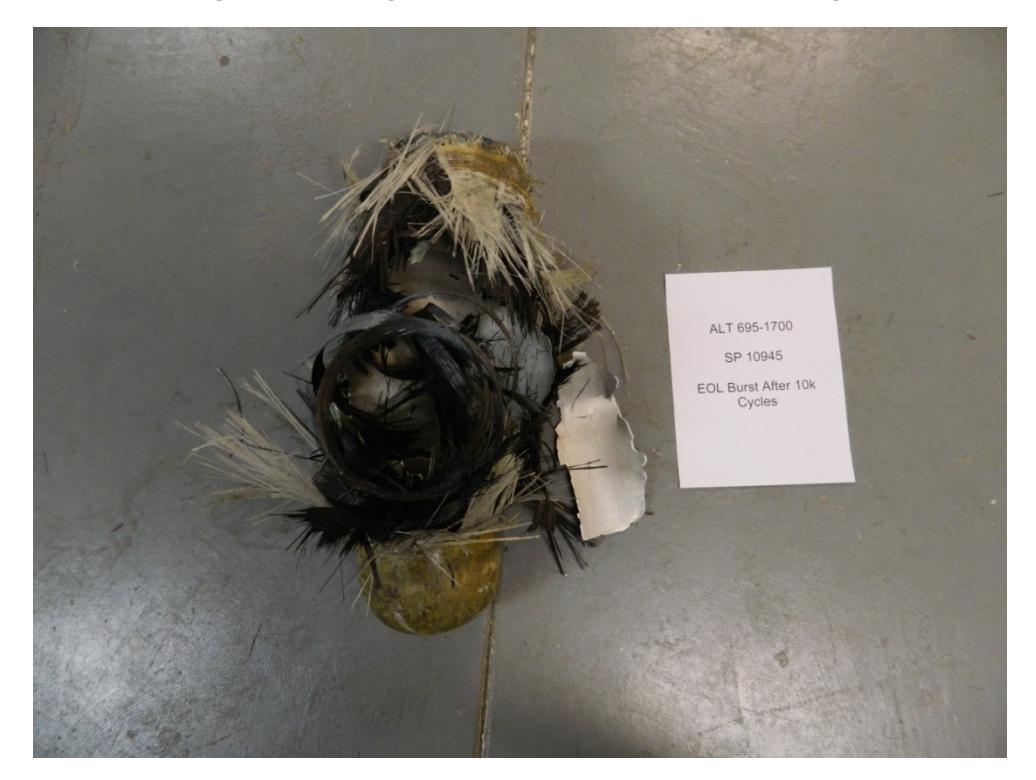
Figure 10.26 – Image of ALT695-1700 after EOL Burst testing.

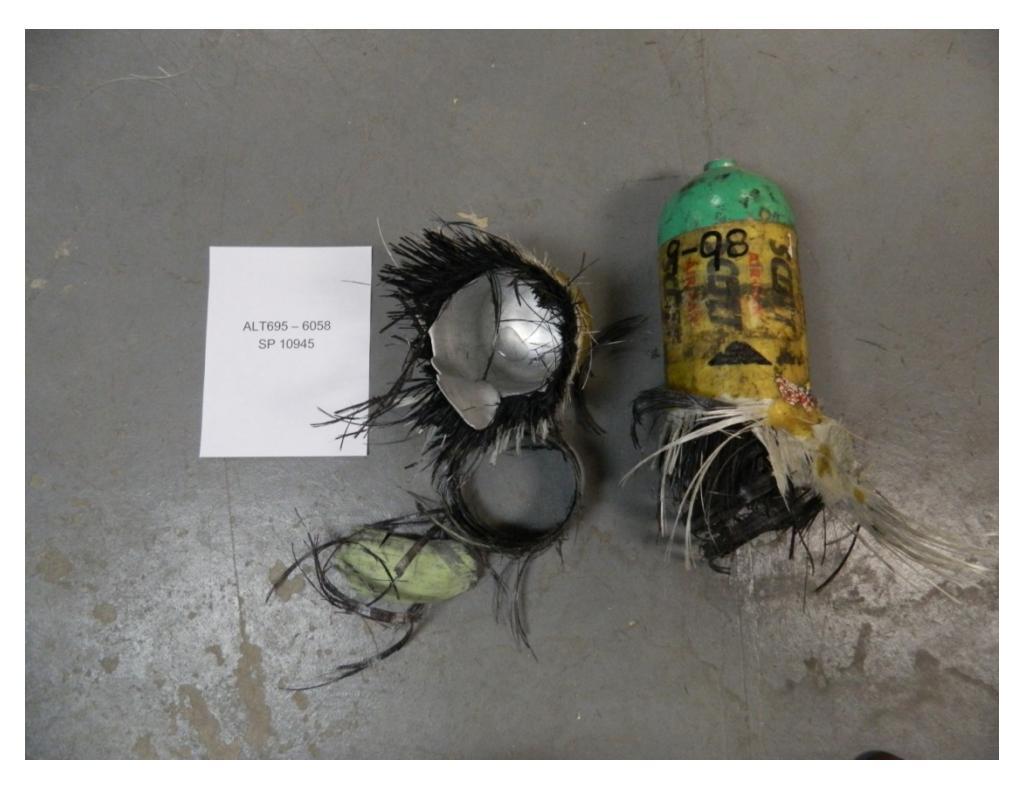
Figure 10.27 – Image of ALT695-6058 after EOL Burst testing.

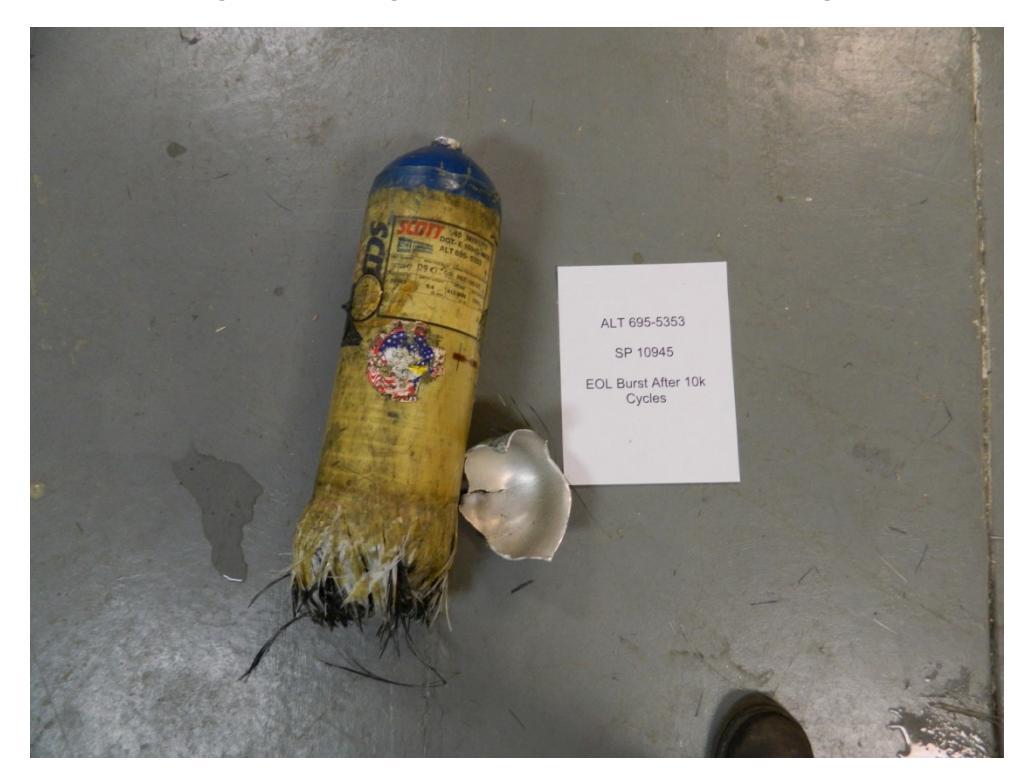
Figure 10.28 – Image of ALT695-5353 after EOL Burst testing.

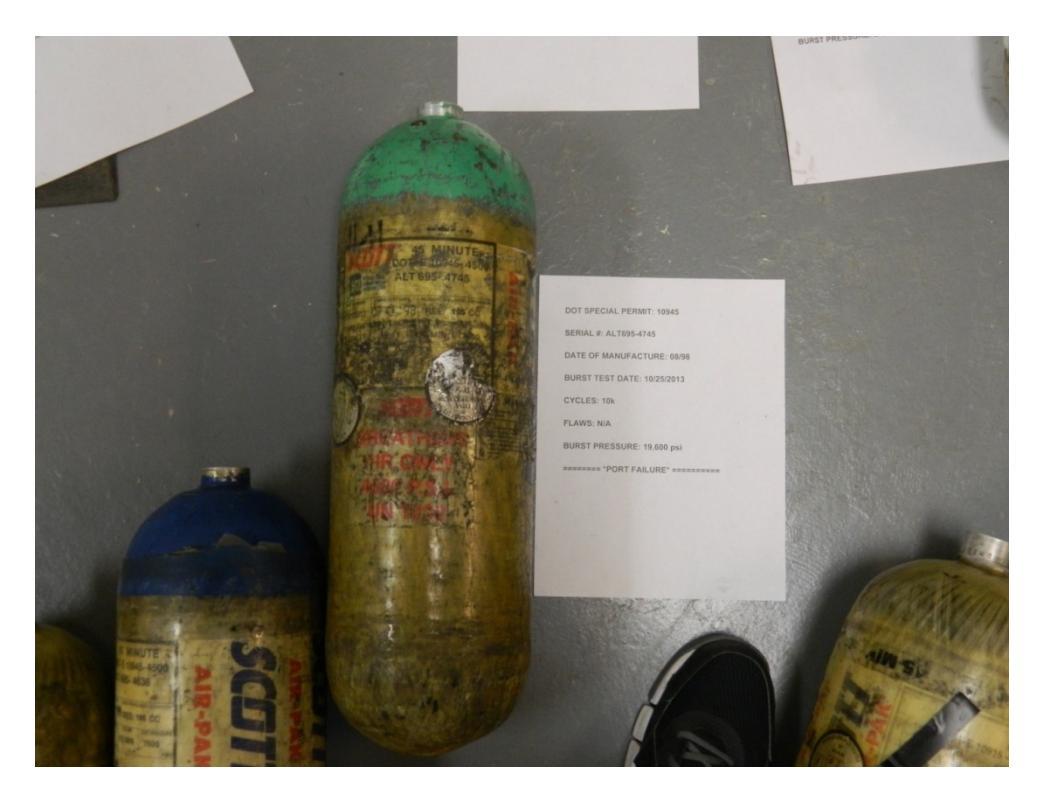
Figure 10.29 – Image of ALT695-4745 after EOL Burst testing.

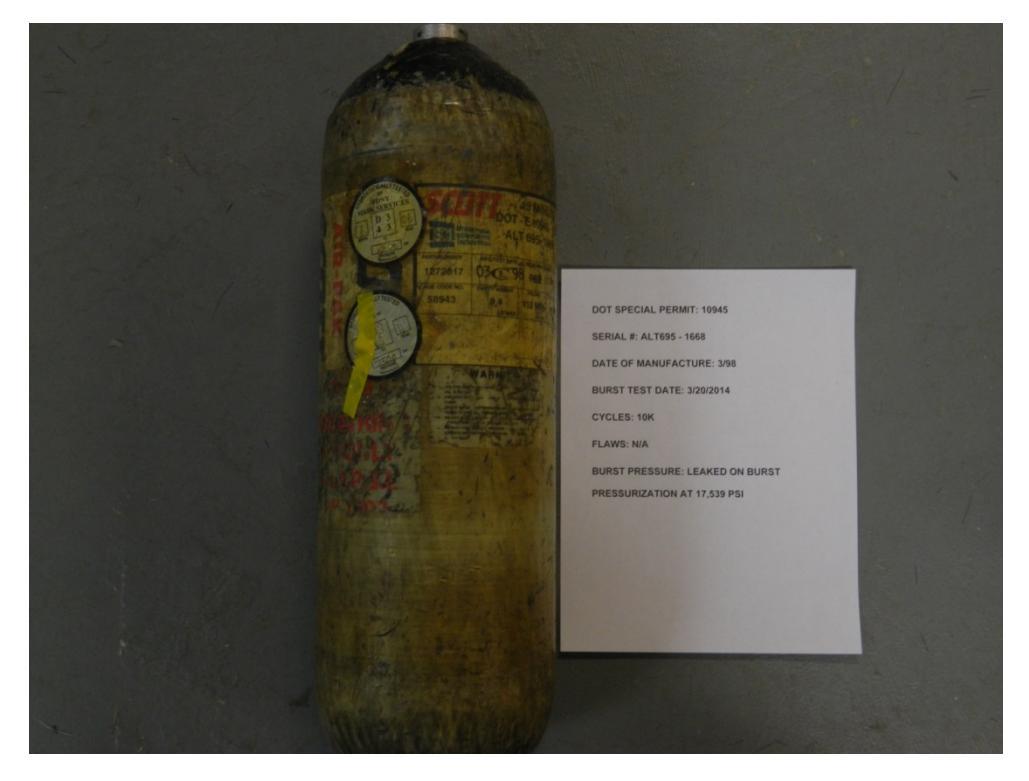
Figure 10.30 – Image of ALT695-1668 after EOL Burst testing.

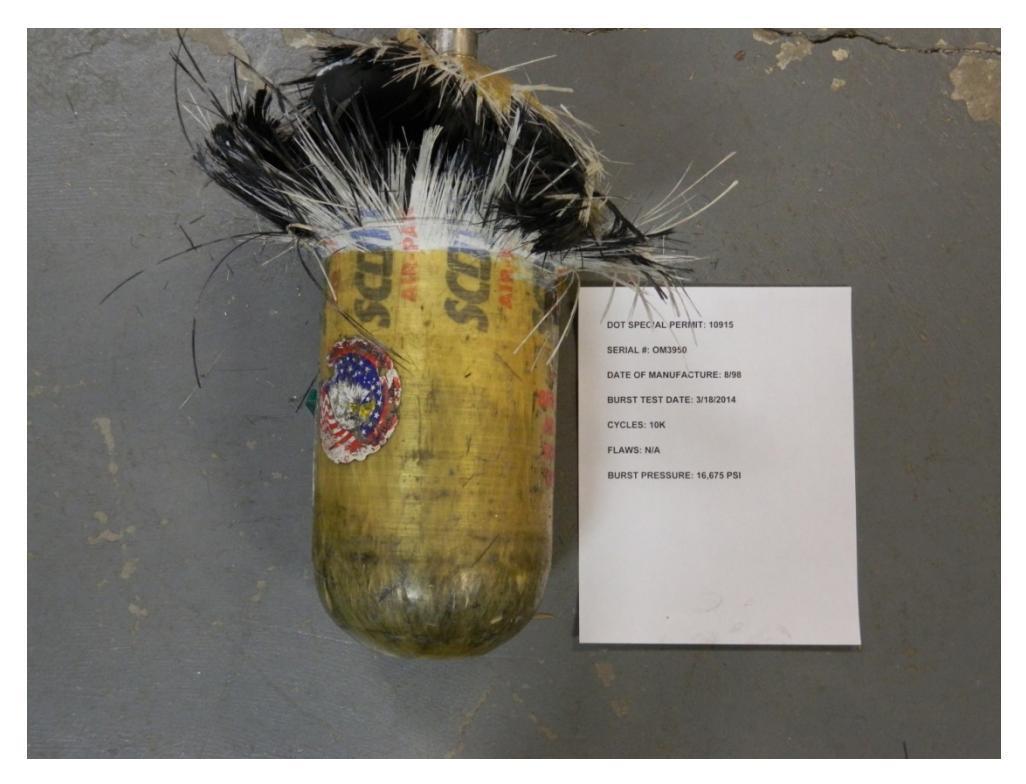
Figure 10.31 – Image of OM3950 after EOL Burst testing.

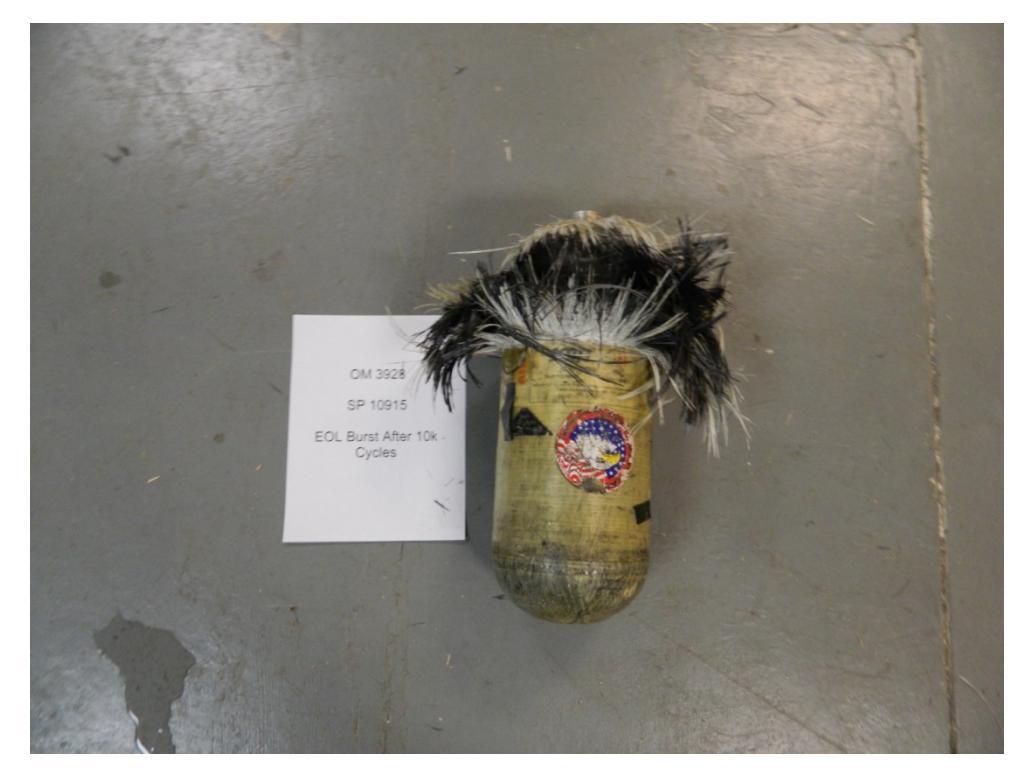
Figure 10.32 – Image of OM3928 after EOL Burst testing.

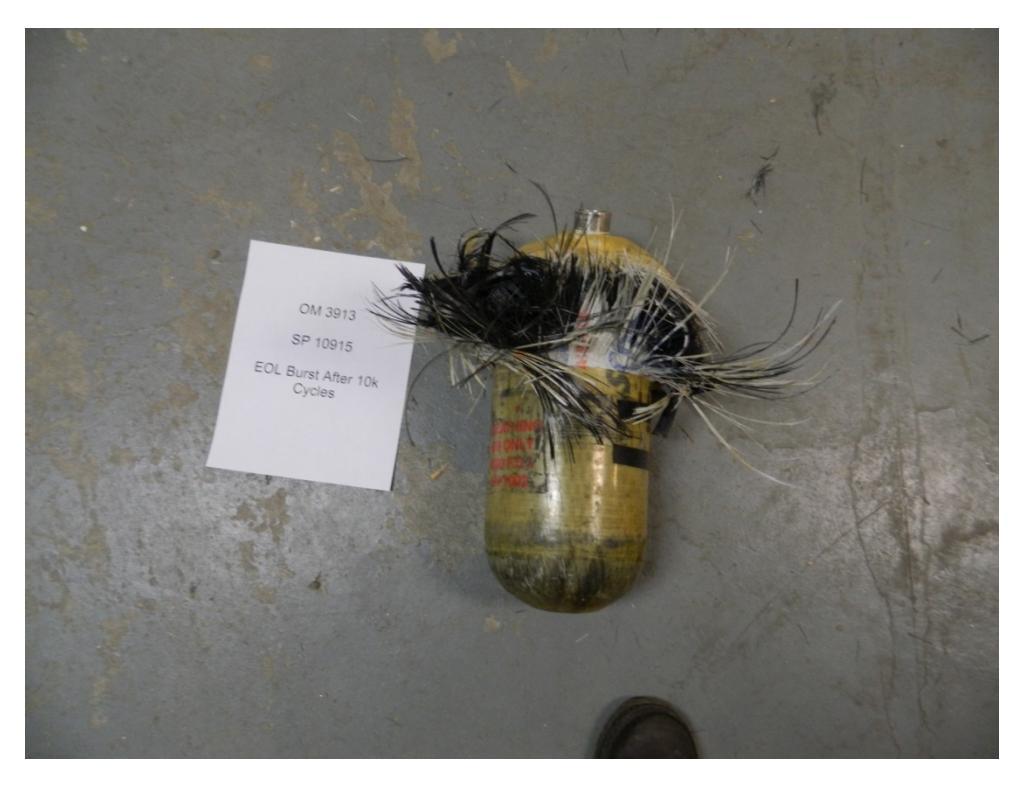
Figure 10.33 – Image of OM3913 after EOL Burst testing.

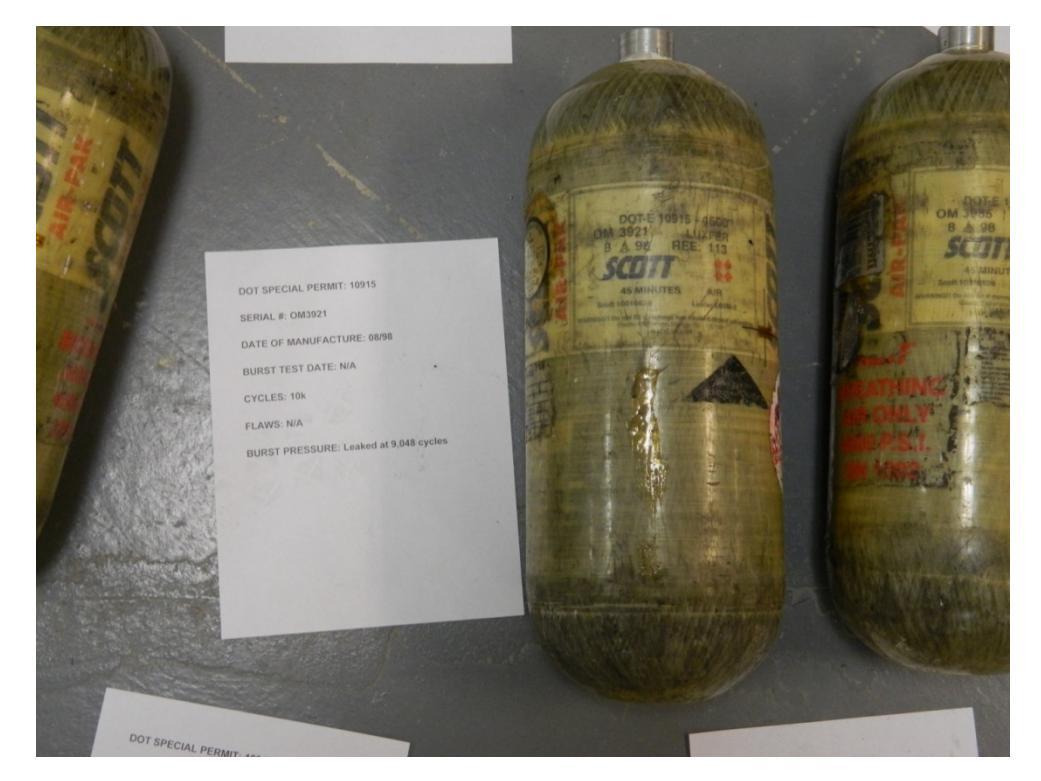
Figure 10.34 – Image of OM3921 after EOL Burst testing.

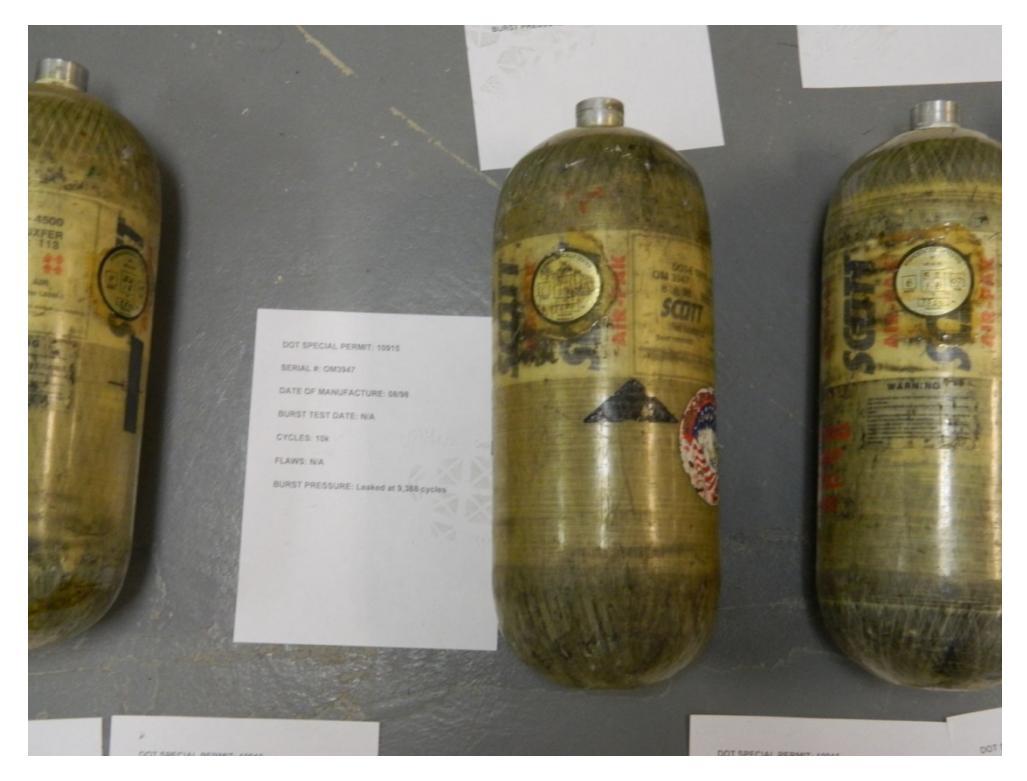
Figure 10.35 – Image of OM3947 after EOL Burst testing.

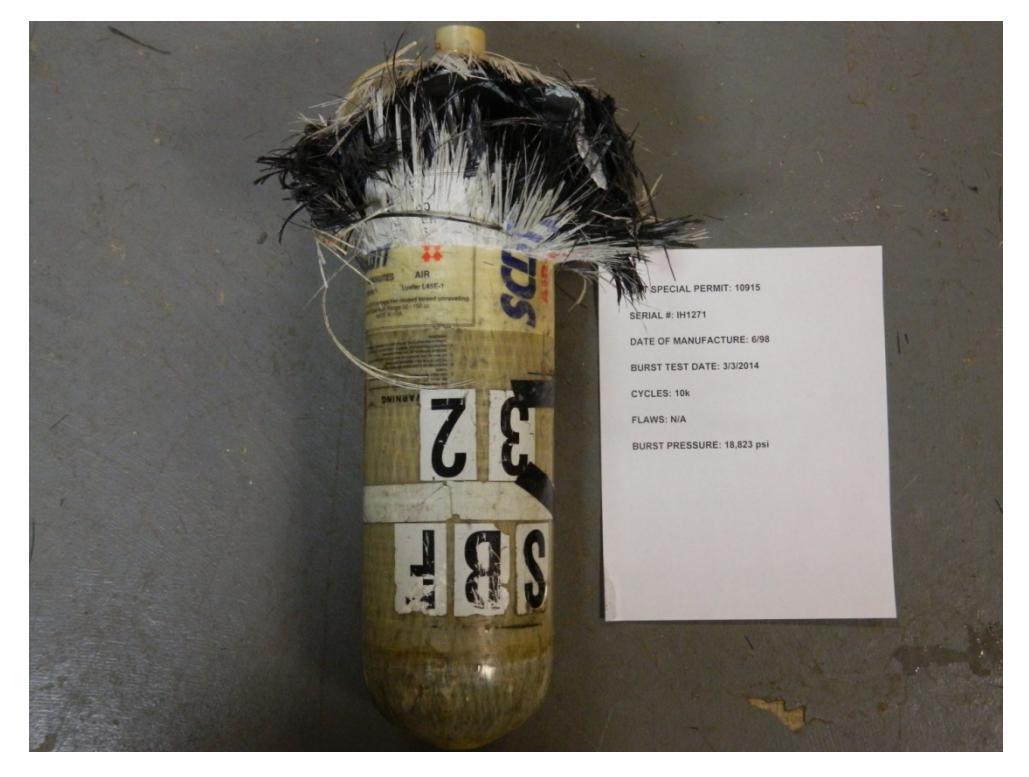
Figure 10.36 – Image of IH1271 after EOL Burst testing.

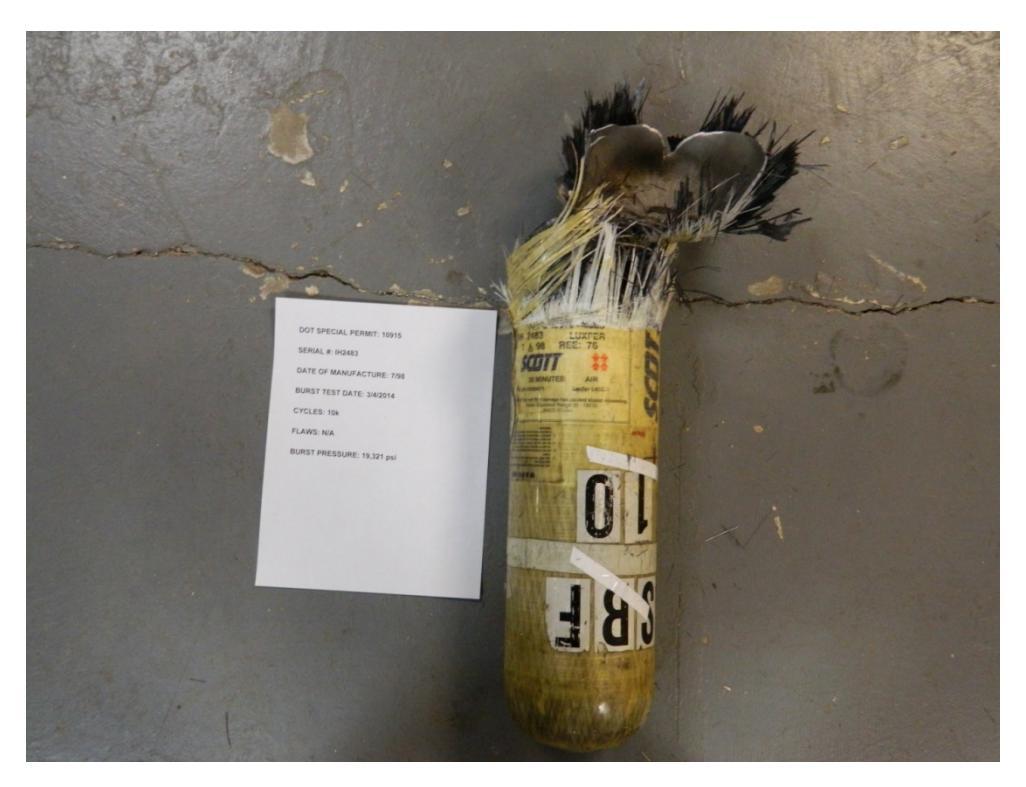
Figure 10.37 – Image of IH2483 after EOL Burst testing.

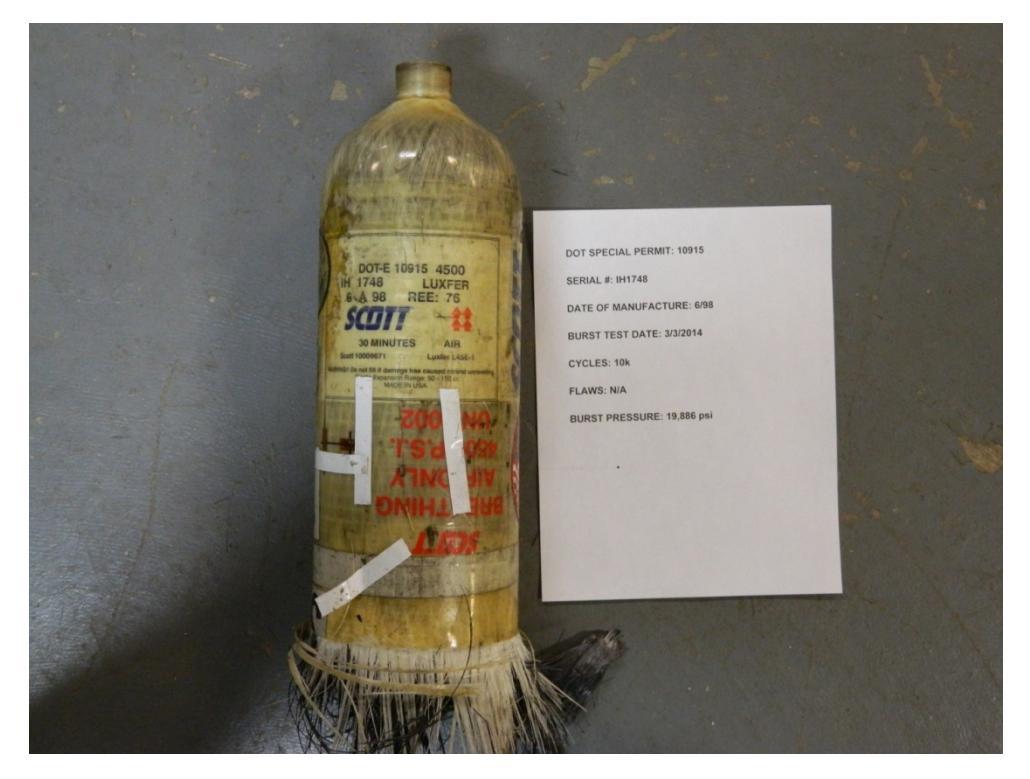
Figure 10.38 – Image of IH1748 after EOL Burst testing.

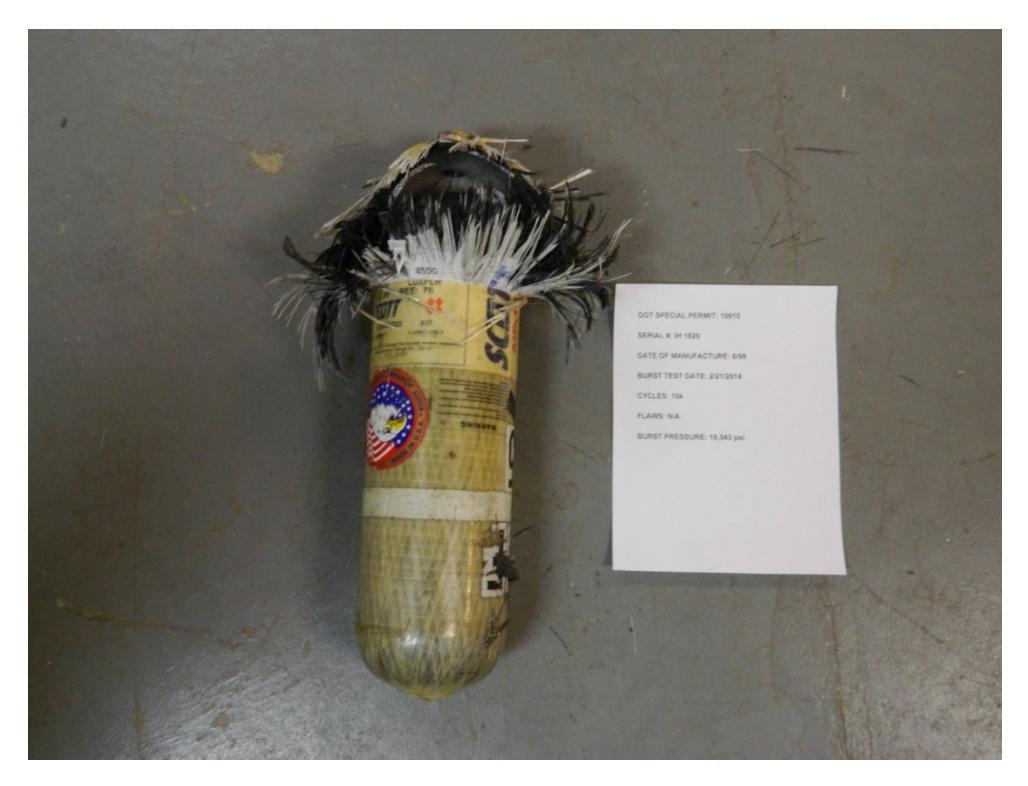
Figure 10.39 – Image of IH1820 after EOL Burst testing.
