**Digital Wave Corporation** 13760 East Arapahoe Road Centennial, CO 80112

Use of Modal Acoustic Emission (MAE) for life extension of civilian self-contained breathing apparatus (SCBA) DOT-CFFC cylinders

# FINAL REPORT

Contract DTPH56-13-P-000029

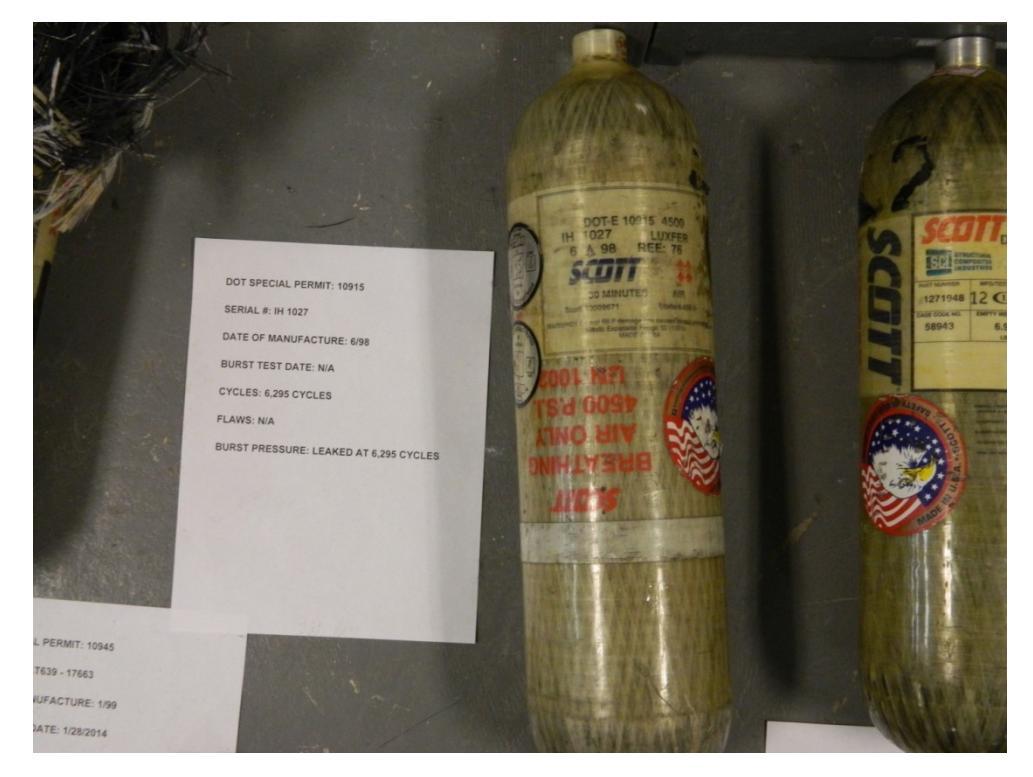
Figure 10.40 – Image of IH1027 after EOL Burst testing.

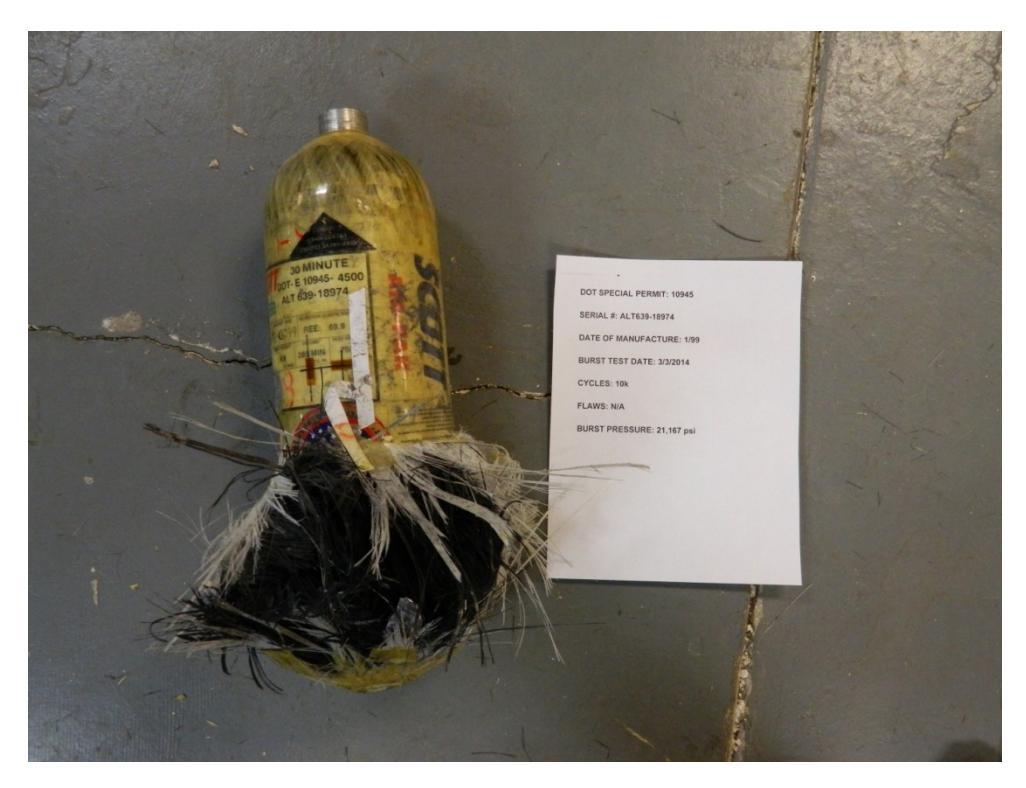
Figure 10.41 – Image of ALT639-18974 after EOL Burst testing.

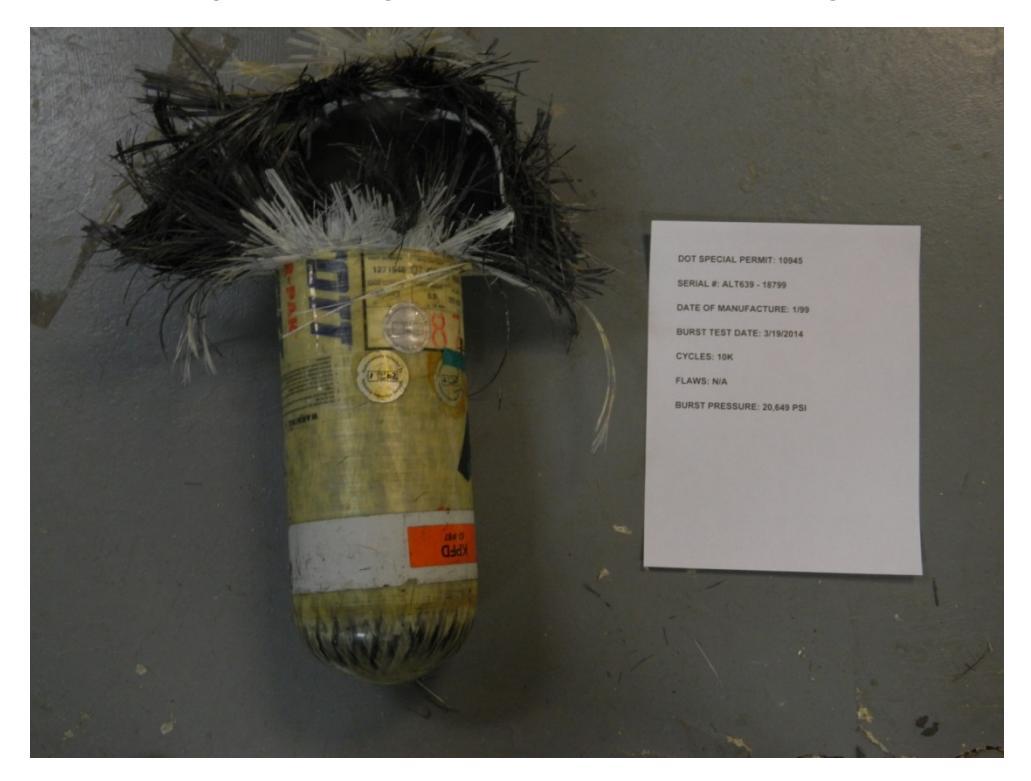
Figure 10.42 – Image of ALT639-18799 after EOL Burst testing.

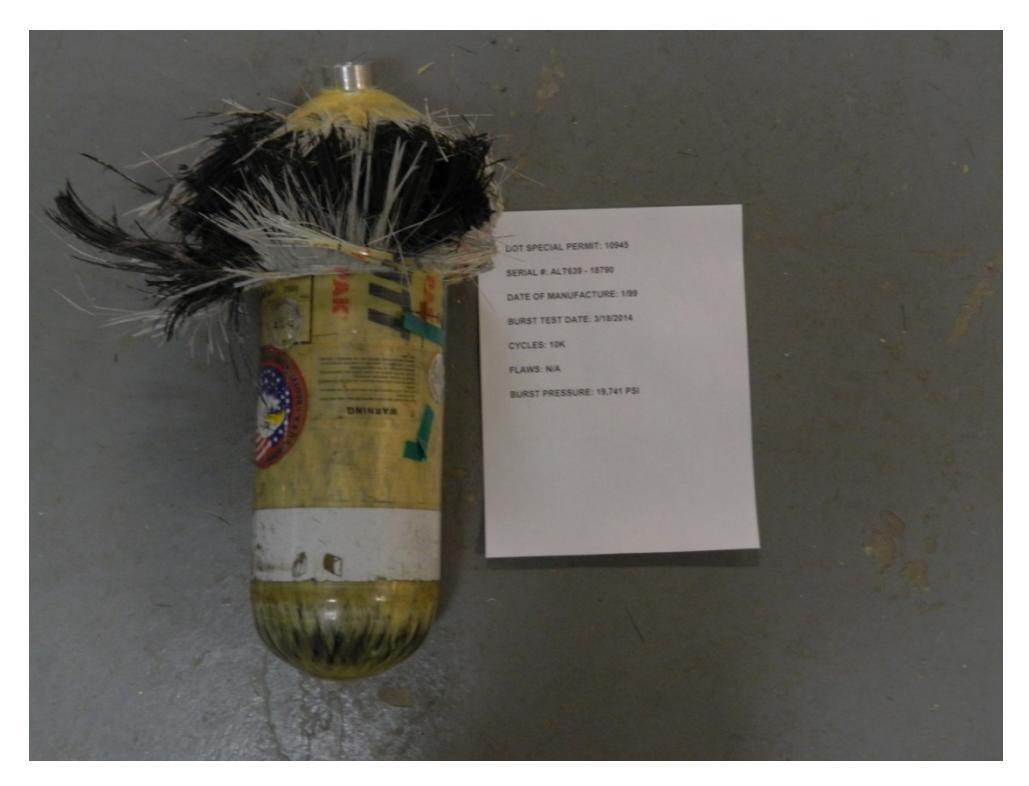
Figure 10.43 – Image of ALT639-18790 after EOL Burst testing.

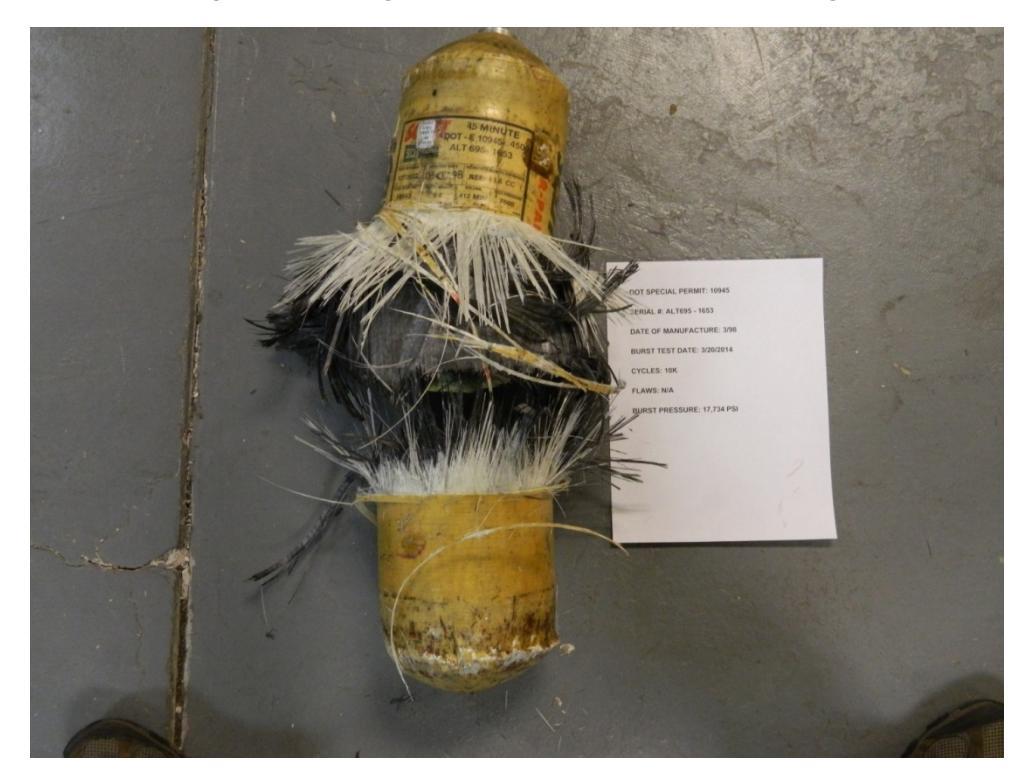
Figure 10.44 – Image of ALT695-1653 after EOL Burst testing.

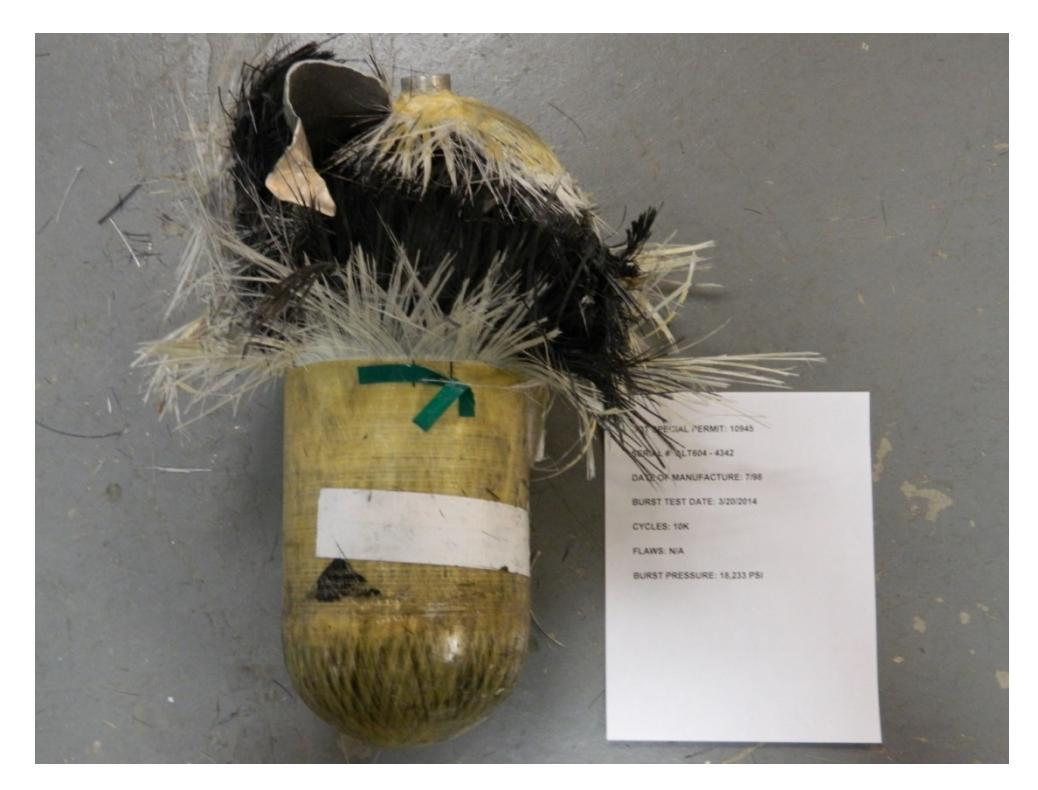
Figure 10.45 – Image of ALT604-4342 after EOL Burst testing.

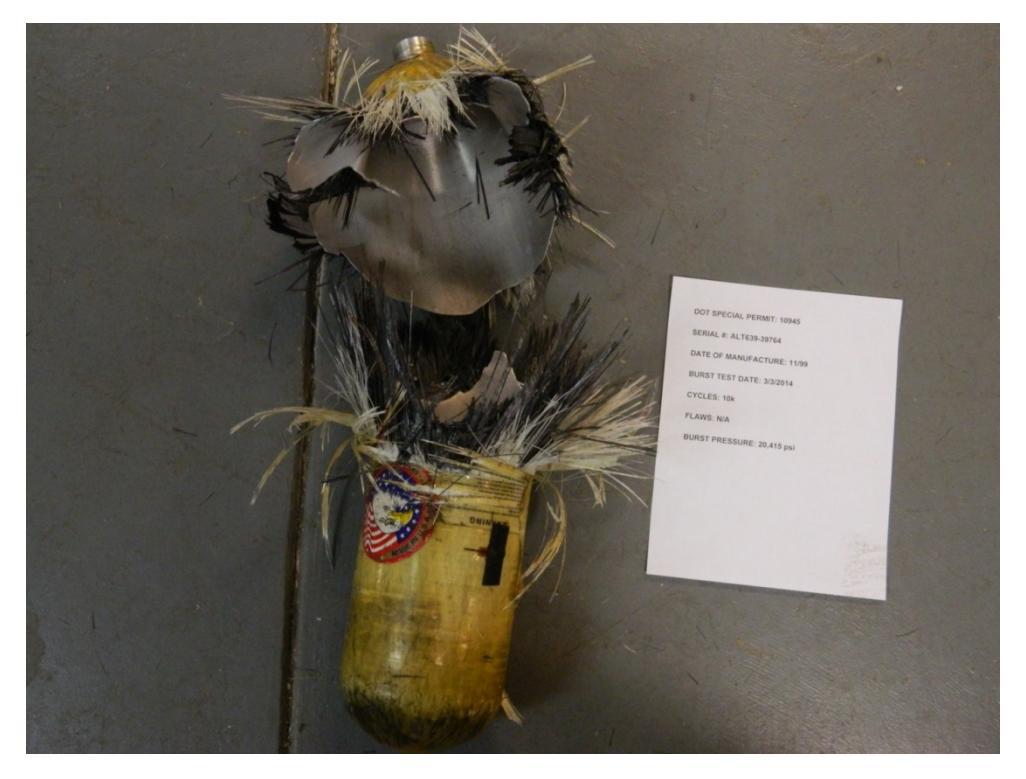
Figure 10.46 – Image of ALT639-39764 after EOL Burst testing.

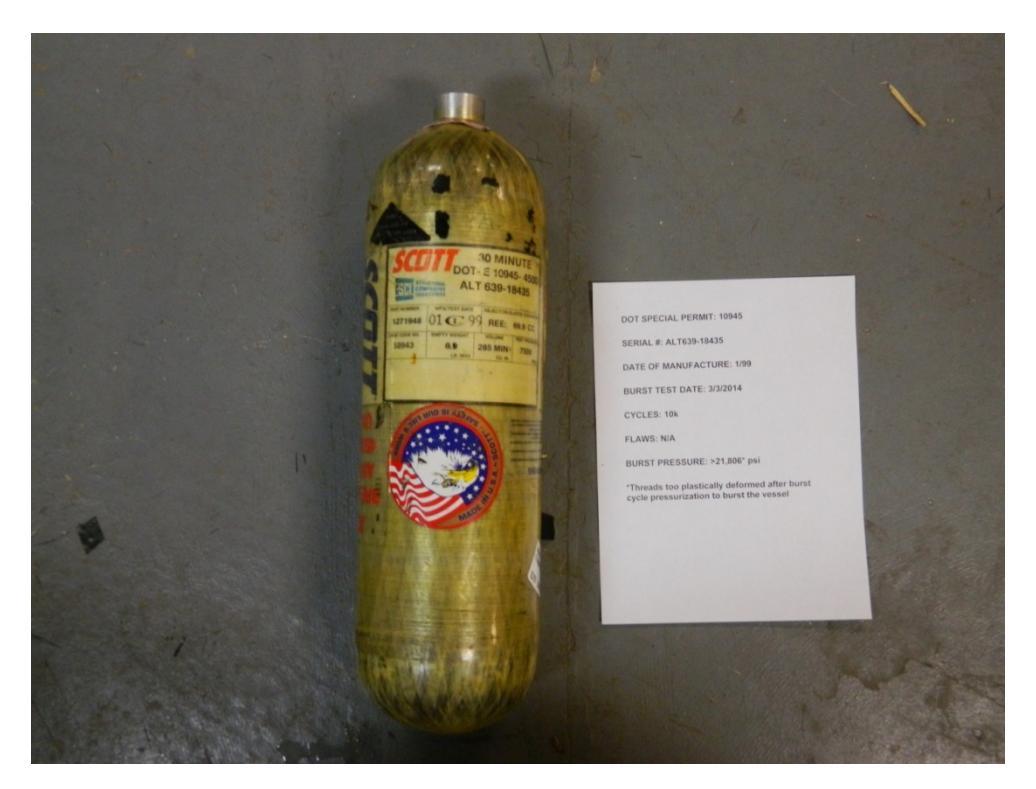
Figure 10.47 – Image of ALT639-18435 after EOL Burst testing.

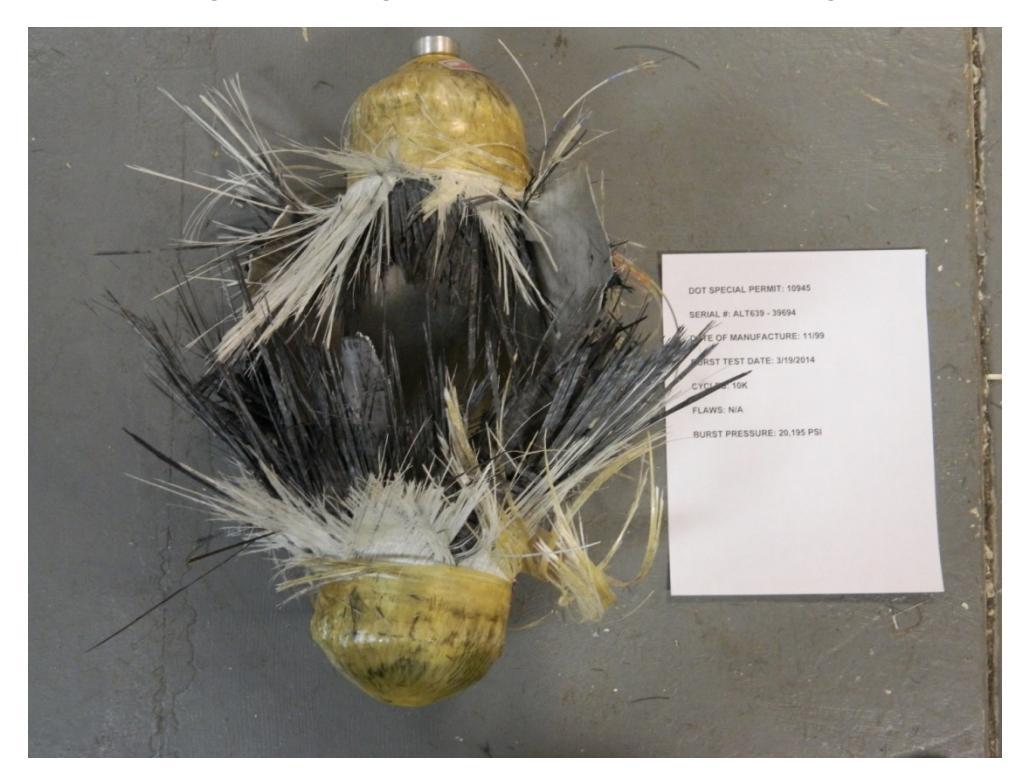
Figure 10.48 – Image of ALT639-39694 after EOL Burst testing.

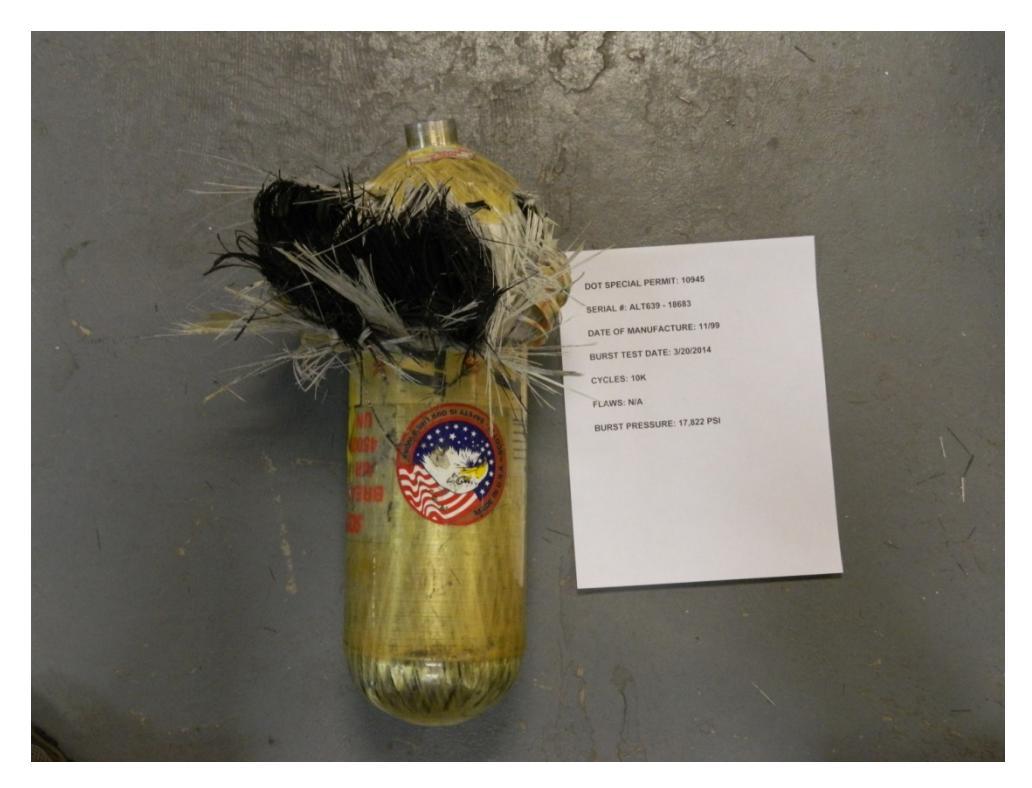
Figure 10.49 – Image of ALT639-18683 after EOL Burst testing.

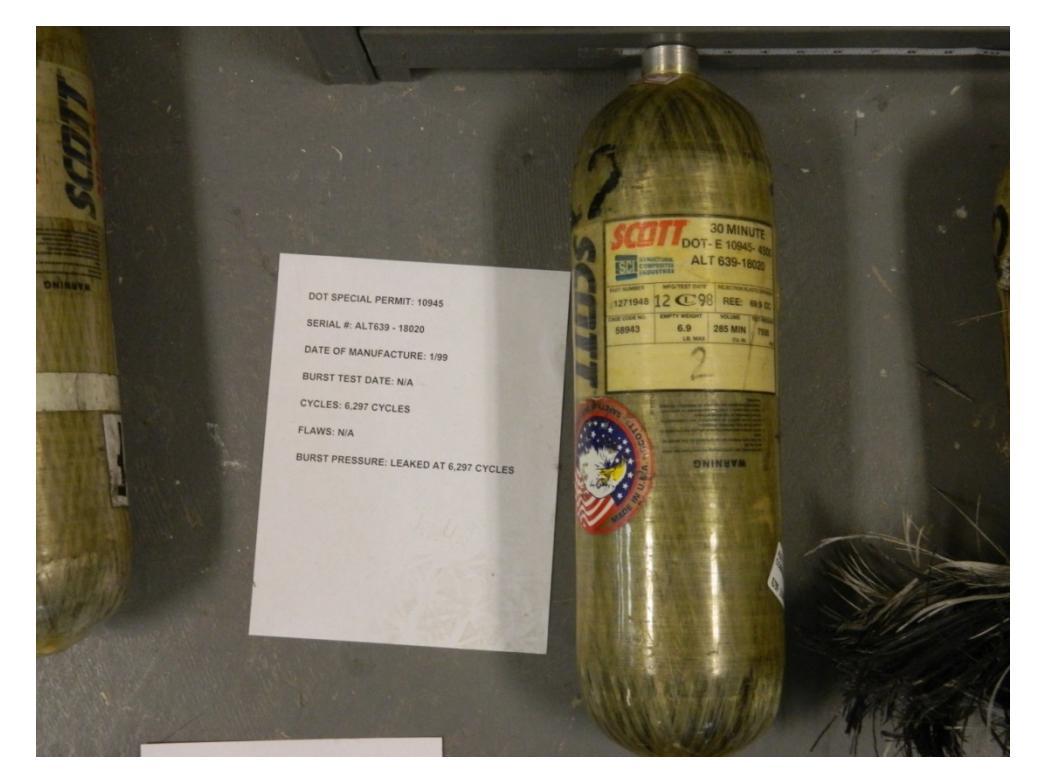
Figure 10.50 – Image of ALT639-18020 after EOL Burst testing.

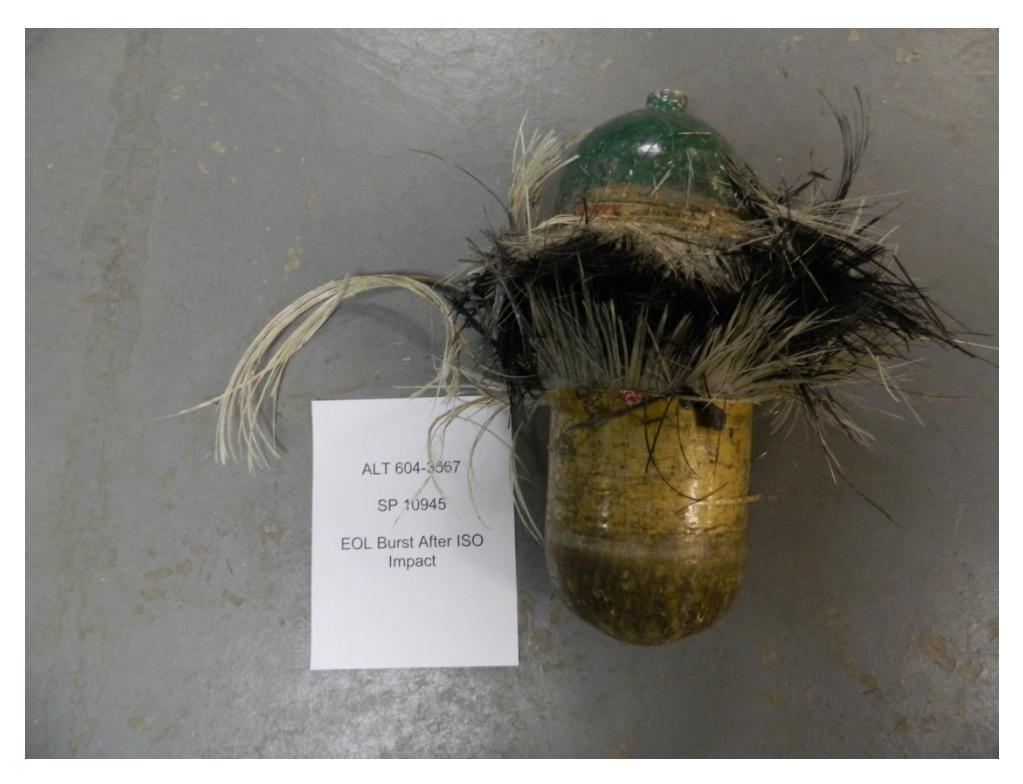
Figure 10.51 – Image of ALT639-3567 after EOL Burst testing.

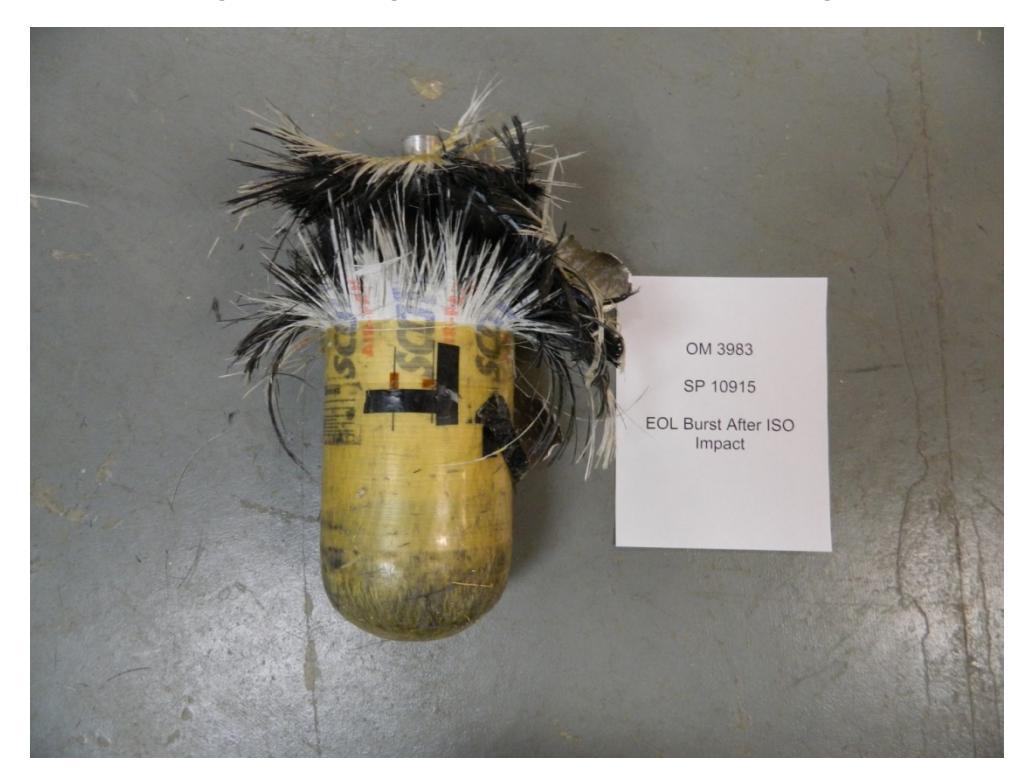
Figure 10.52 – Image of OM3983 after EOL Burst testing.

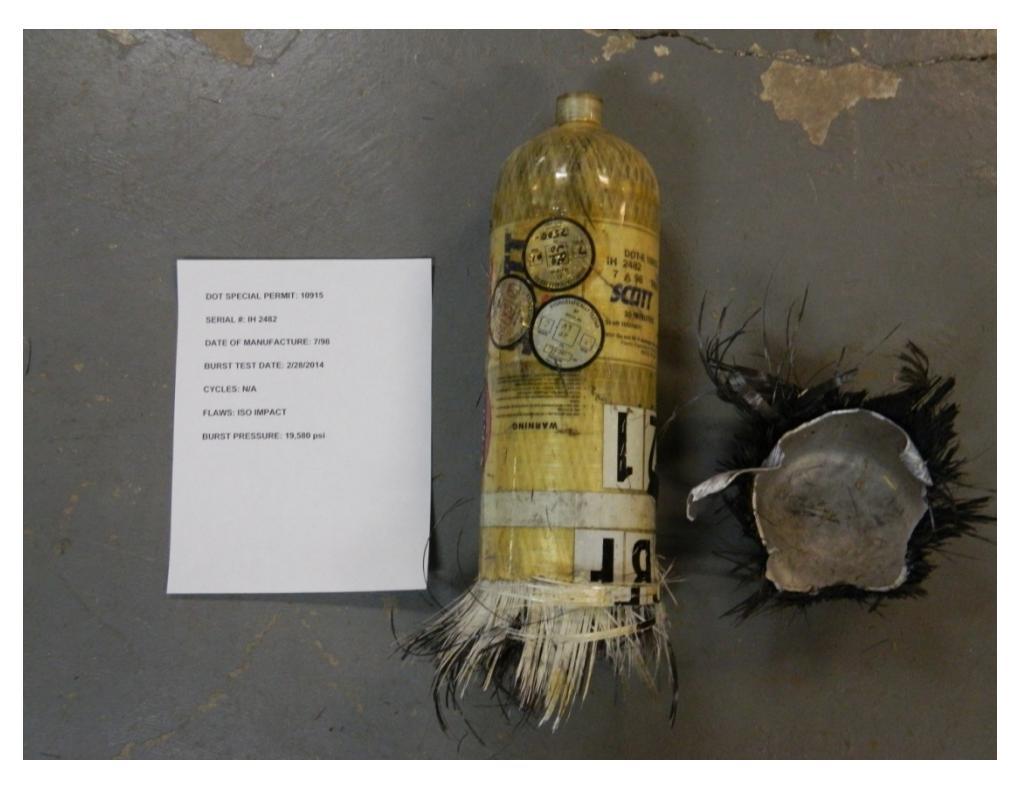
Figure 10.53 – Image of IH2482 after EOL Burst testing.

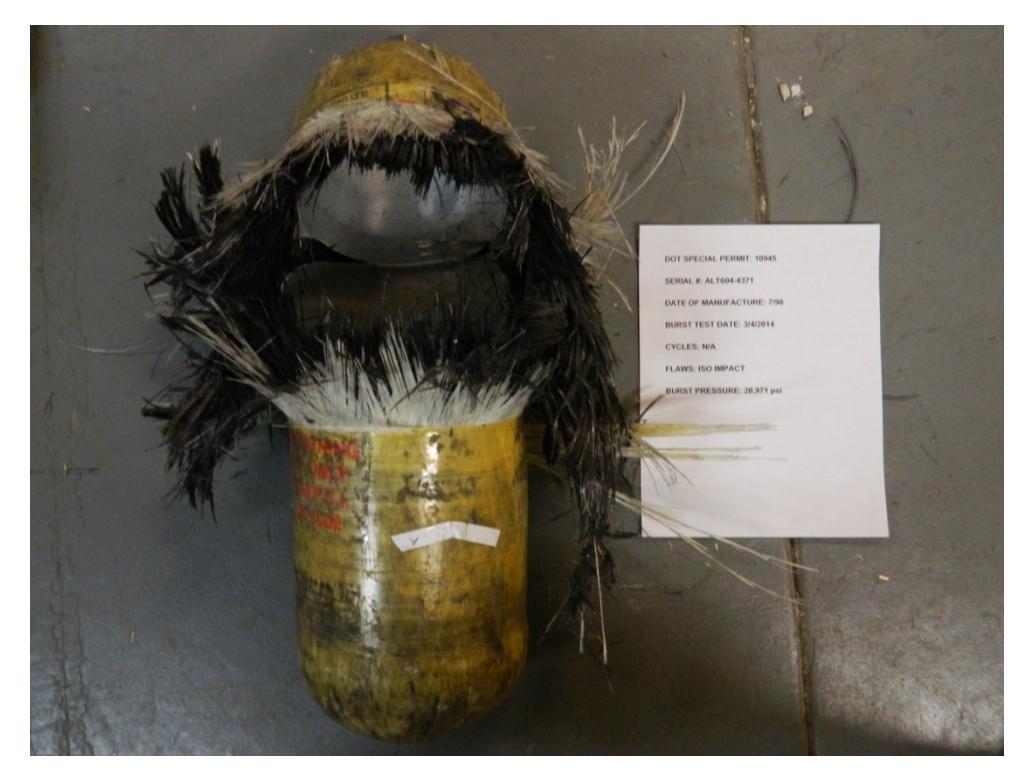
Figure 10.54 – Image of ALT604-4371 after EOL Burst testing.

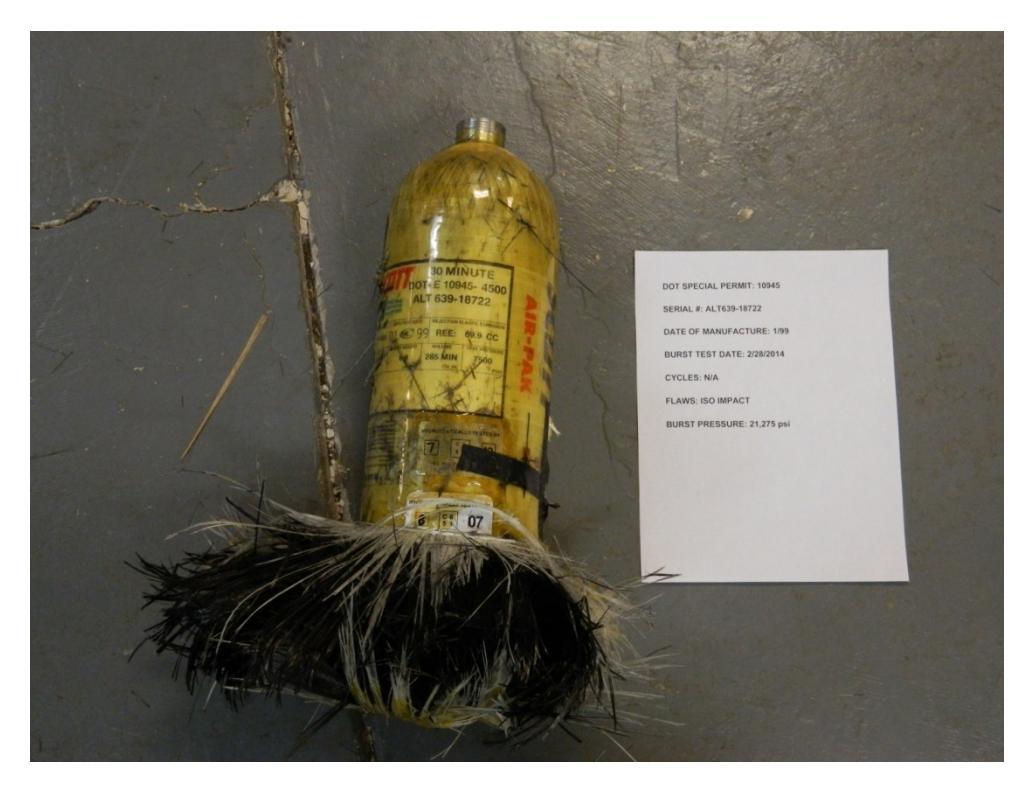
Figure 10.55 – Image of ALT639-18722 after EOL Burst testing.

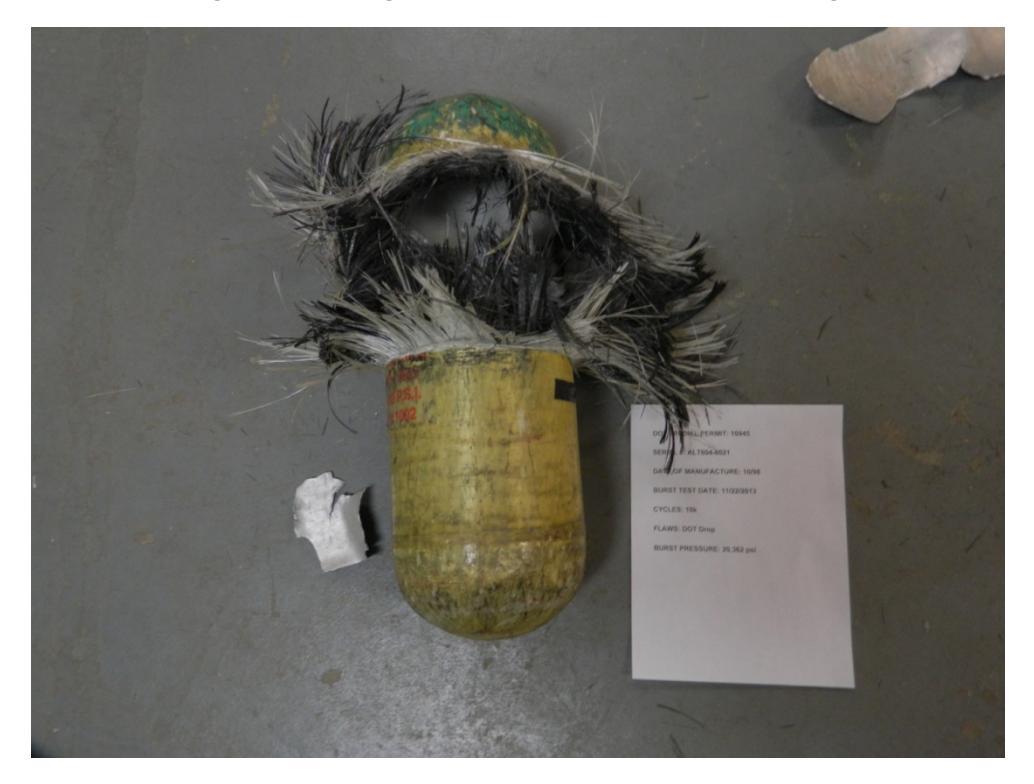
Figure 10.56 – Image of ALT604-6021 after EOL Burst testing.

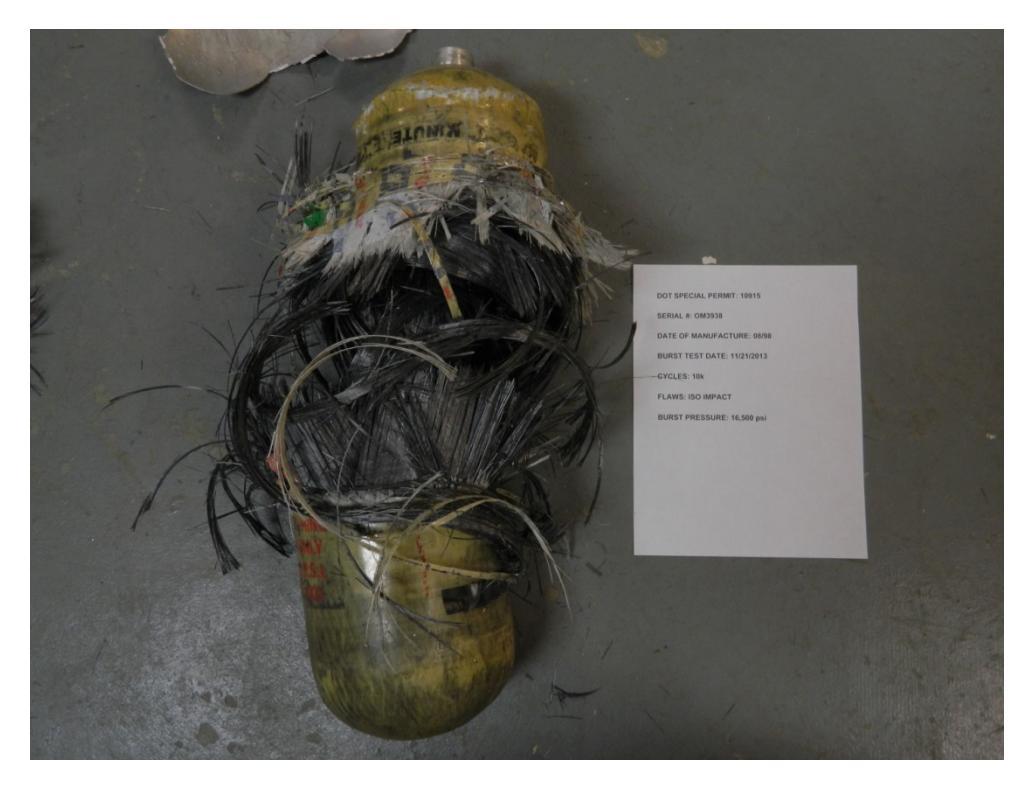
Figure 10.57 – Image of OM3938 after EOL Burst testing.

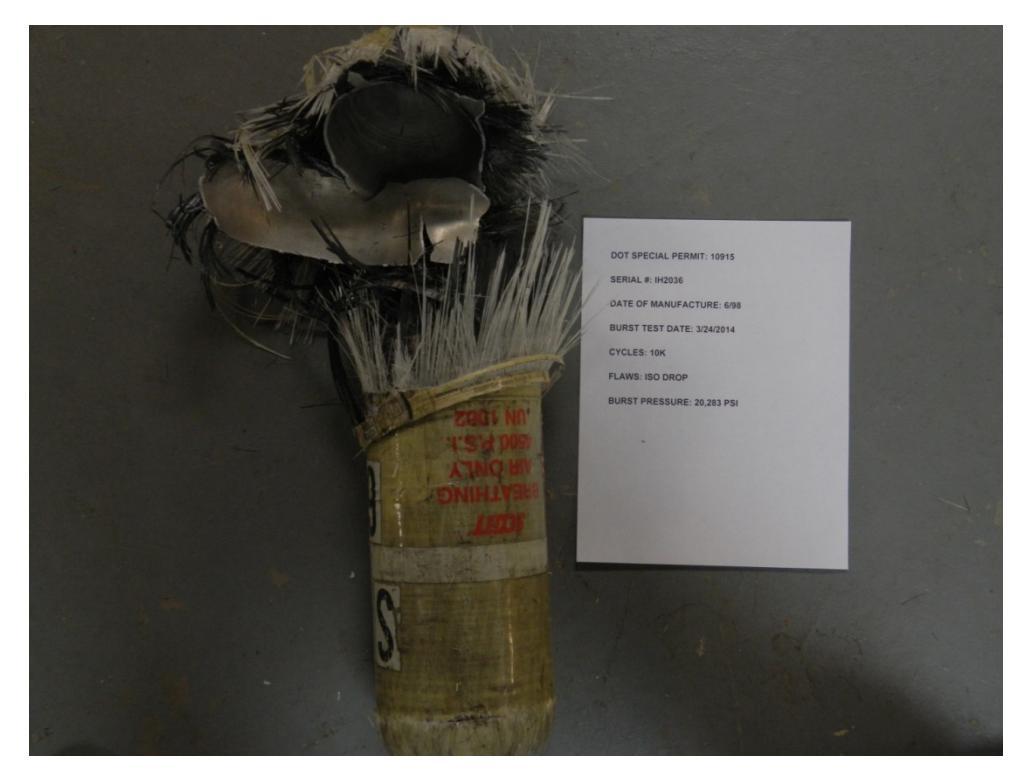
Figure 10.58 – Image of IH2036 after EOL Burst testing.

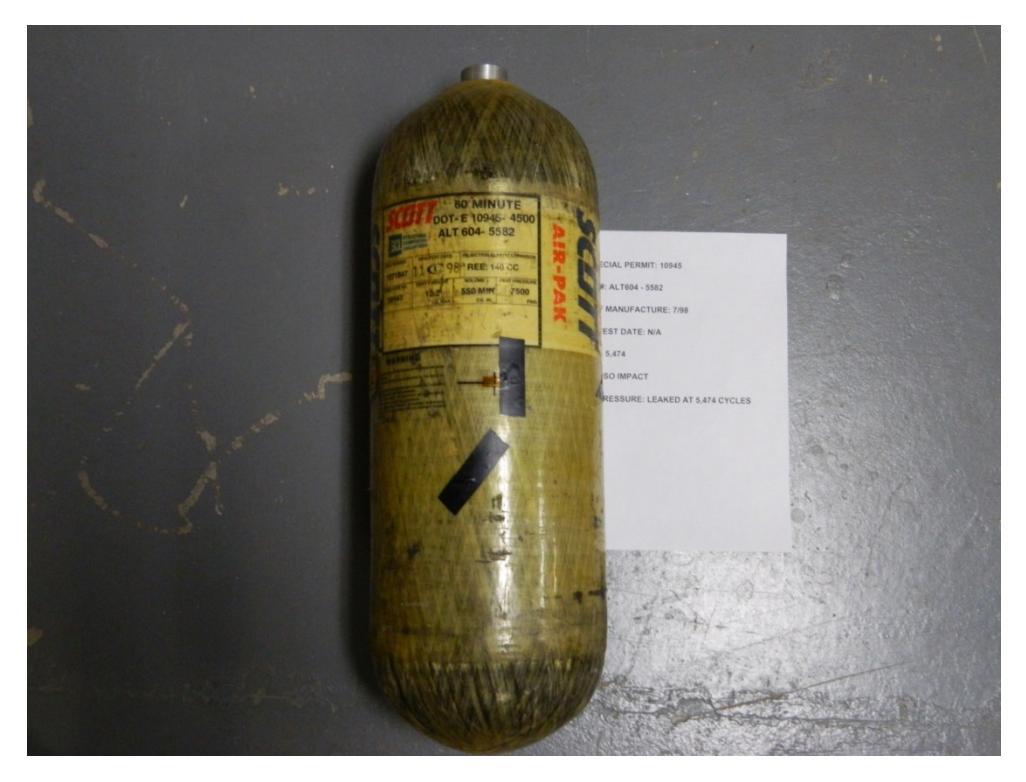
Figure 10.59 – Image of ALT604-5582 after EOL Burst testing.

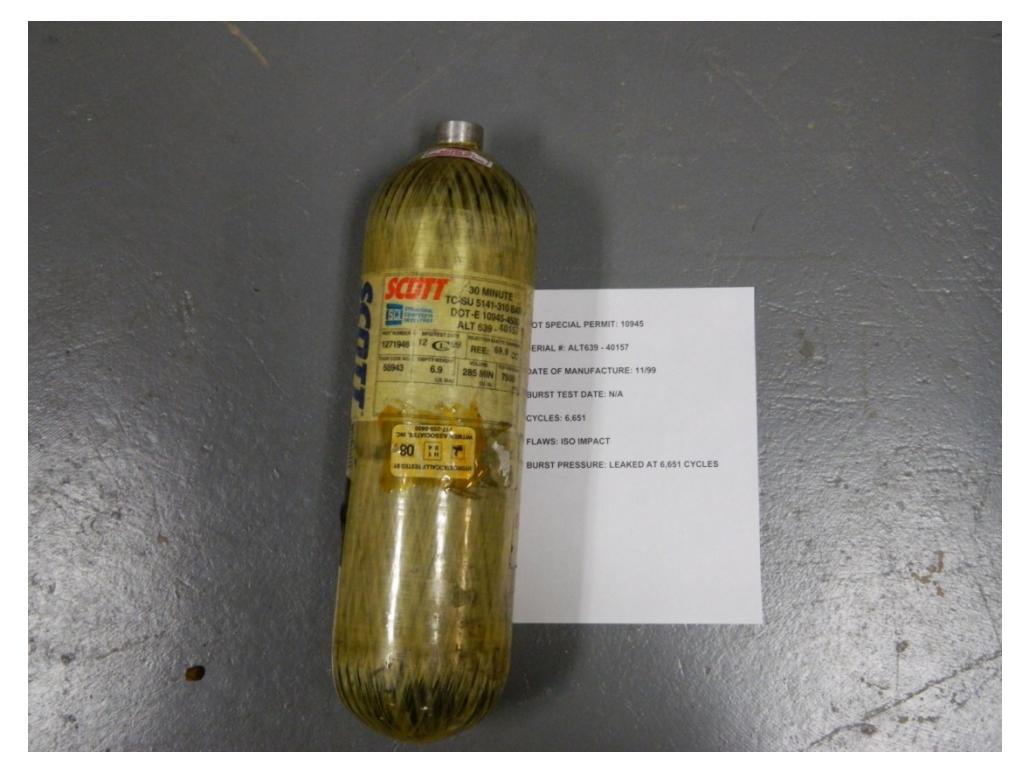
Figure 10.60 – Image of ALT639-40157 after EOL Burst testing.

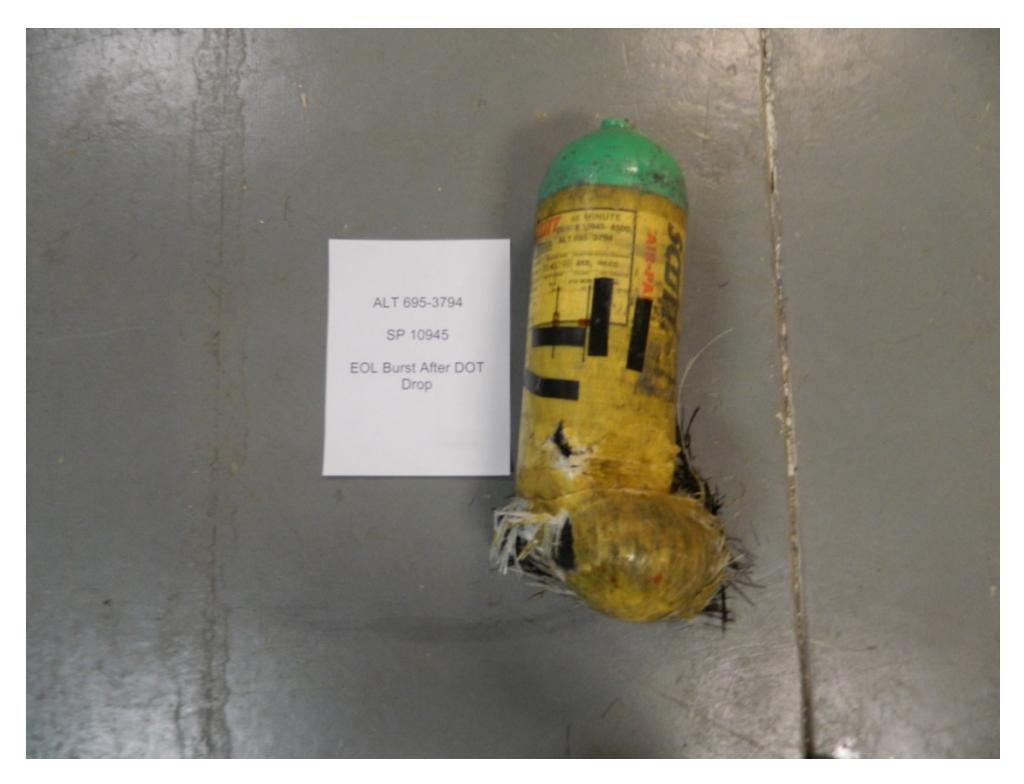
Figure 10.61 – Image of ALT695-3794 after EOL Burst testing.

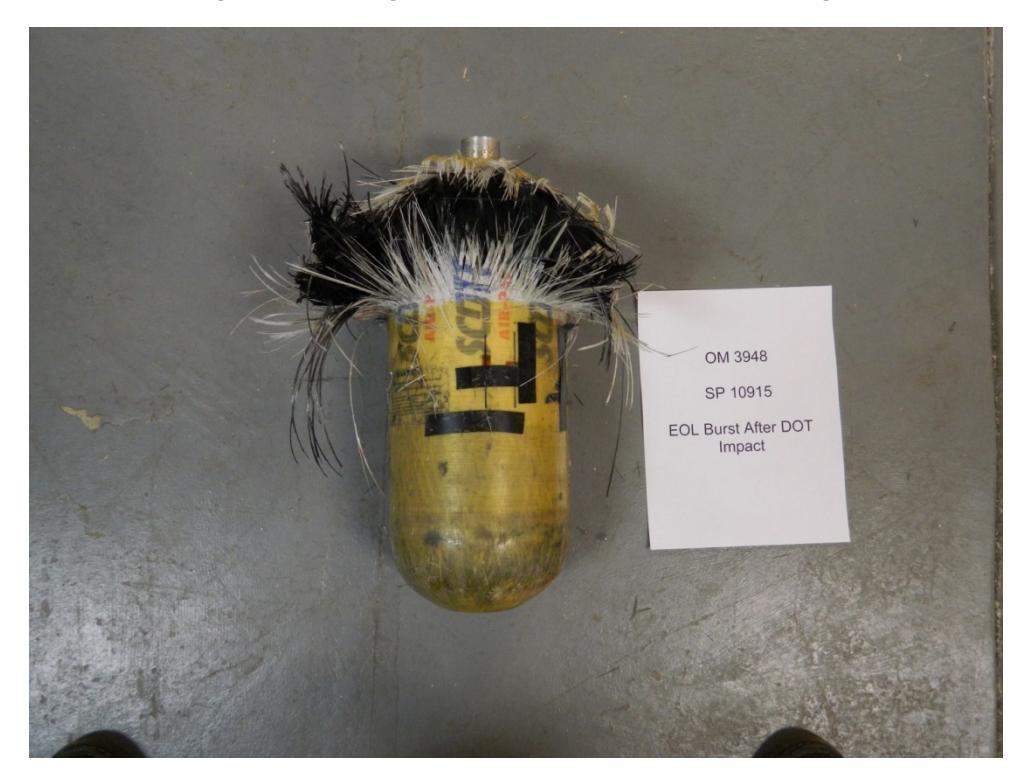
Figure 10.62 – Image of OM3948 after EOL Burst testing.

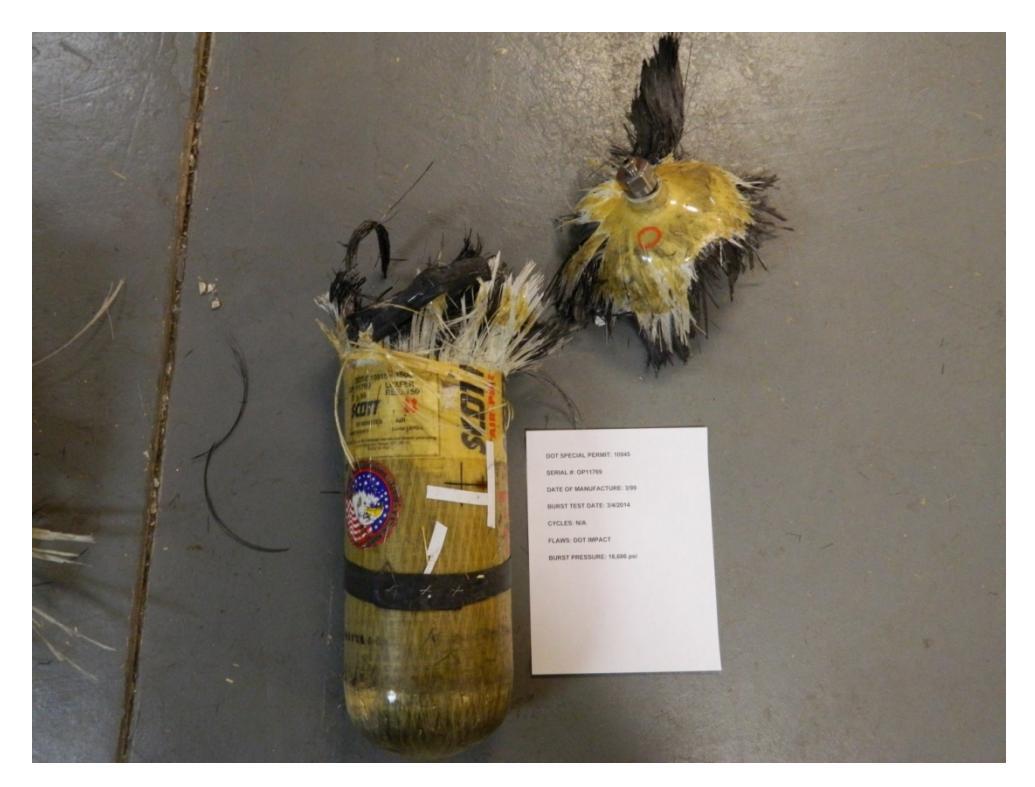
Figure 10.63 – Image of OP11769 after EOL Burst testinzg.

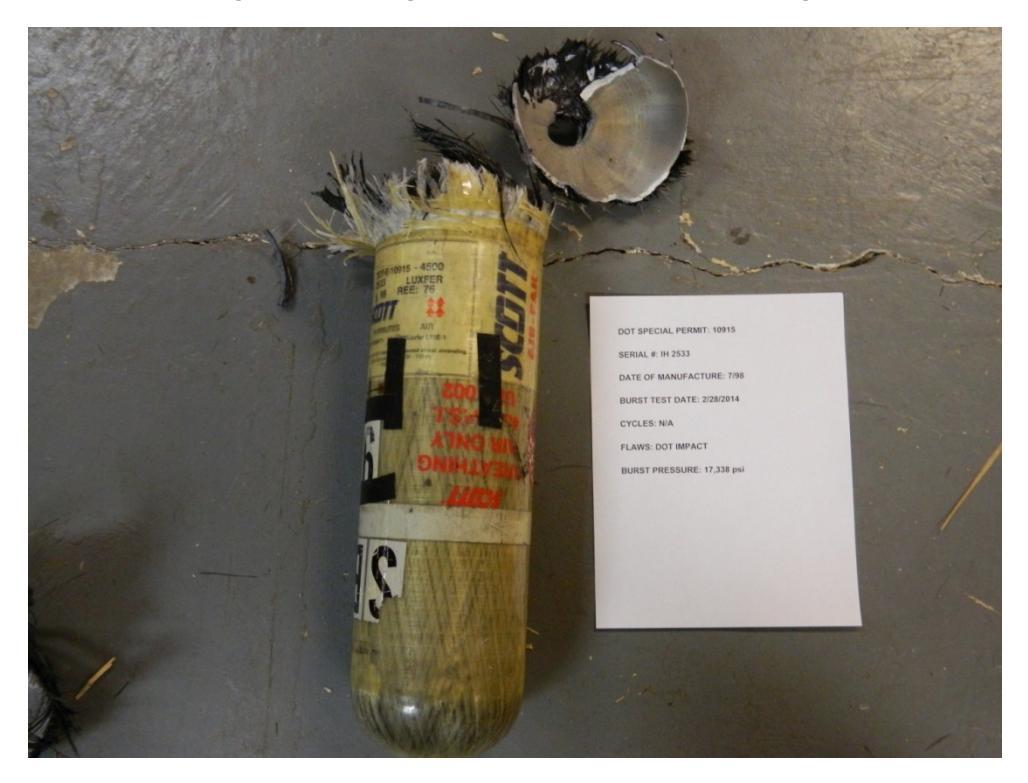
Figure 10.64 – Image of IH2533 after EOL Burst testing.

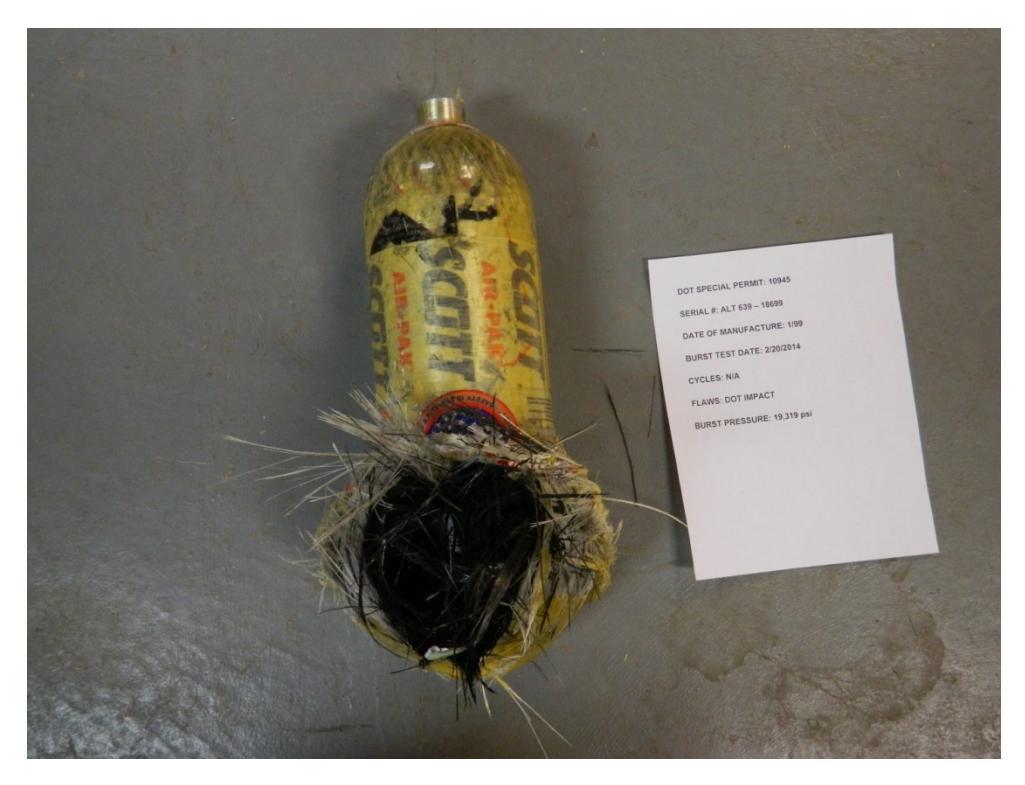
Figure 10.65 – Image of ALT639-18699 after EOL Burst testing.

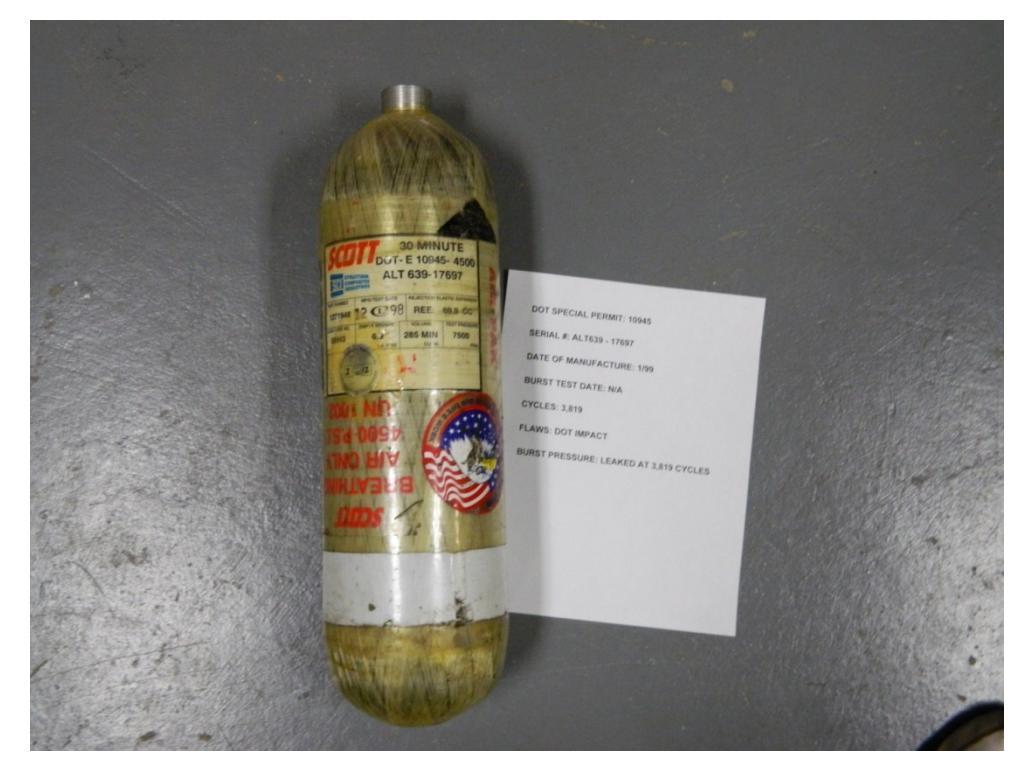
Figure 10.68 – Image of ALT639-17697 after EOL Burst testing.

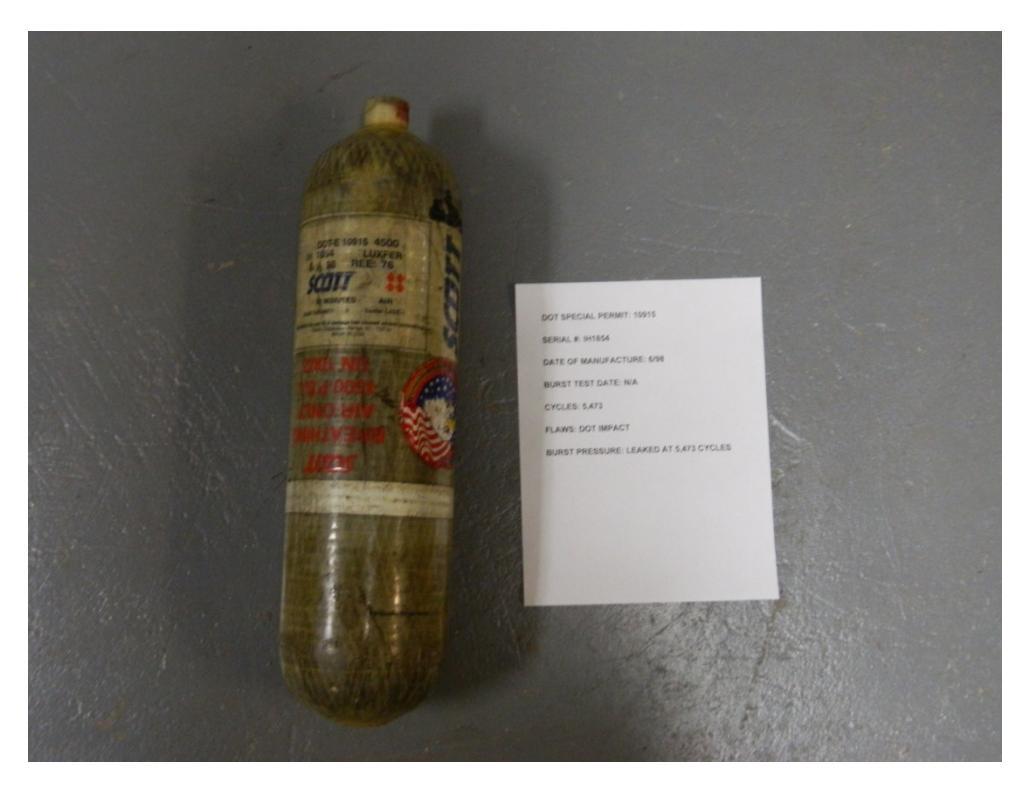
Figure 10.69 – Image of IH1854 after EOL Burst testing.
