**Digital Wave Corporation** 13760 East Arapahoe Road Centennial, CO 80112

Use of Modal Acoustic Emission (MAE) for life extension of civilian self-contained breathing apparatus (SCBA) DOT-CFFC cylinders

# FINAL REPORT

Contract DTPH56-13-P-000029

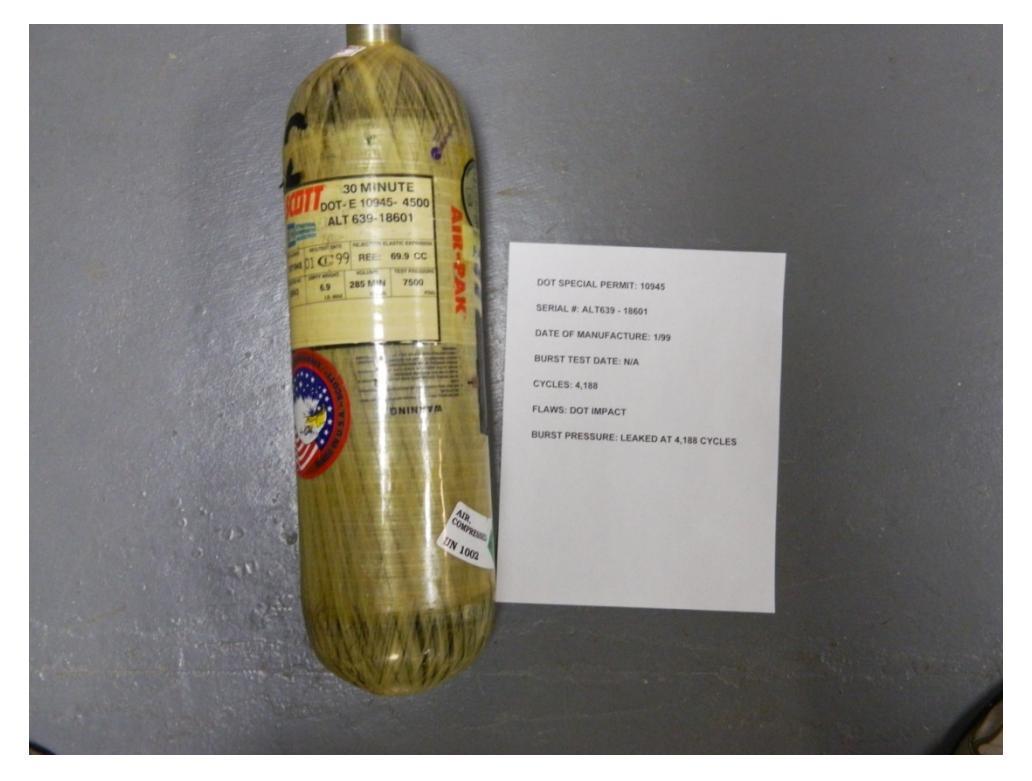
Figure 10.70 – Image of ALT639-18601 after EOL Burst testing.

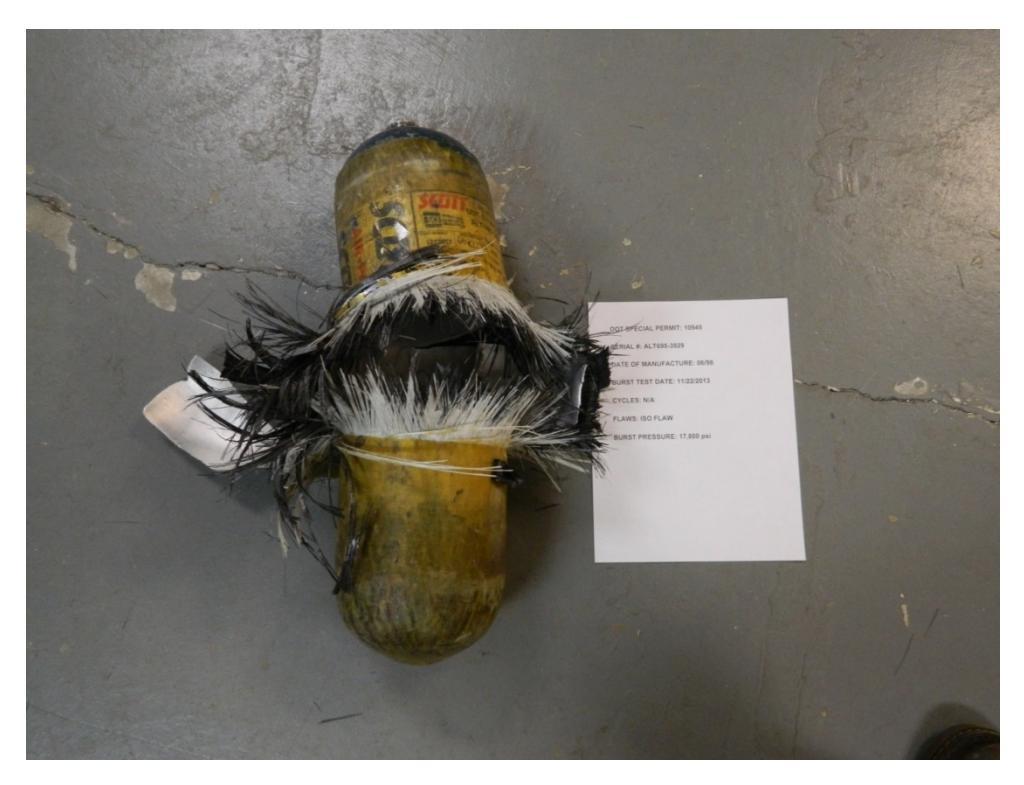
Figure 10. 71 – Image of ALT695-3929 after EOL Burst testing.

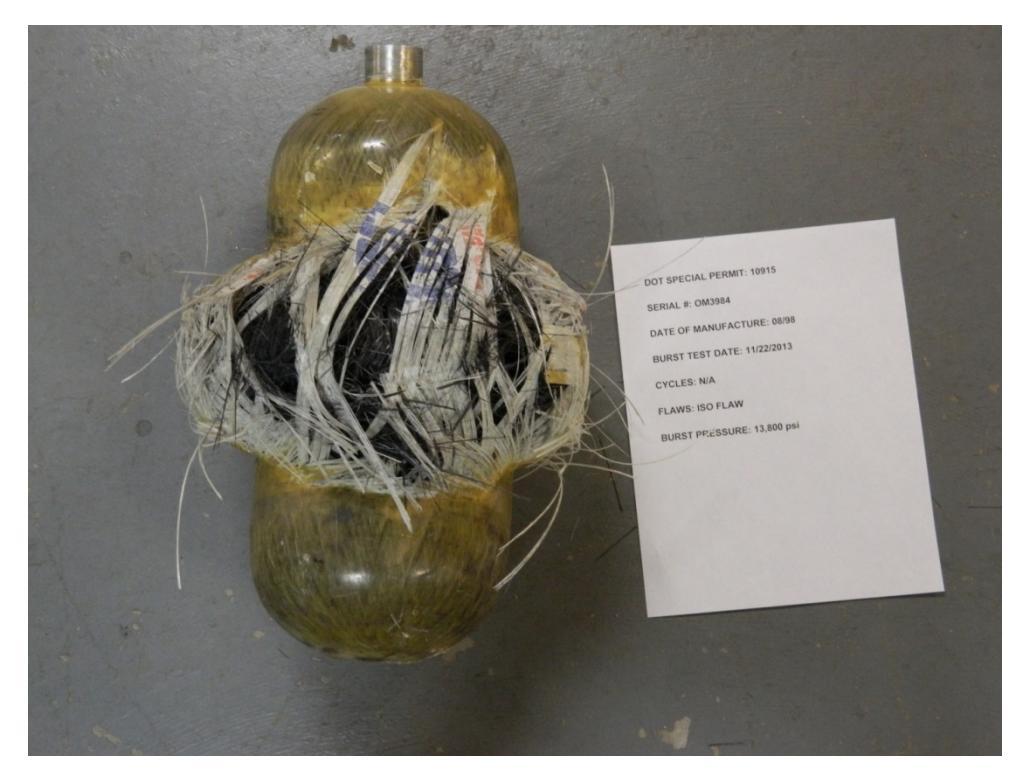
Figure 10.72 – Image of OM3984 after EOL Burst testing.

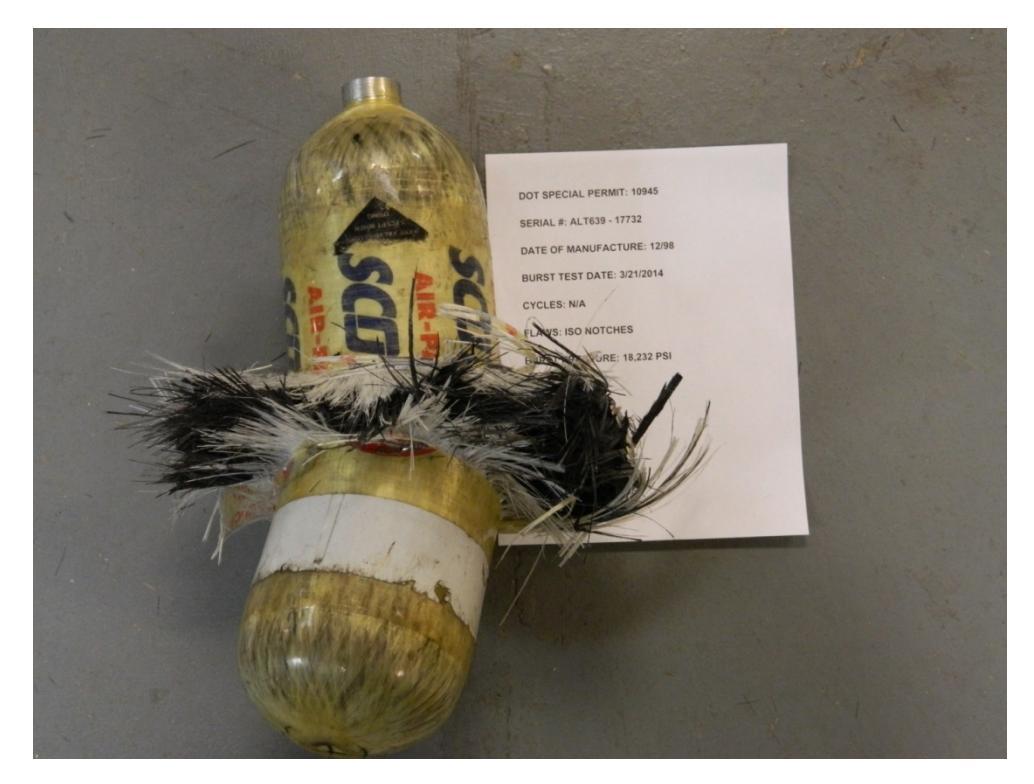
Figure 10.73 – Image of ALT639-17732 after EOL Burst testing.

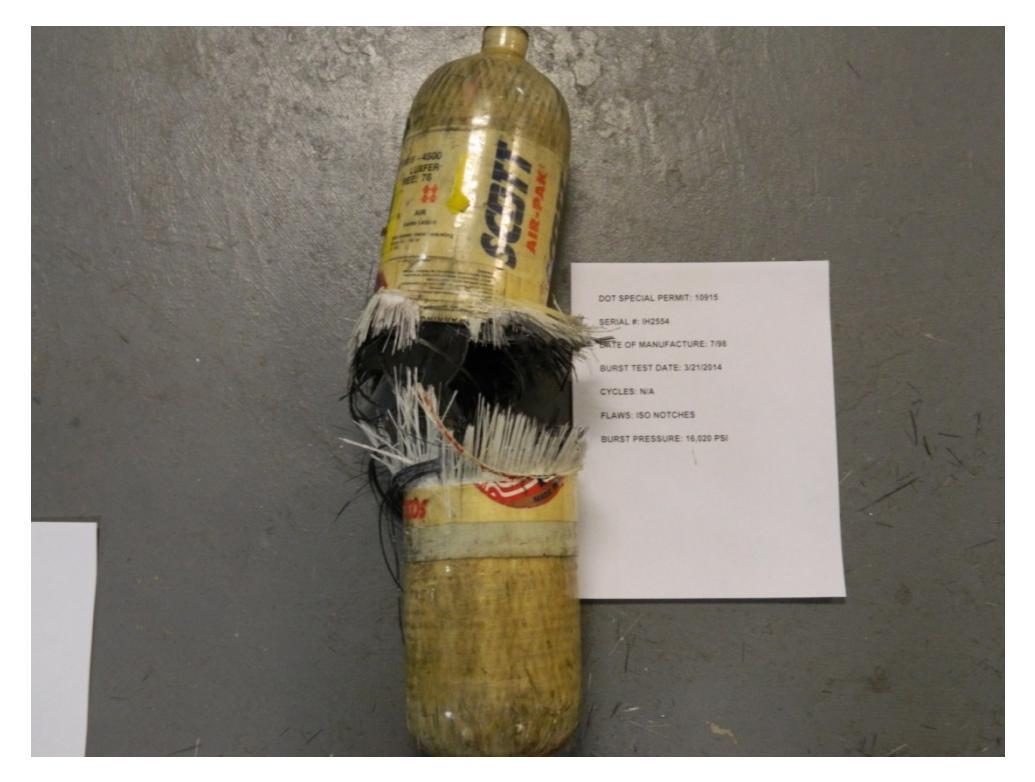
Figure 10.74 – Image of IH2554 after EOL Burst testing.

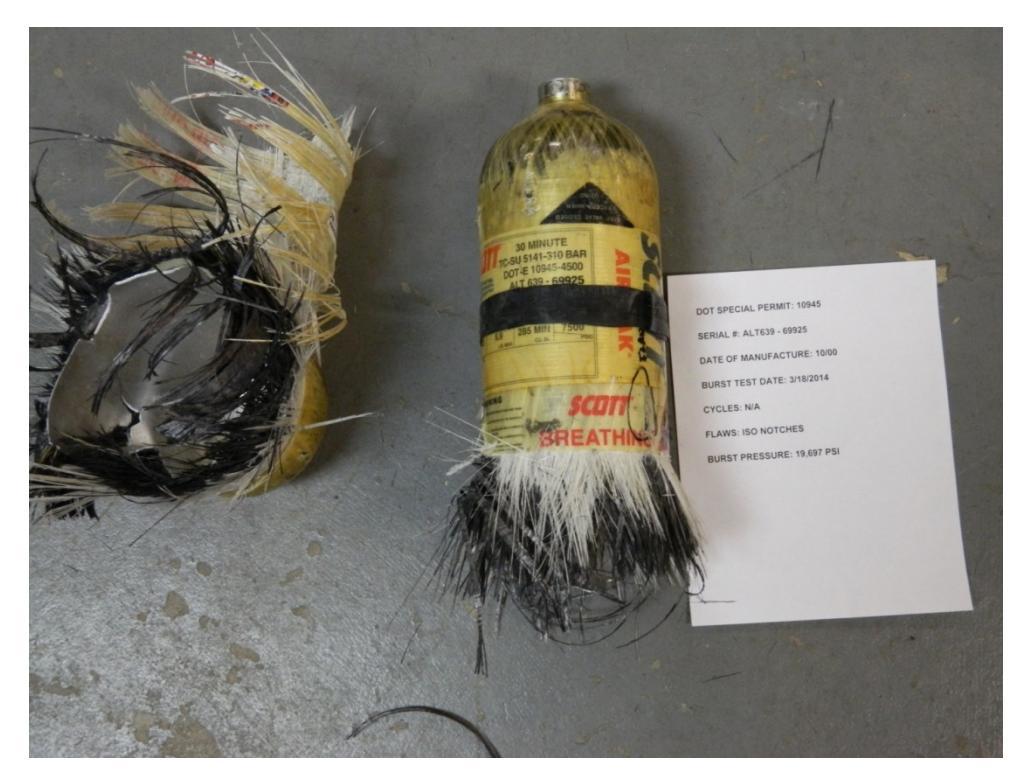
Figure 10.75 – Image of ALT639-69925 after EOL Burst testing.

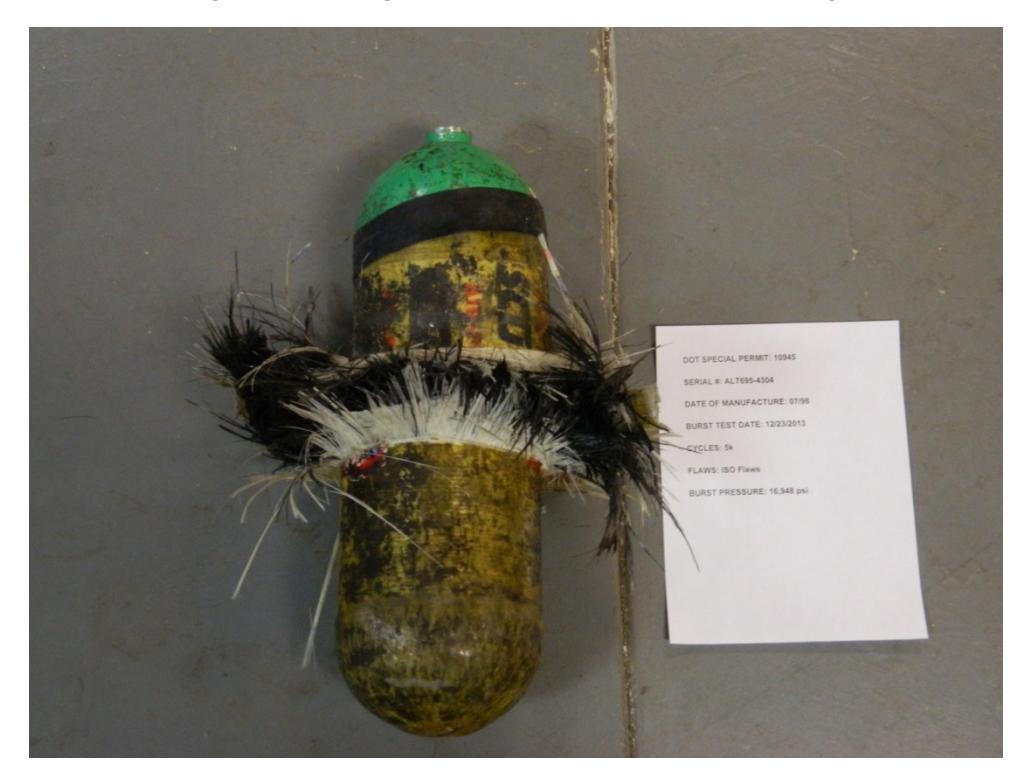
Figure 10.76 – Image of ALT695-4304 after EOL Burst testing.

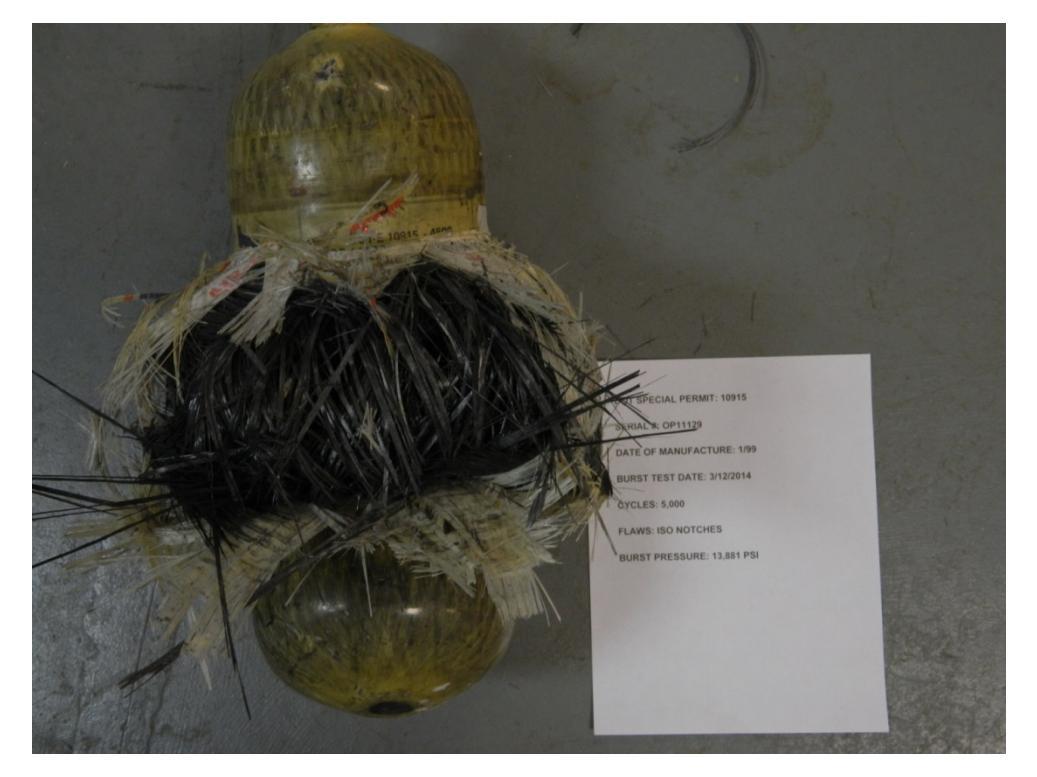
Figure 10.78 – Image of OP11129 after EOL Burst testing.

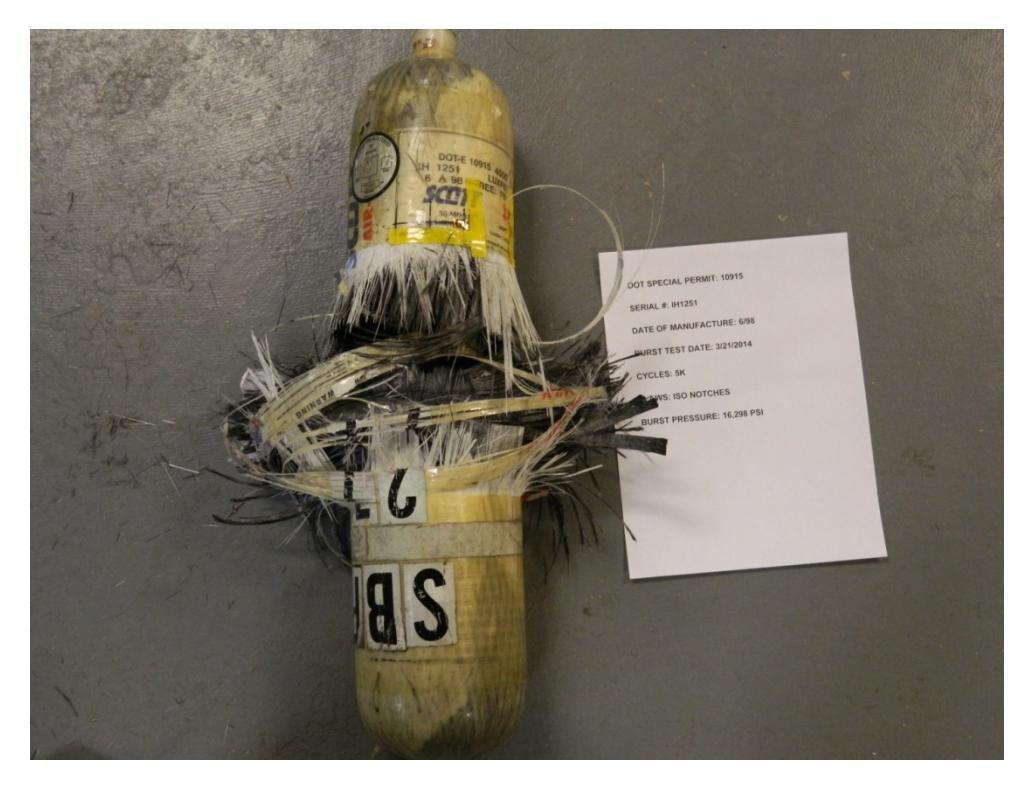
Figure 10.79 – Image of IH1251 after EOL Burst testing.

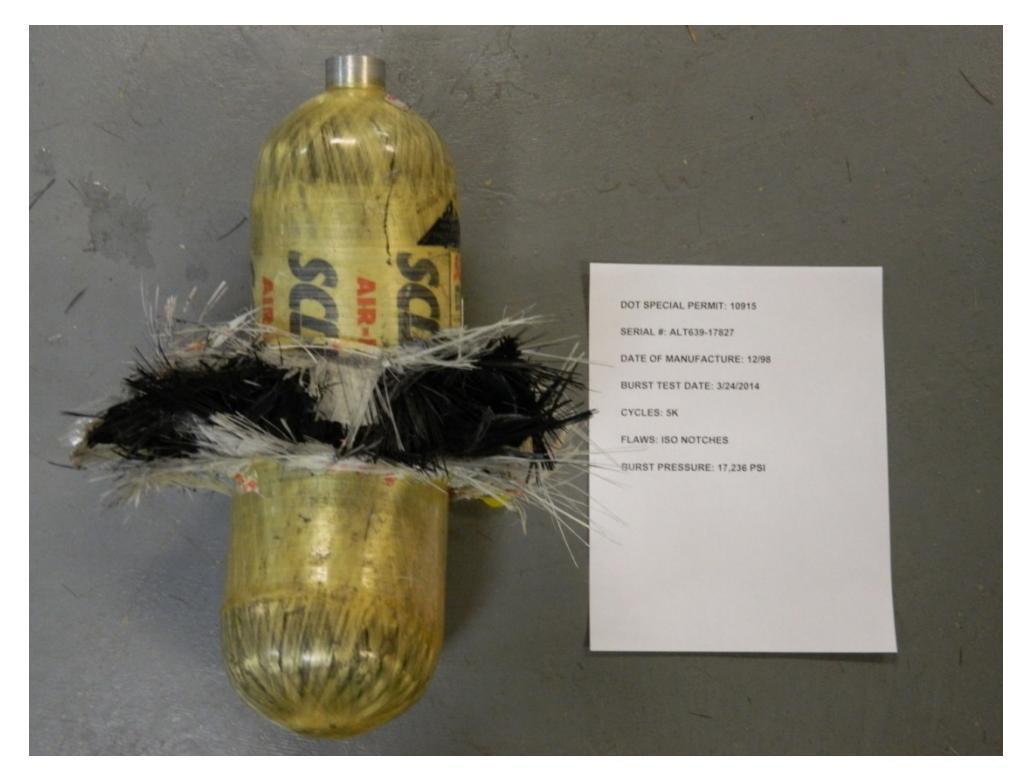
Figure 10.80 – Image of ALT639-17827 after EOL Burst testing.

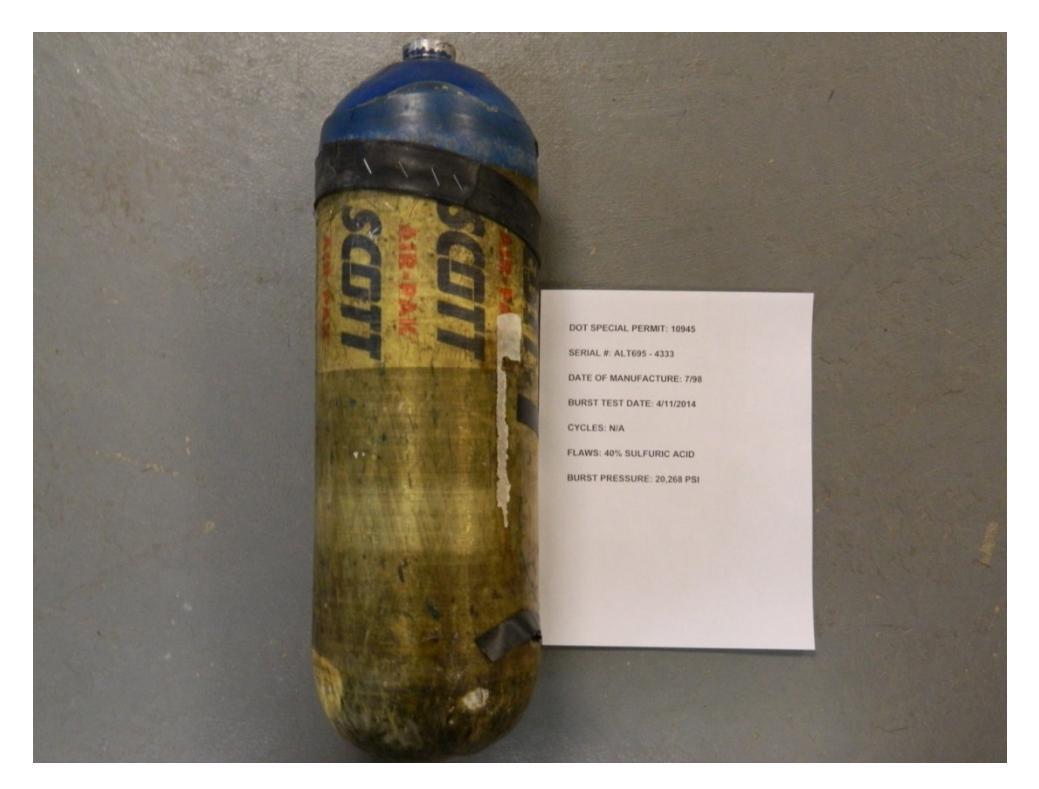
Figure 10.81 – Image of ALT695-4333 after EOL Burst testing.

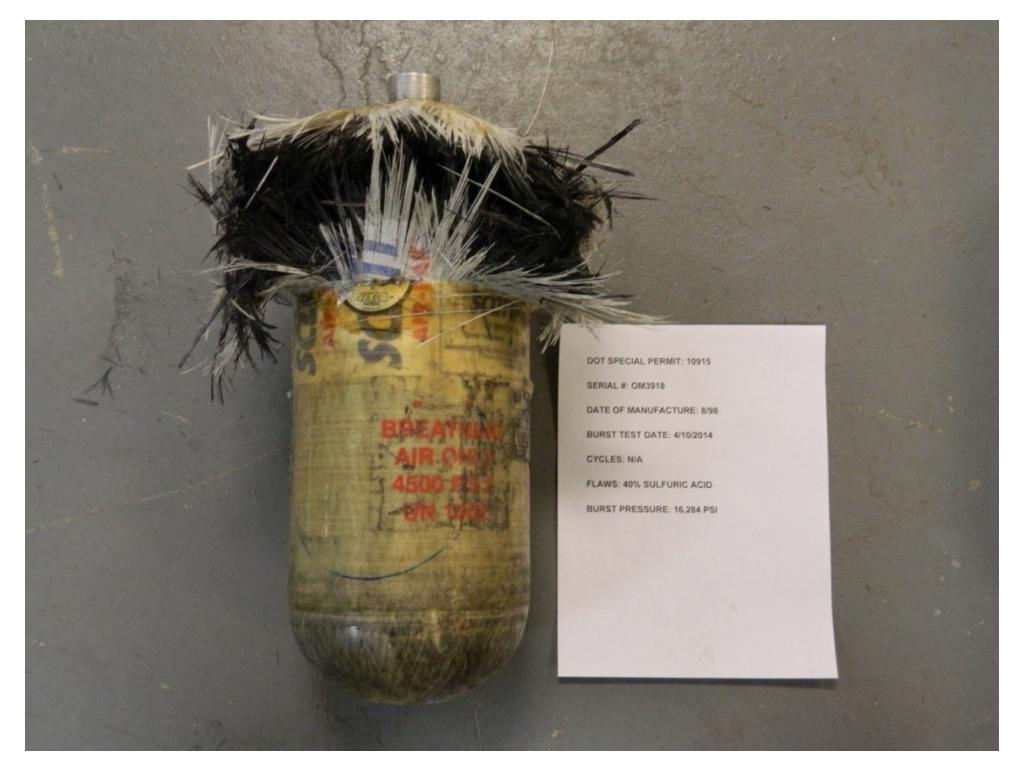
Figure 10.82 – Image of OM3918 after EOL Burst testing.

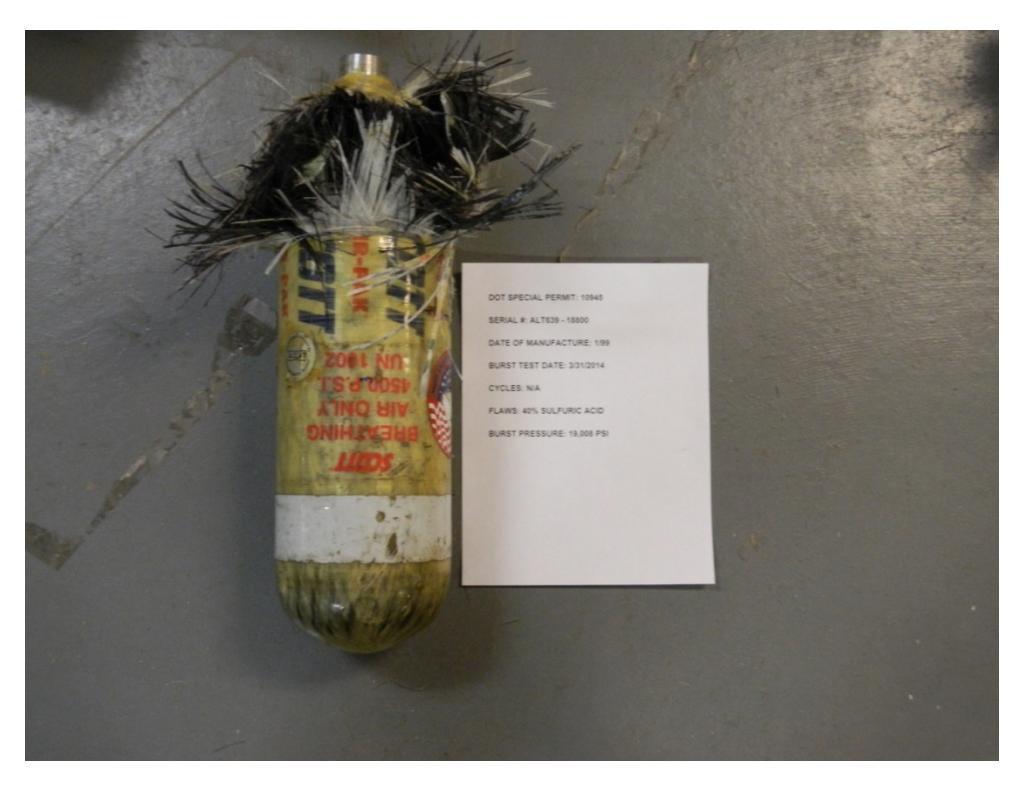
Figure 10.83 – Image of ALT639-18800 after EOL Burst testing.

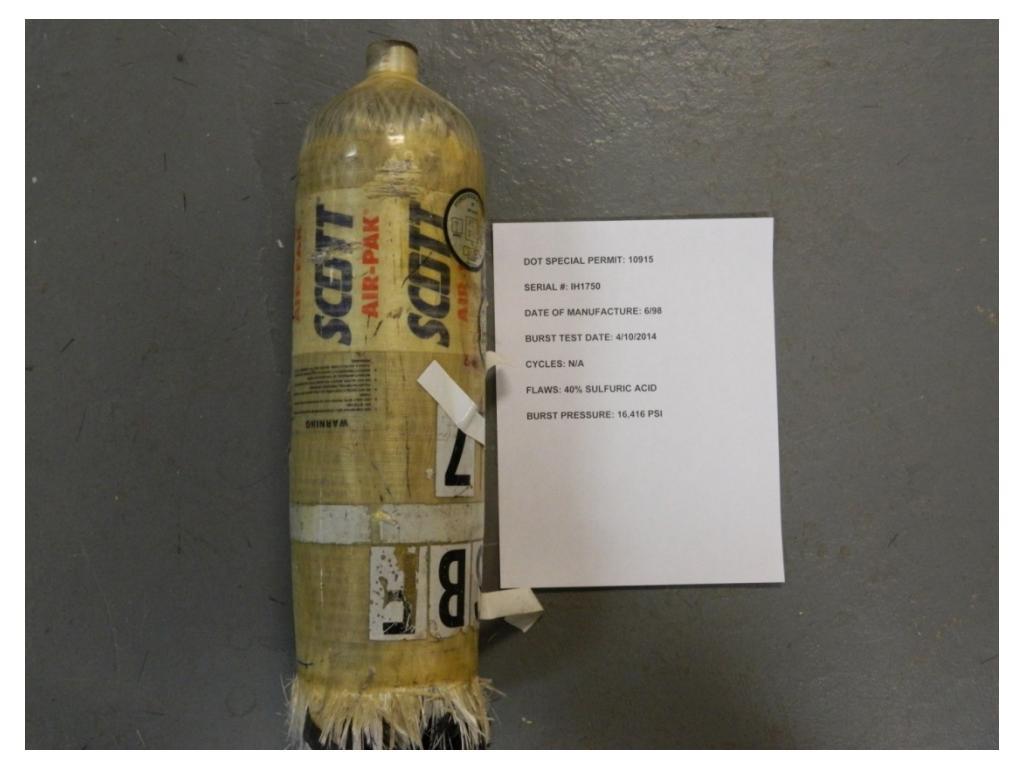
Figure 10.84 – Image of IH1750 after EOL Burst testing.

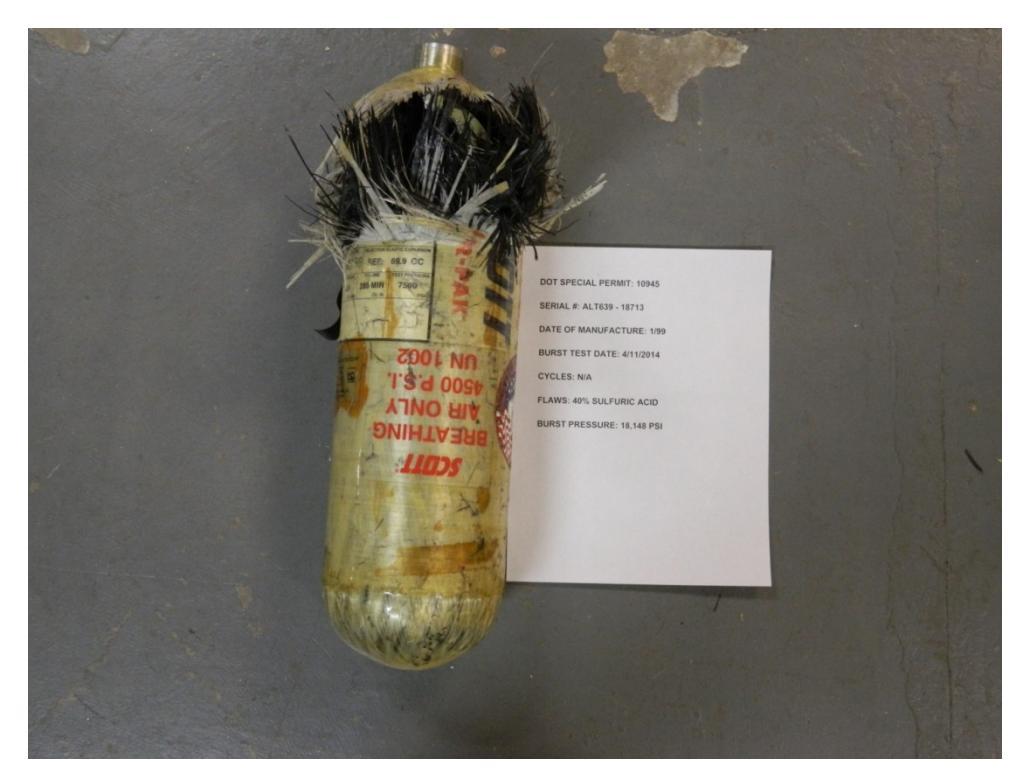
Figure 10.85 – Image of ALT639-18713 after EOL Burst testing.

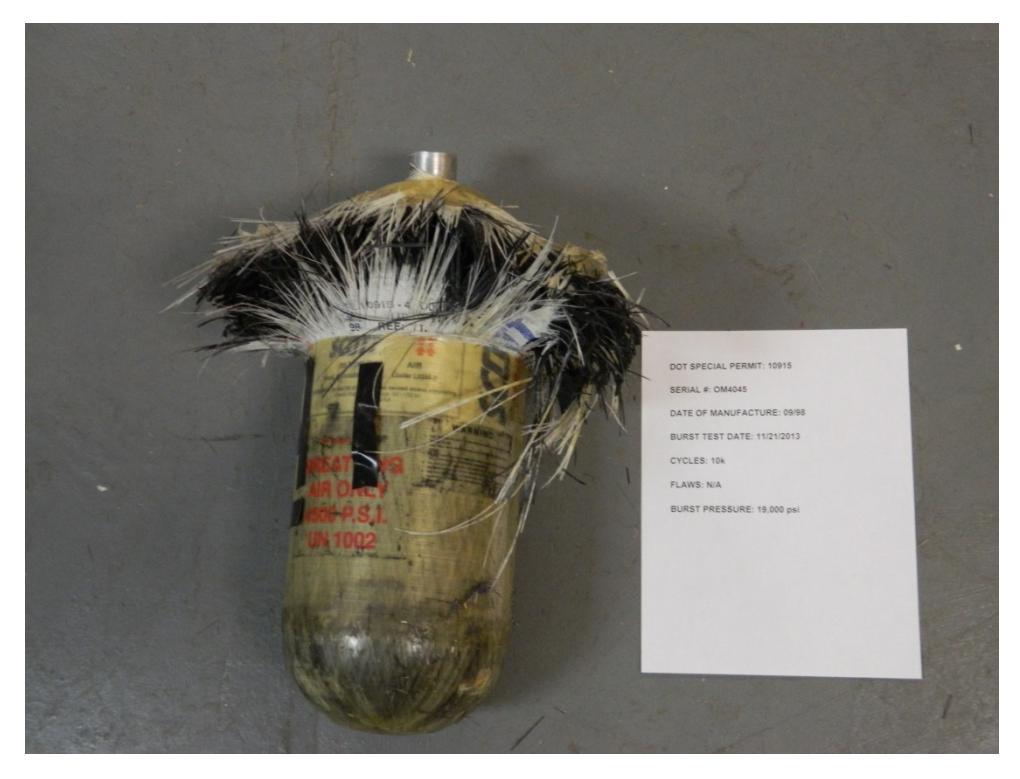
Figure 10.90 – Image of OM4045, after EOL Burst test.

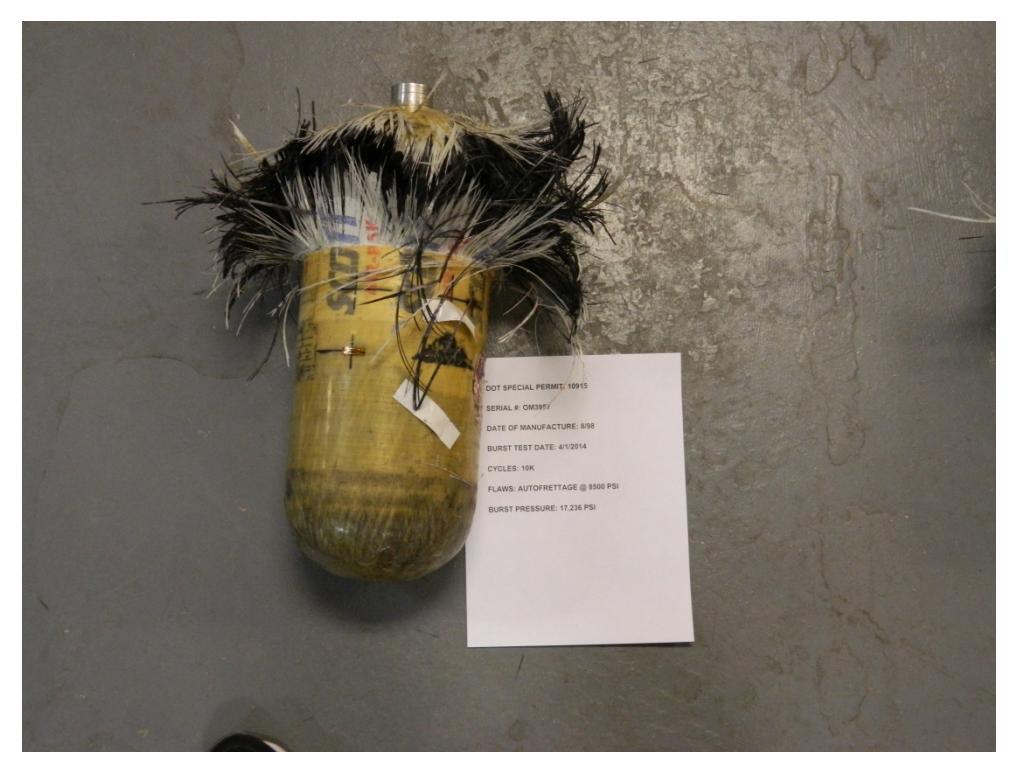
Figure 10.94 – Image of OM3957, after EOL Burst.

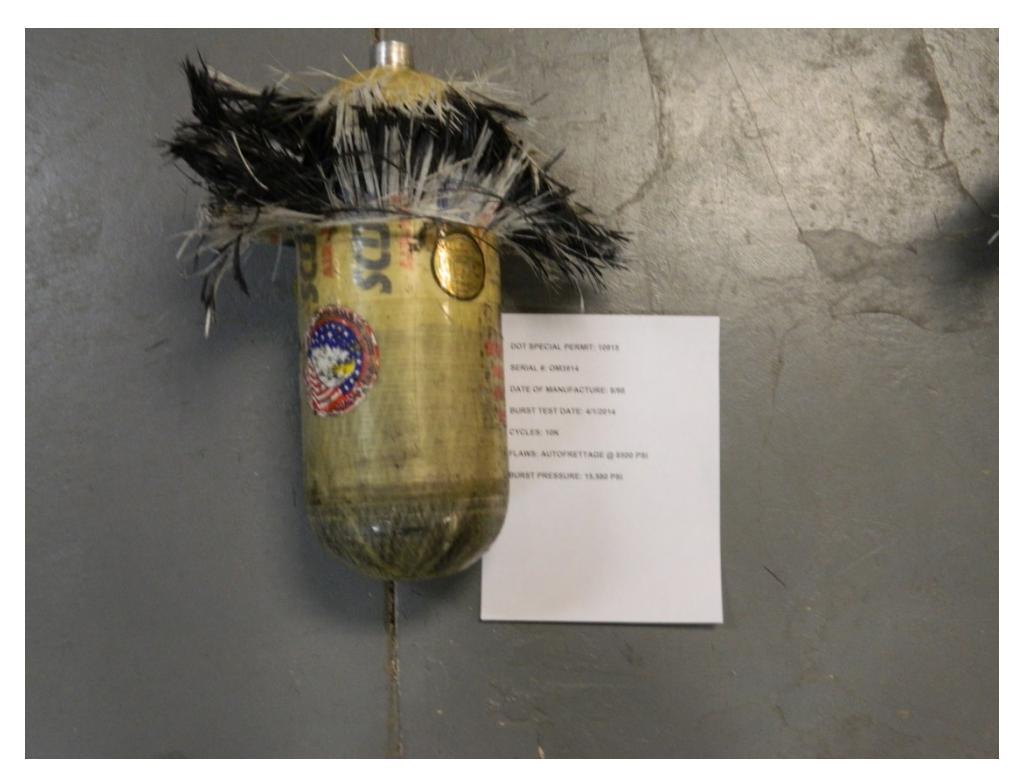
Figure 10.95 – Image of OM3914, after EOL Burst.

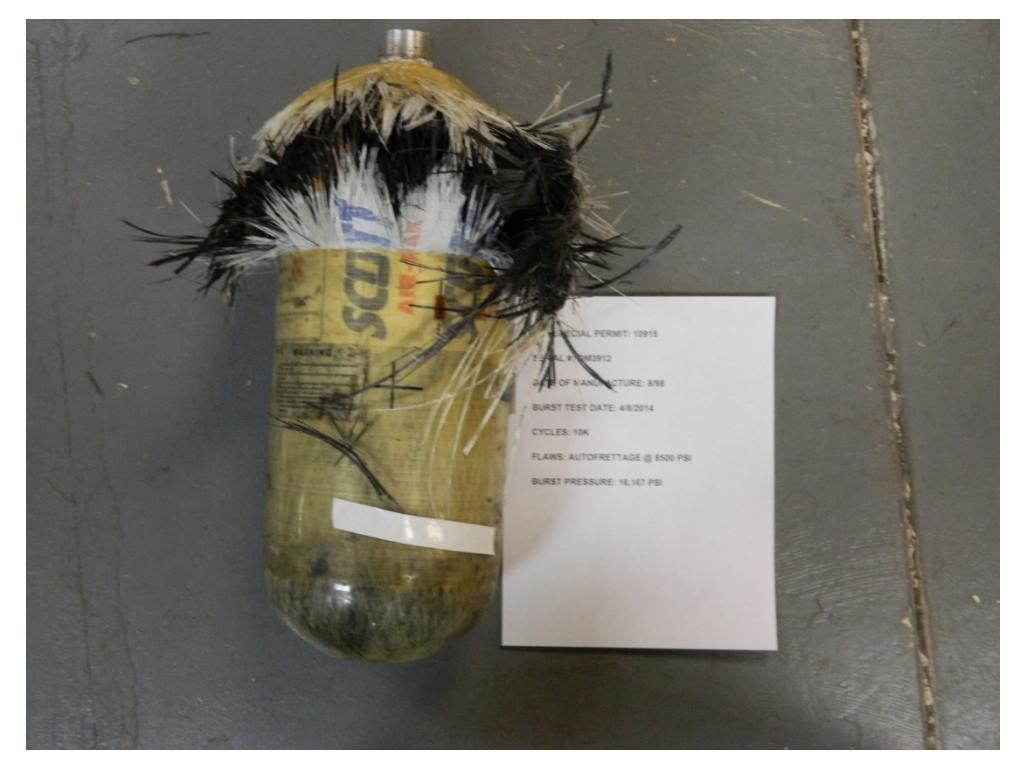
Figure 10.96 – Image of OM3912, after EOL Burst.

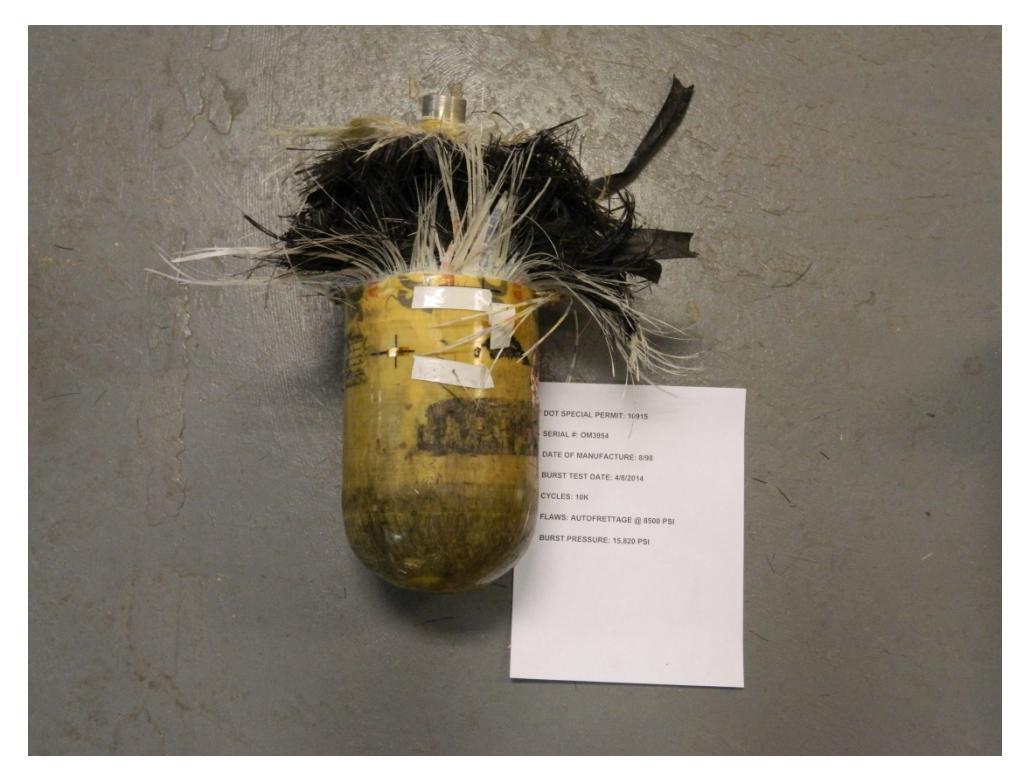
Figure 10.97 – Image of OM3954, after EOL Burst.

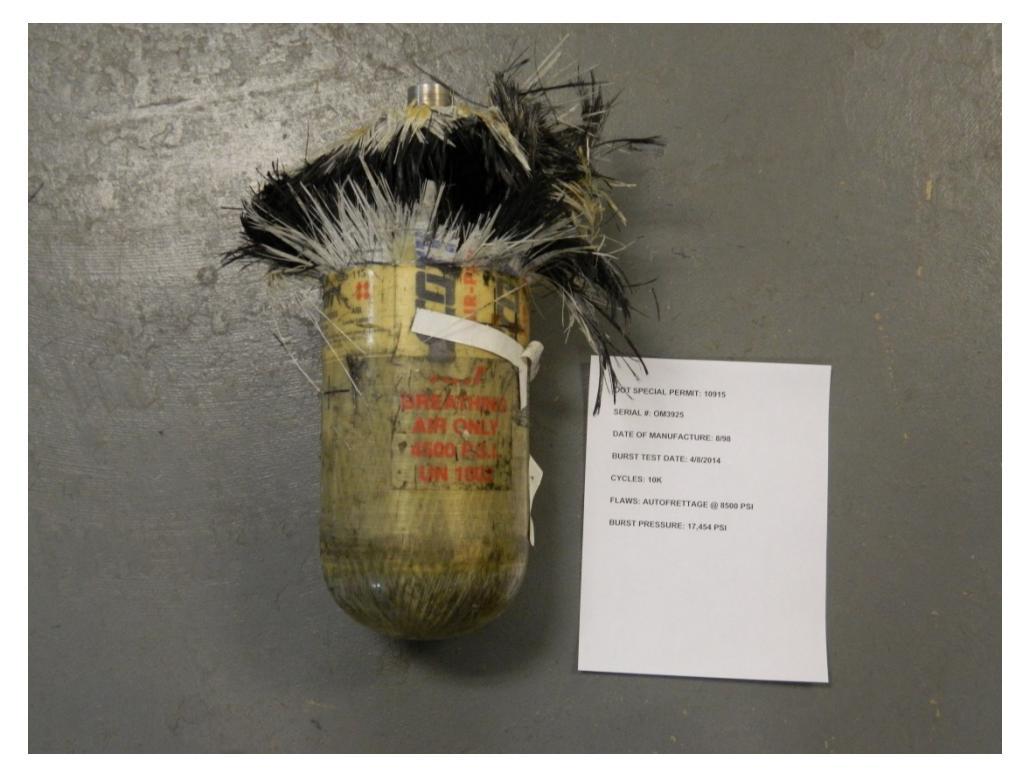
Figure 10.98 – Image of OM3925, after EOL Burst.

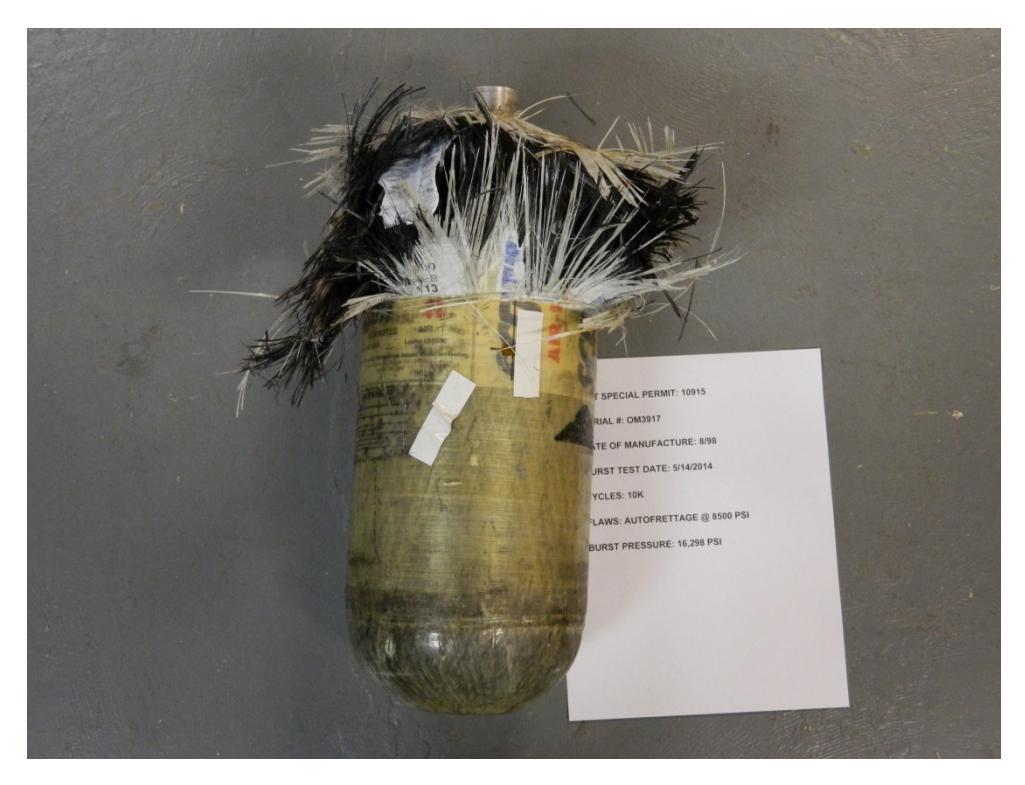
Figure 10.99 – Image of OM3917, after EOL Burst.

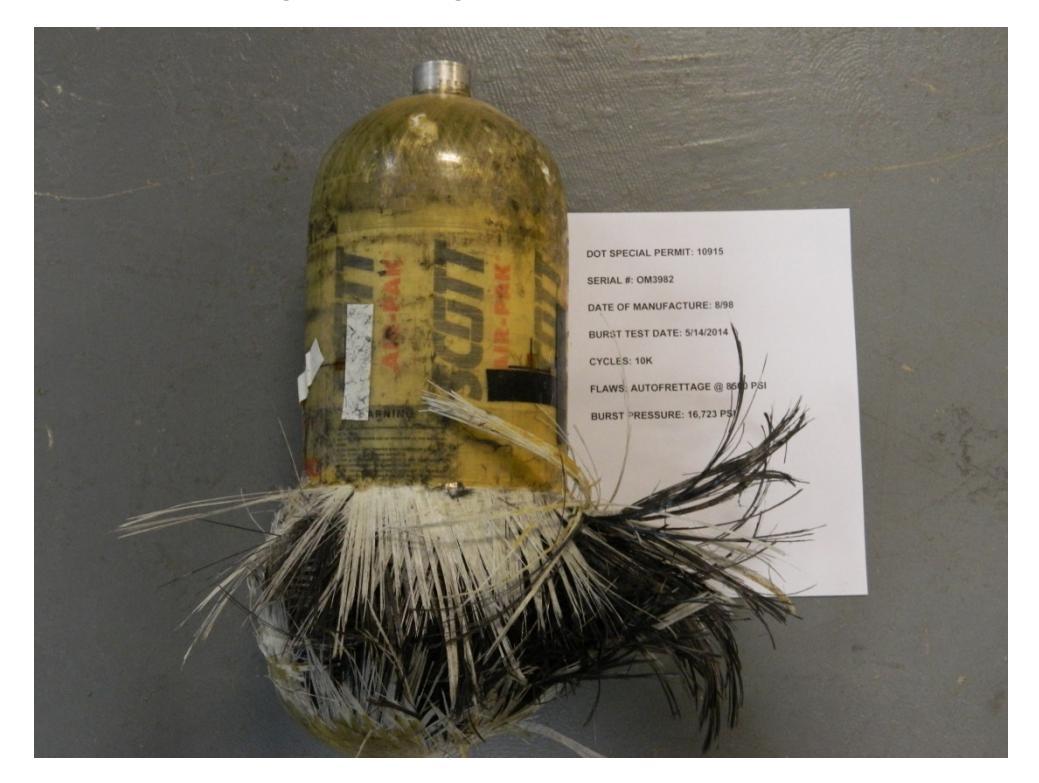
Figure 10.100 - - Image of OM3982, after EOL Burst.
