# Fatigue life improvement of DOT-CFFC composite cylinders

December 2015

Digital Wave Corporation Brian Burks PhD, Steven Ziola PhD, Michael Gorman PhD 13760 East Arapahoe Road Centennial, CO 80121 (303) 790-7559

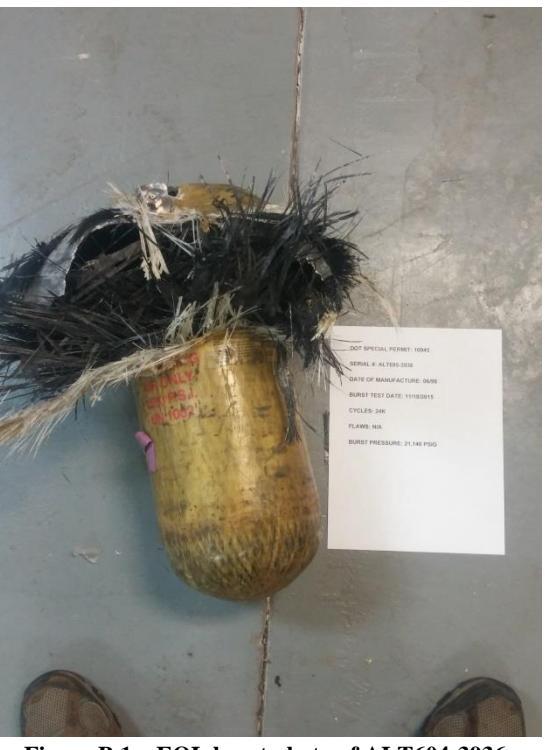
Figure B.1 – EOL burst photo of ALT604-3936.

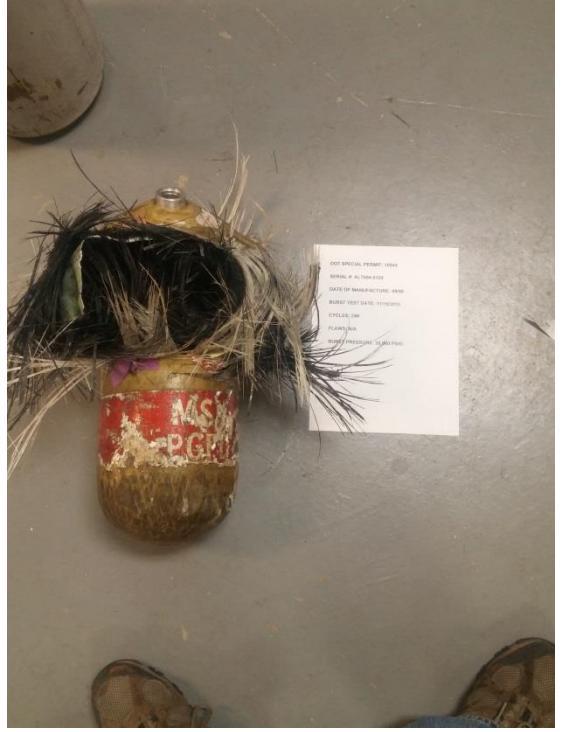
Figure B.2 – EOL burst photo of ALT604-5155.

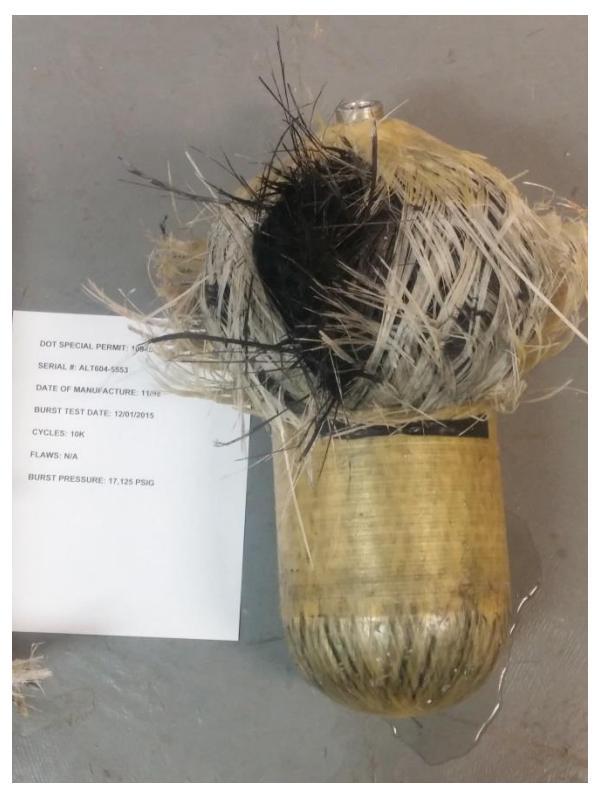
Figure B.3 – EOL burst photo of ALT604-5553.

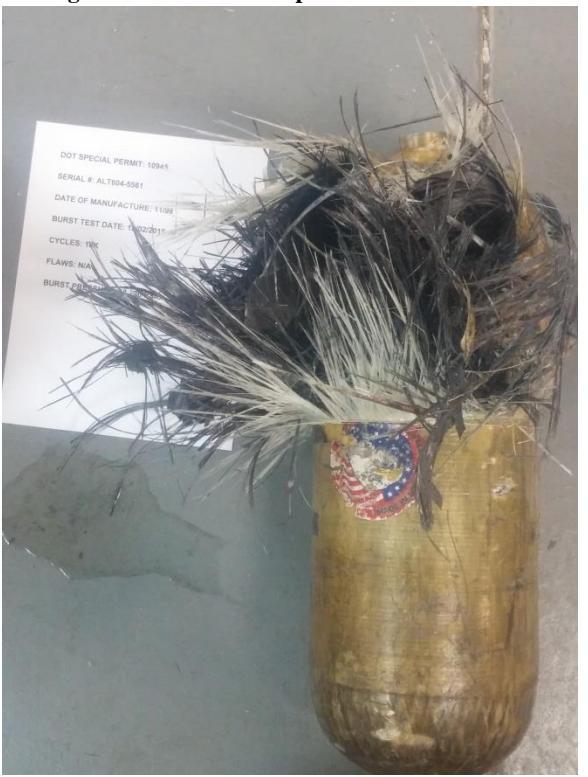
Figure B.4 – EOL burst photo of ALT604-5561.

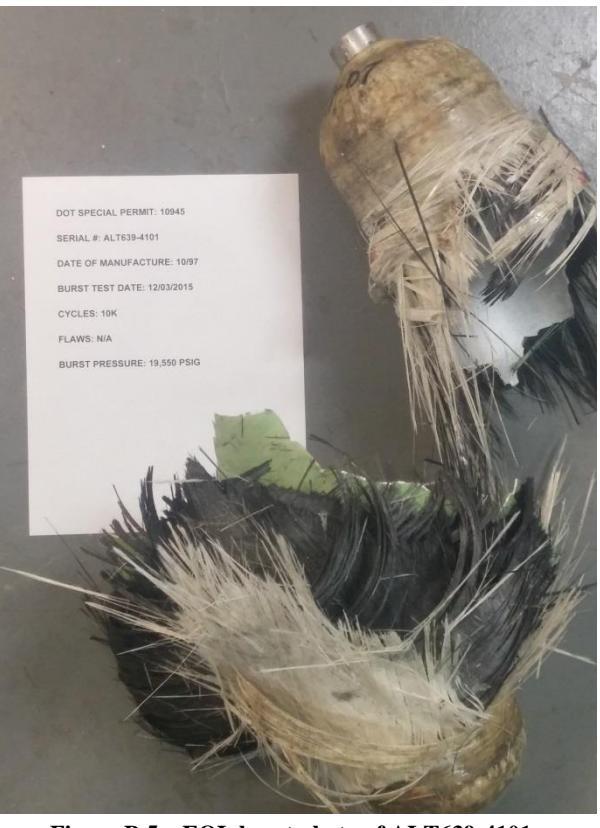
Figure B.5 – EOL burst photo of ALT639-4101.

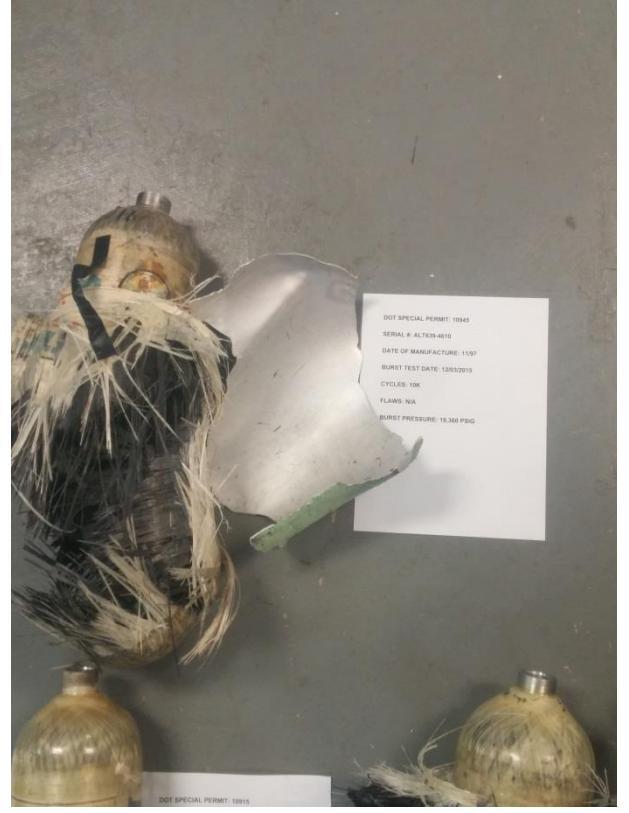
Figure B.6 – EOL burst photo of ALT639-4610.

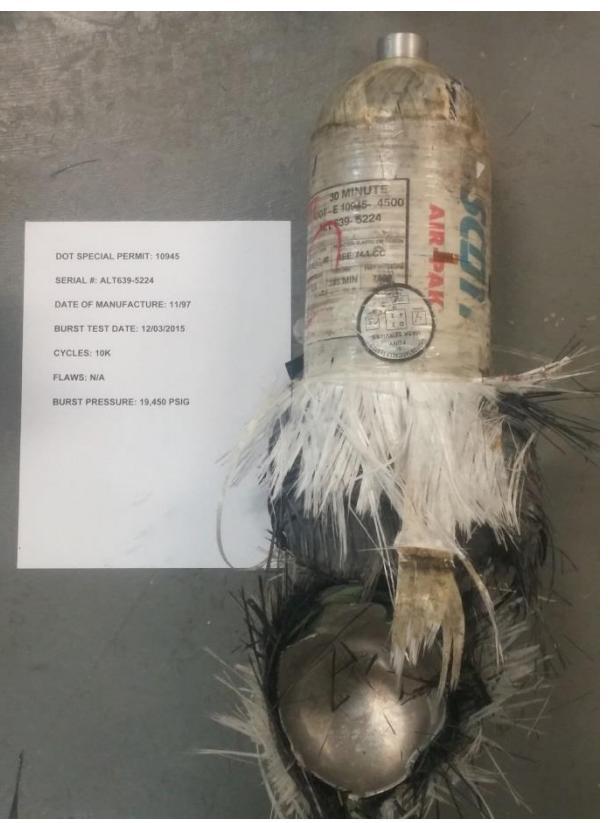
Figure B.7 – EOL burst photo of ALT639-5224.

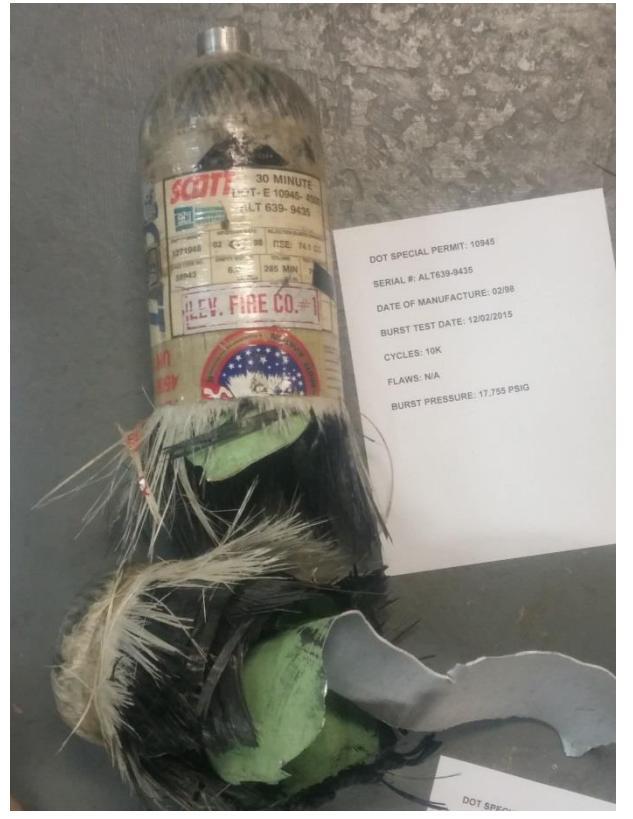
Figure B.8 – EOL burst photo of ALT639-9435.

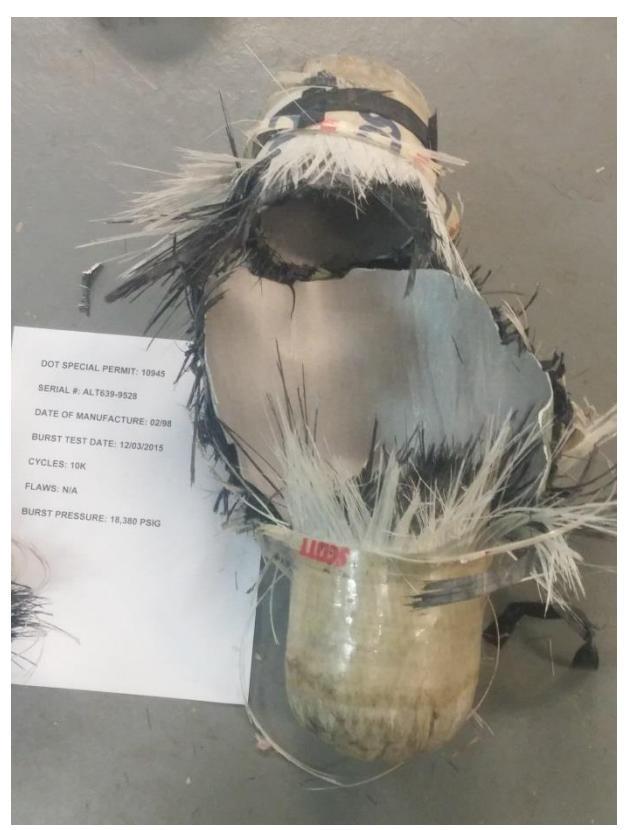
Figure B.9 – EOL burst photo of ALT639-9528.

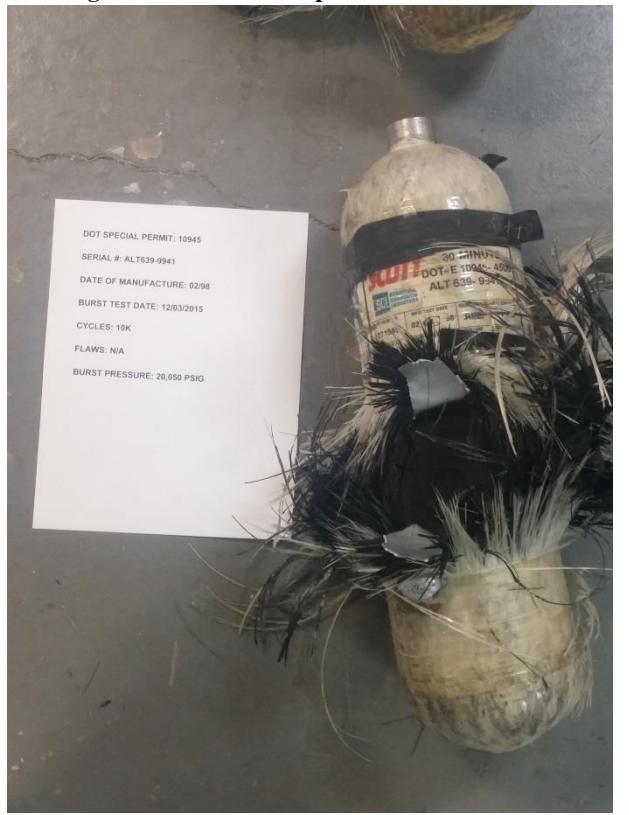
Figure B.10 – EOL burst photo of ALT639-9941.

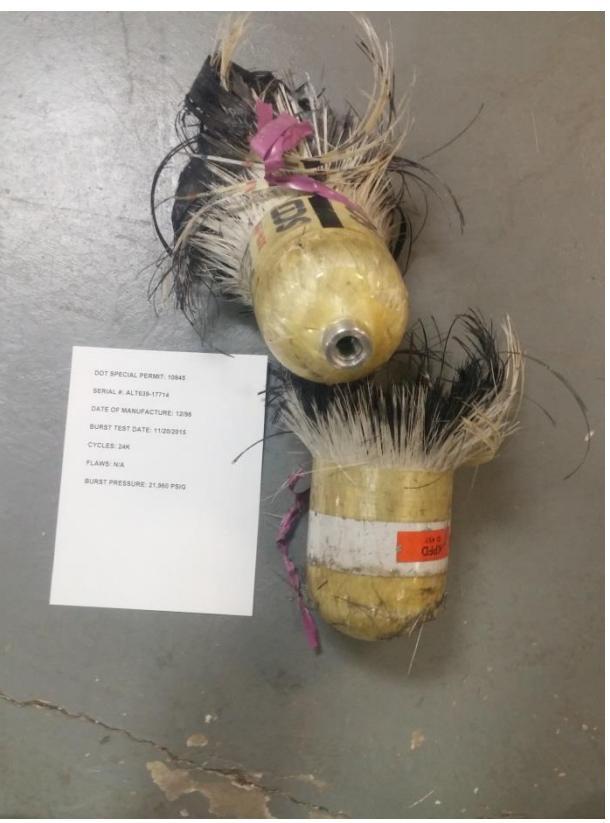
Figure B.11 – EOL burst photo of ALT639-17714.

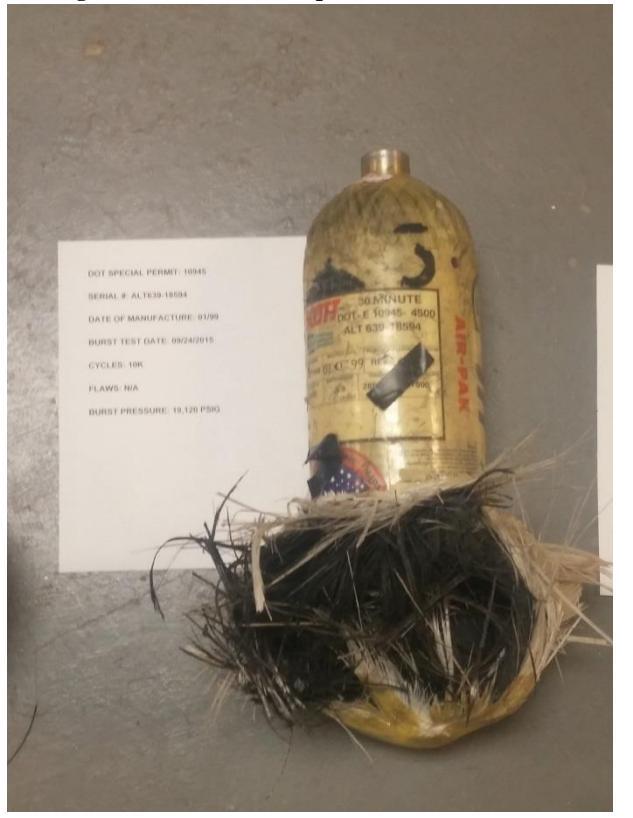
Figure B.12 – EOL burst photo of ALT639-18594.

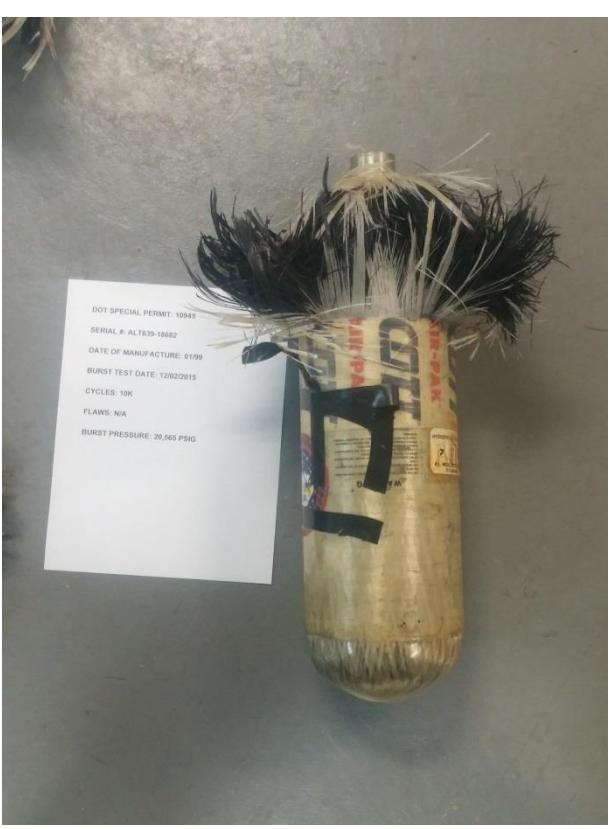
Figure B.13 – EOL burst photo of ALT639-18682.

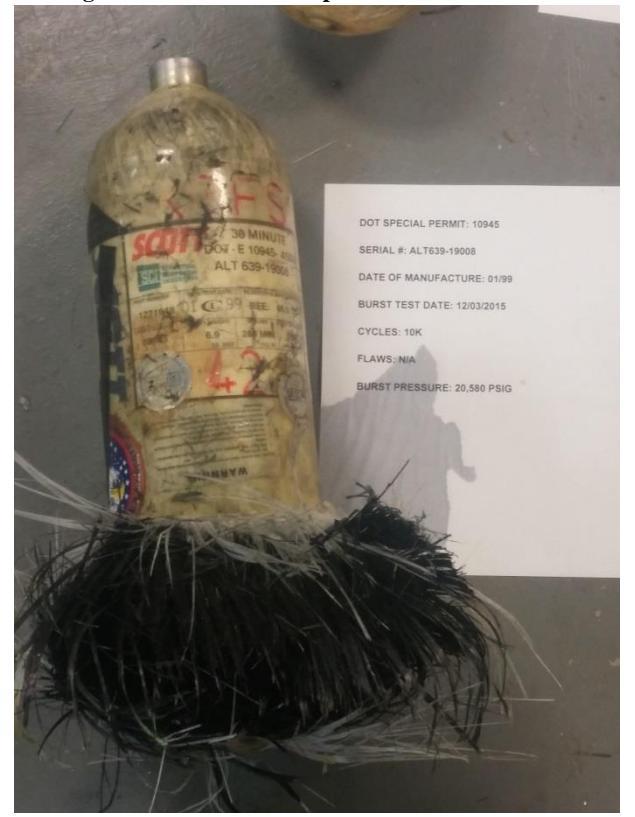
Figure B.14 – EOL burst photo of ALT639-19008.

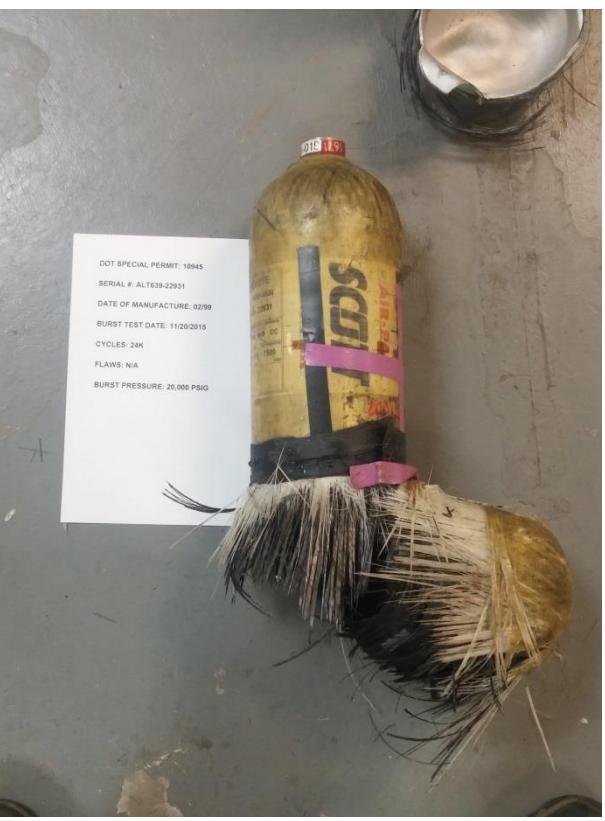
Figure B.15 – EOL burst photo of ALT639-22931.

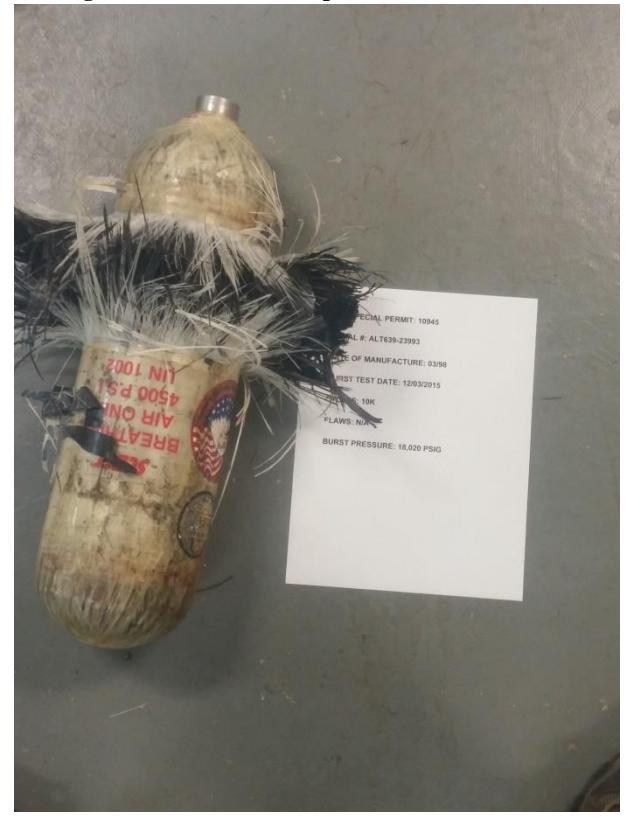
Figure B.16 – EOL burst photo of ALT639-23993.

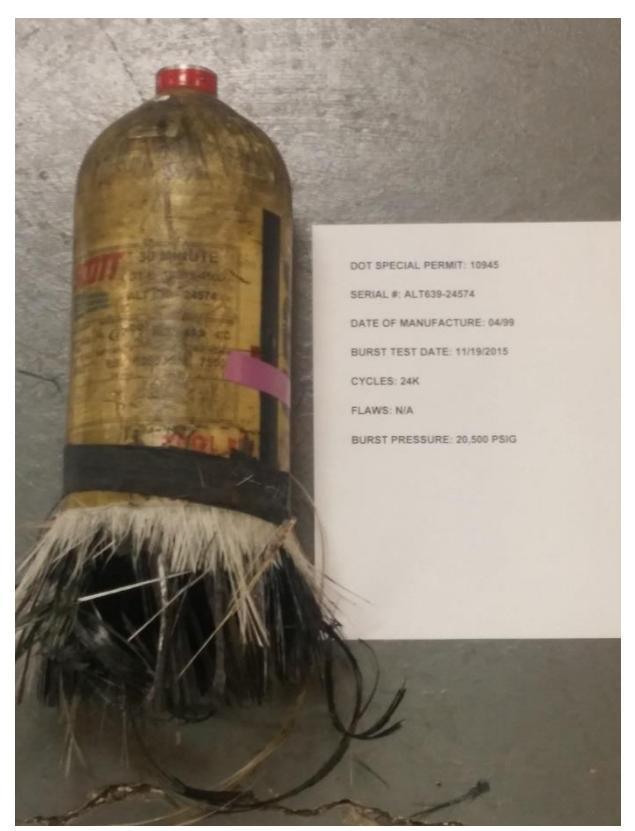
Figure B.17 – EOL burst photo of ALT639-24574.

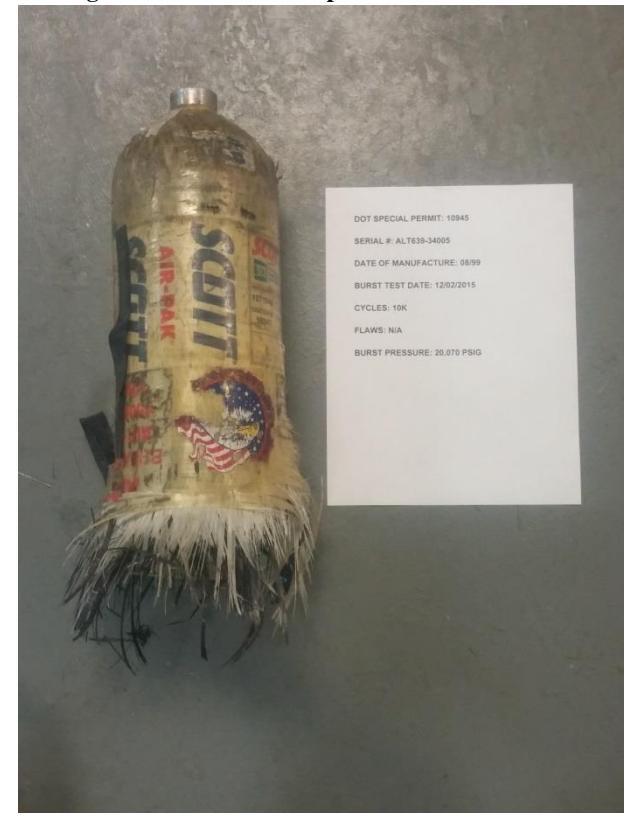
Figure B.18 – EOL burst photo of ALT639-34005.

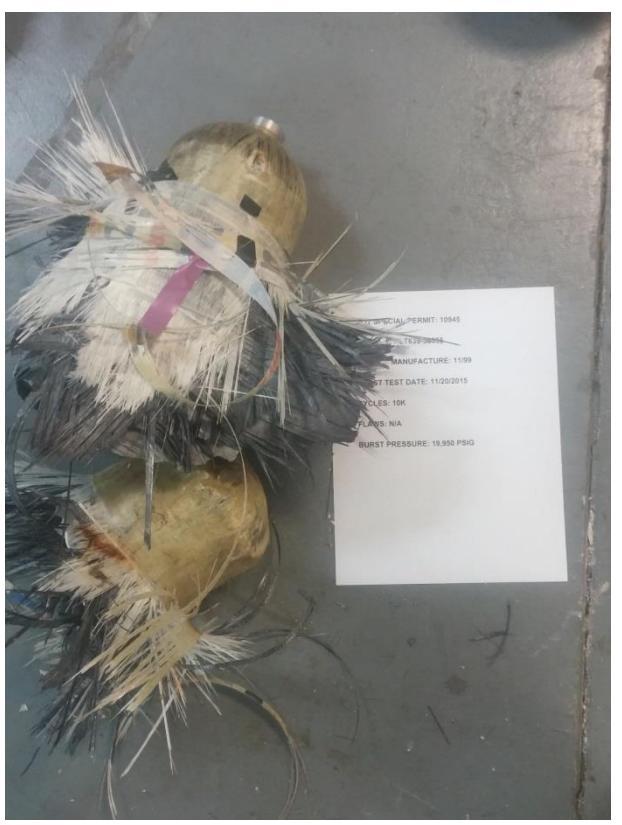
Figure B.19 – EOL burst photo of ALT639-38566.

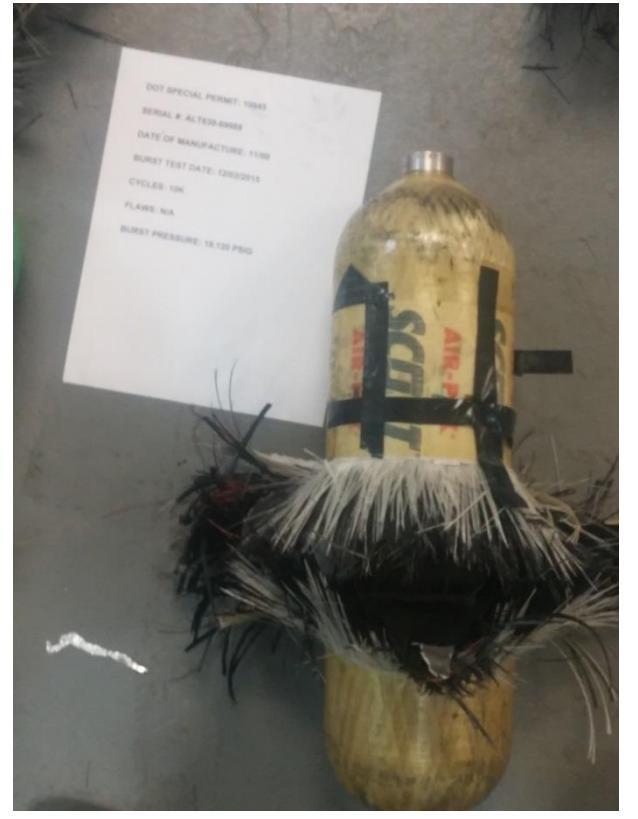
Figure B.20 – EOL burst photo of ALT639-69988.

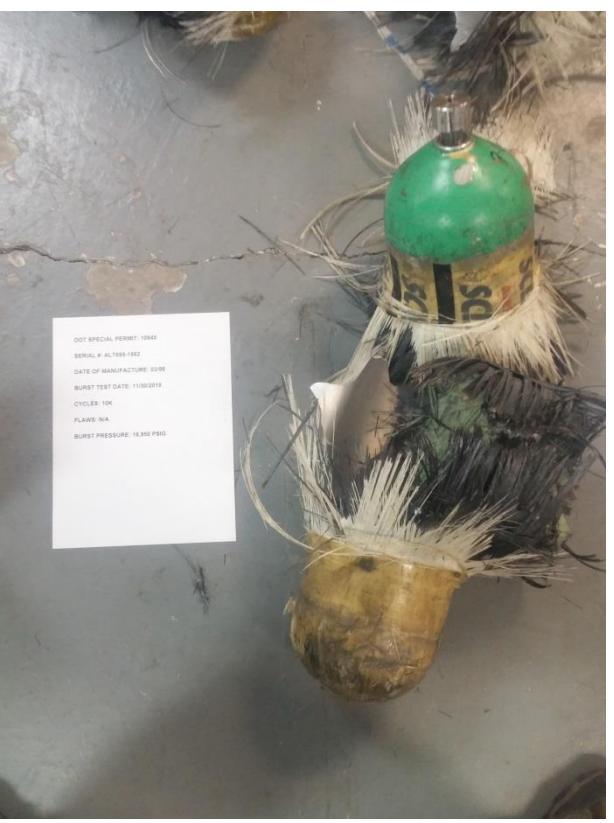
Figure B.21 – EOL burst photo of ALT695-1862.

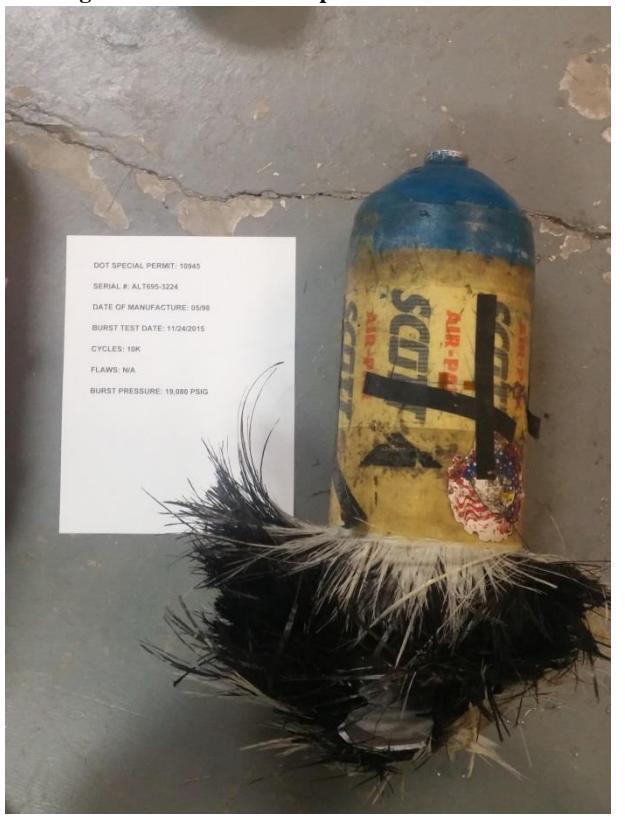
Figure B.22 – EOL burst photo of ALT695-3224.

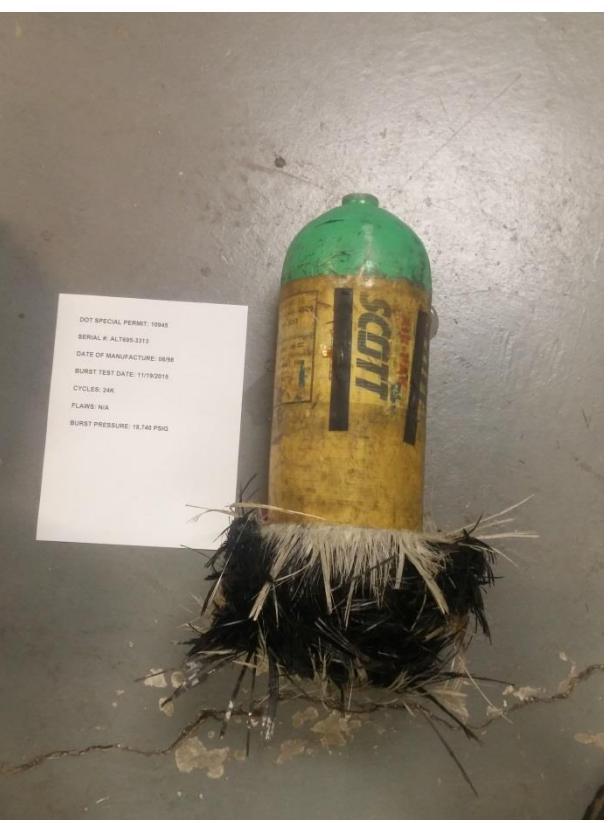
Figure B.23 – EOL burst photo of ALT695-3313.

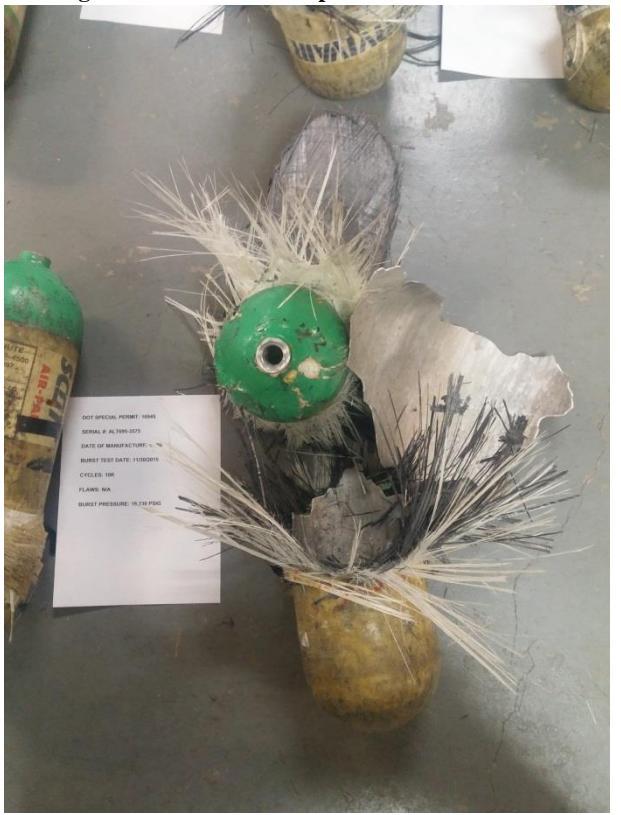
Figure B.24 – EOL burst photo of ALT695-3575.

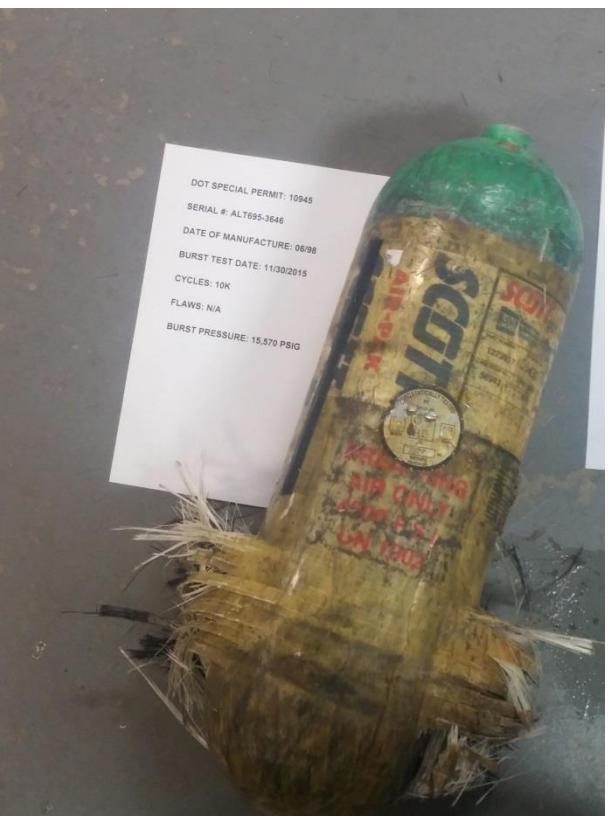
Figure B.25 – EOL burst photo of ALT695-3646.

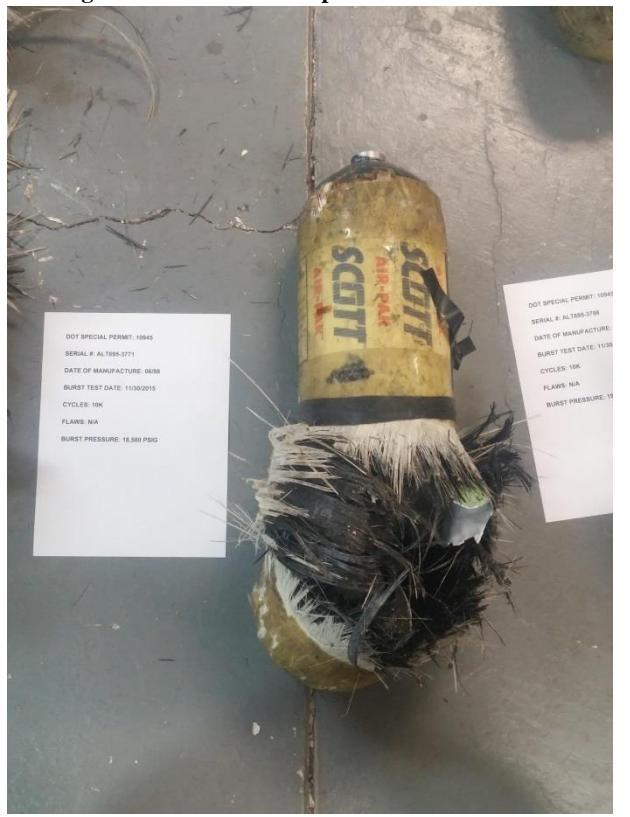
Figure B.26 – EOL burst photo of ALT695-3771.

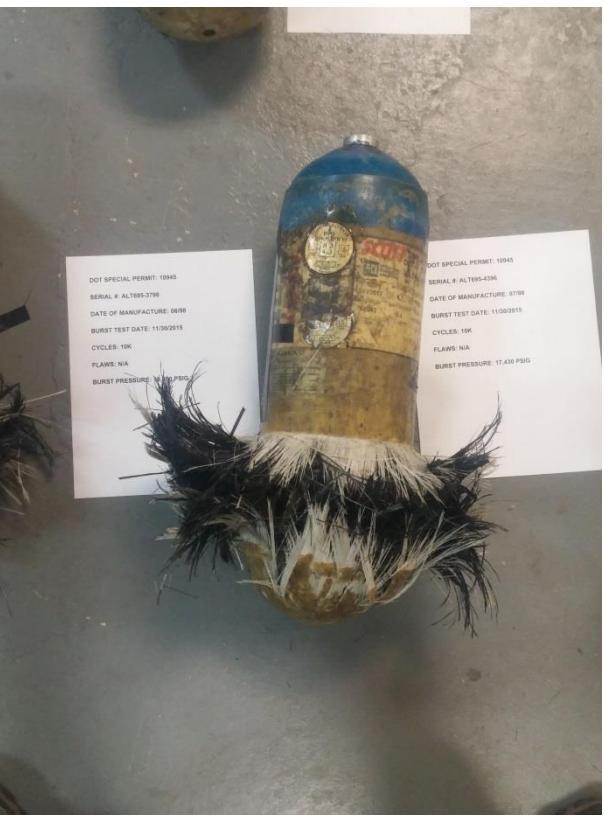
Figure B.27 – EOL burst photo of ALT695-3798.

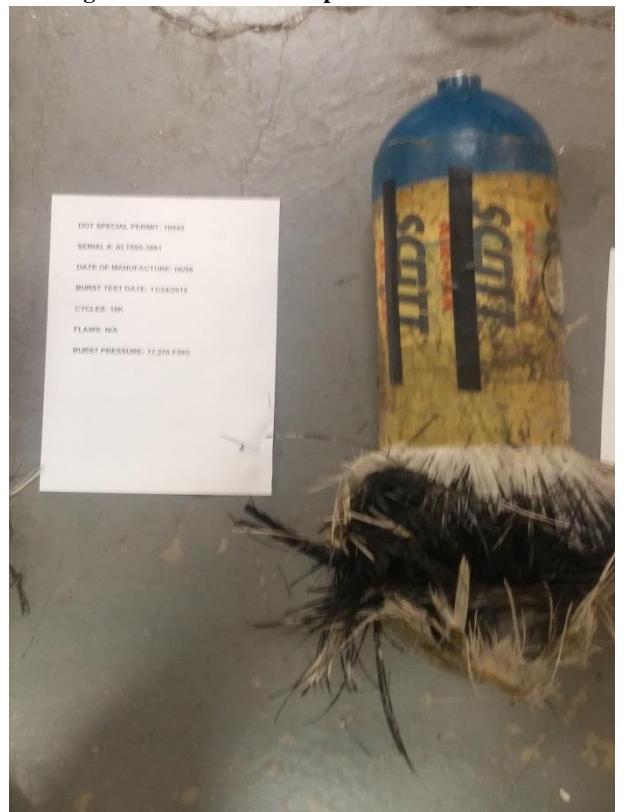
Figure B.28 – EOL burst photo of ALT695-3881.

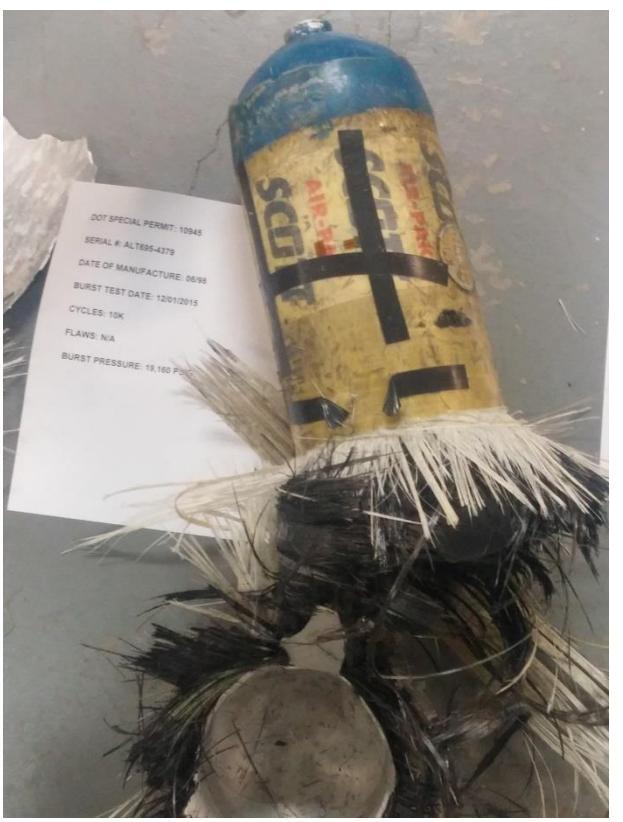
Figure B.29 – EOL burst photo of ALT695-4379.

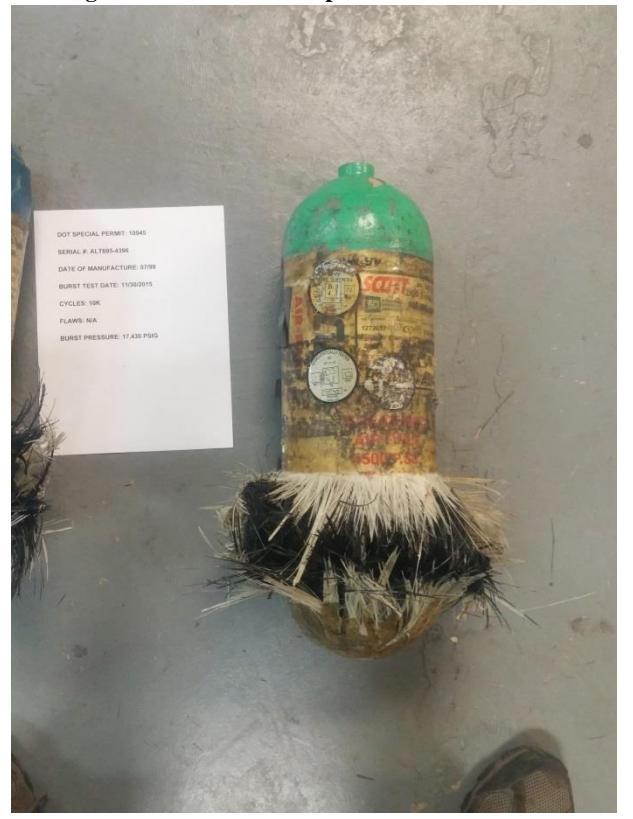
Figure B.30 – EOL burst photo of ALT695-4396.

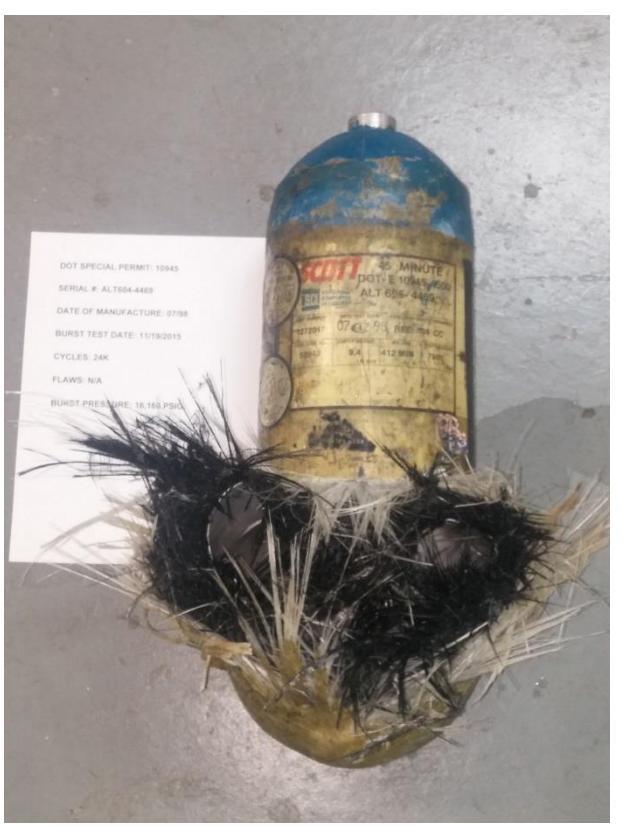
Figure B.31 – EOL burst photo of ALT695-4469.

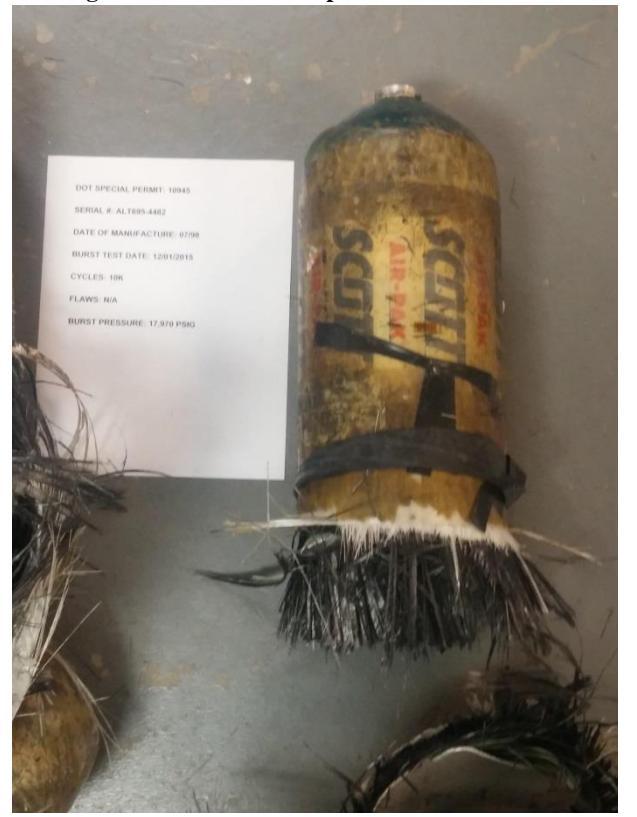
Figure B.32 – EOL burst photo of ALT695-4482.

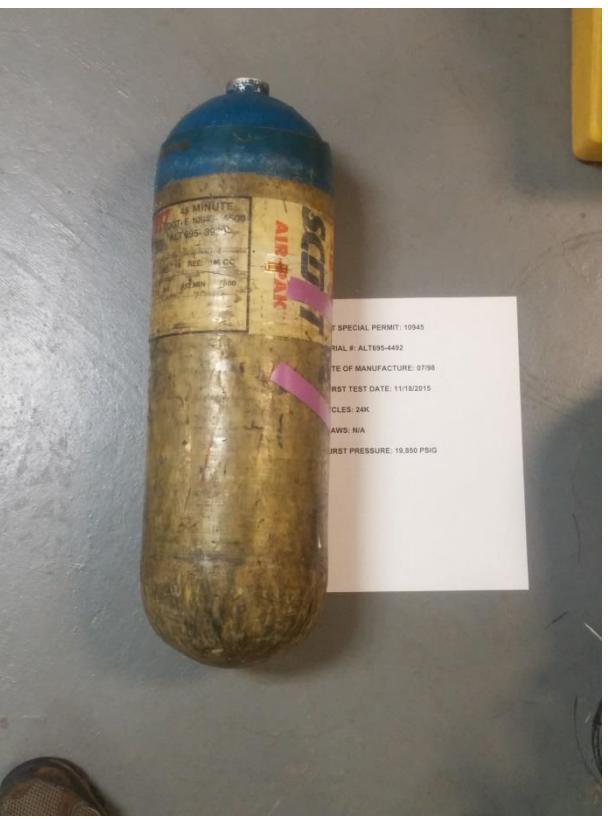
Figure B.33 – EOL burst photo of ALT695-4492.

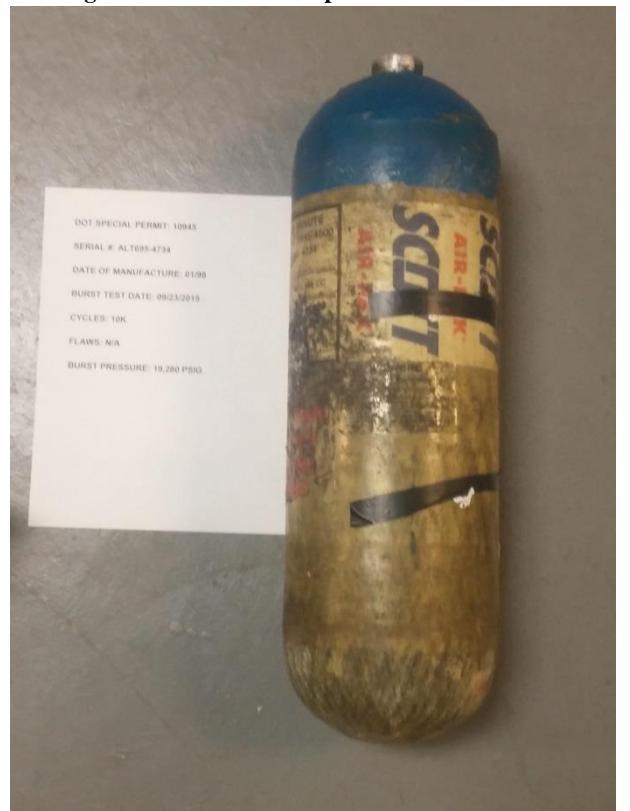
Figure B.34 – EOL burst photo of ALT695-4734.

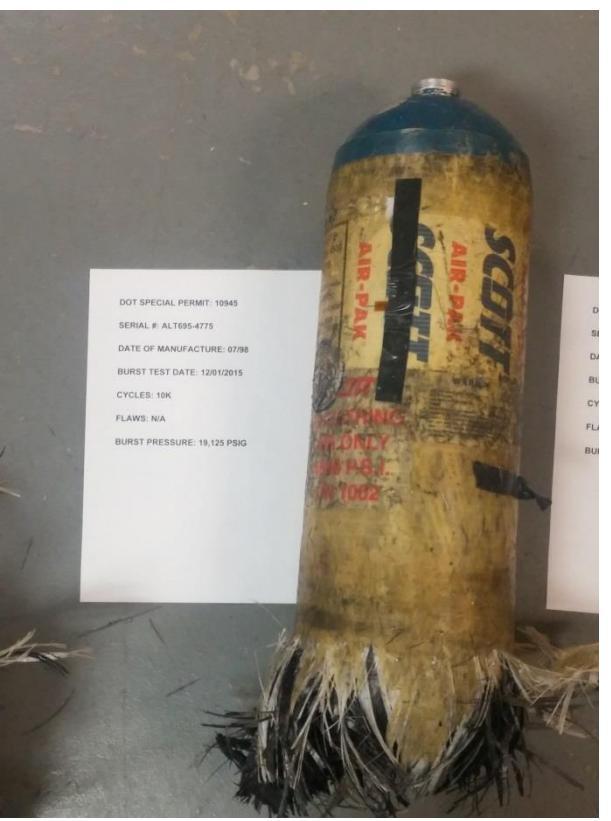
Figure B.35 – EOL burst photo of ALT695-4775.

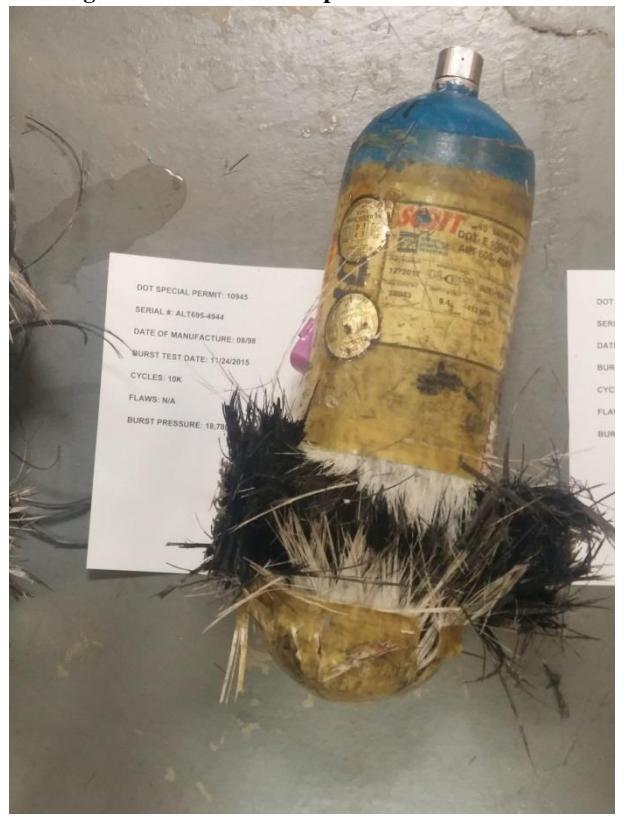
Figure B.36 – EOL burst photo of ALT695-4944.

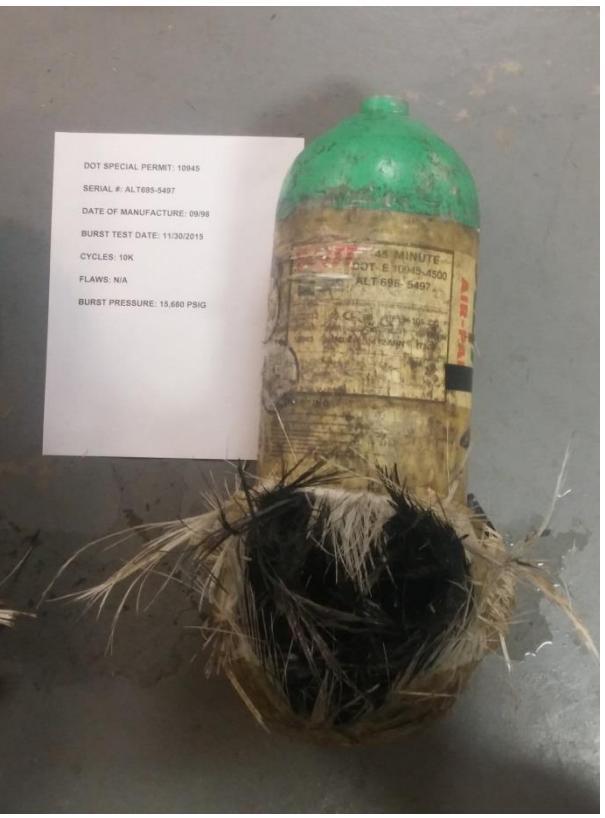
Figure B.37 – EOL burst photo of ALT695-5497.
