**Hydraulic Pressure Cycling and Performance Evaluation of five DOT-3AL 2015
Cylinders**

FINAL REPORT

Packer Project # 501856

**Prepared for
Mark Toughiry
Office of Hazardous Materials Technology
Pipeline and Hazardous
Materials Safety Administration
U.S. Department of Transportation**

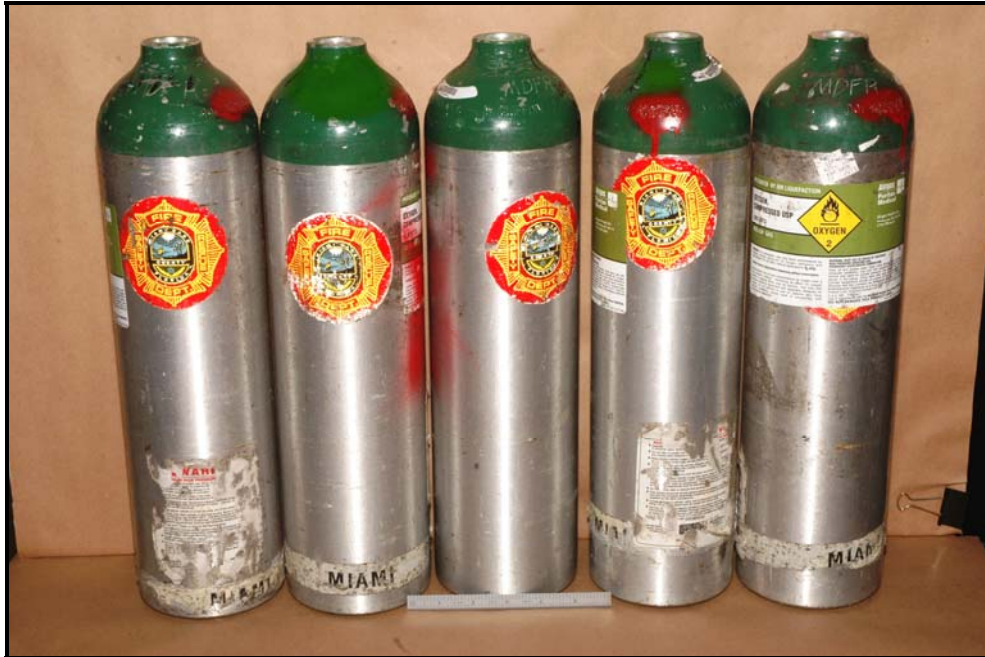
Based on visual inspection of all the five cylinders submitted to Packer Engineering for evaluation, the cylinders were produced by Airgas Puritan medical at Airgas S inc, Kennesaw GA 30144. These cylinders were used by Miami Dade Fire department. During their service live, these cylinders contained compressed oxygen compliant with USP (United States Pharmacopoeia). It is a medical gas. The shipping ID of these cylinders is UN1072. The received five cylinders are shown in Figure 1.

Figure 1: Shows the five received DOT-3AL 2015 cylinders.

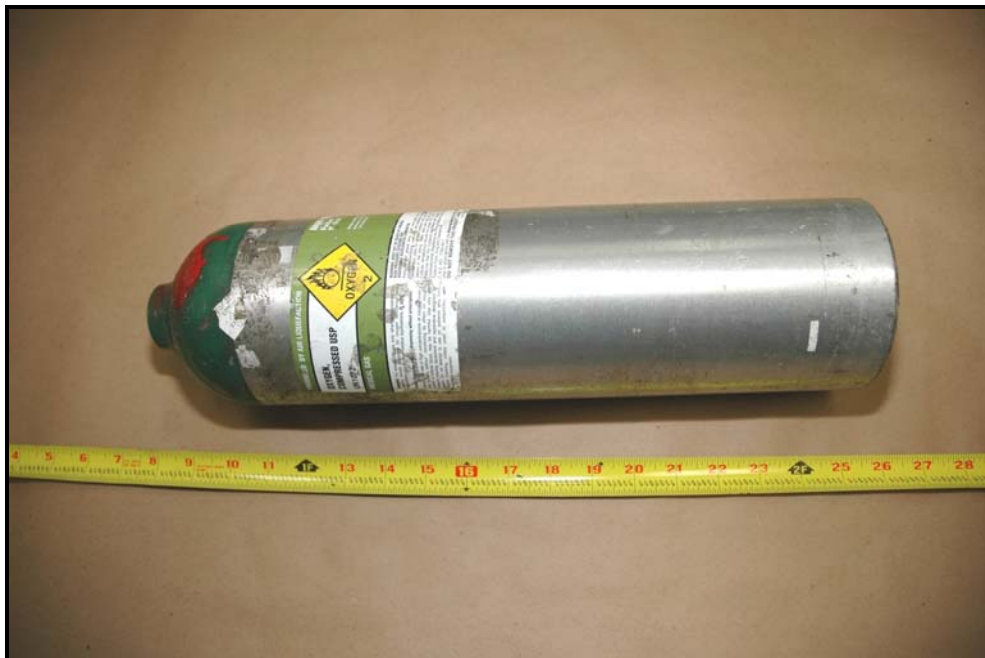
- The cylinder is identified as DOT- XXX AR0119582 O2 CLIFF DIV 12 @ 03 TC – 3AL M139.
- It is marked as MDFR
- Lot # invisible
Capacity: 4.25 liters
Expiration date: 2013
- There were no visible cracks observed on the outer surface of the cylinder.
The paint on the cylinder was scratched at several locations.

Figure 2: Shows the as received DOT-3AL cylinder # AR0119582

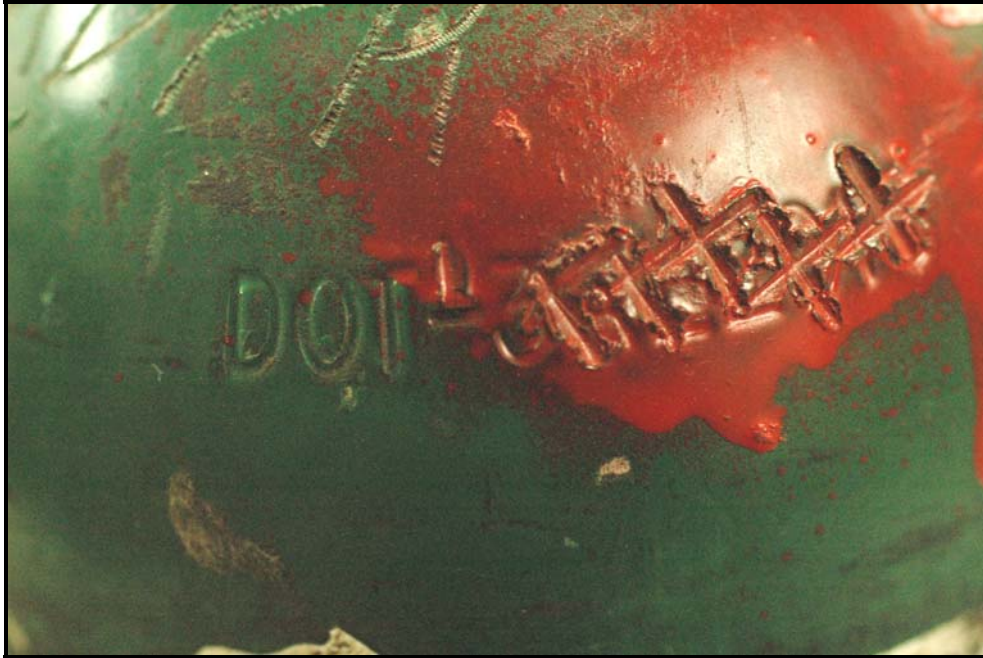
Figure 3: Indented marking on the DOT-3AL cylinder # AR0119582

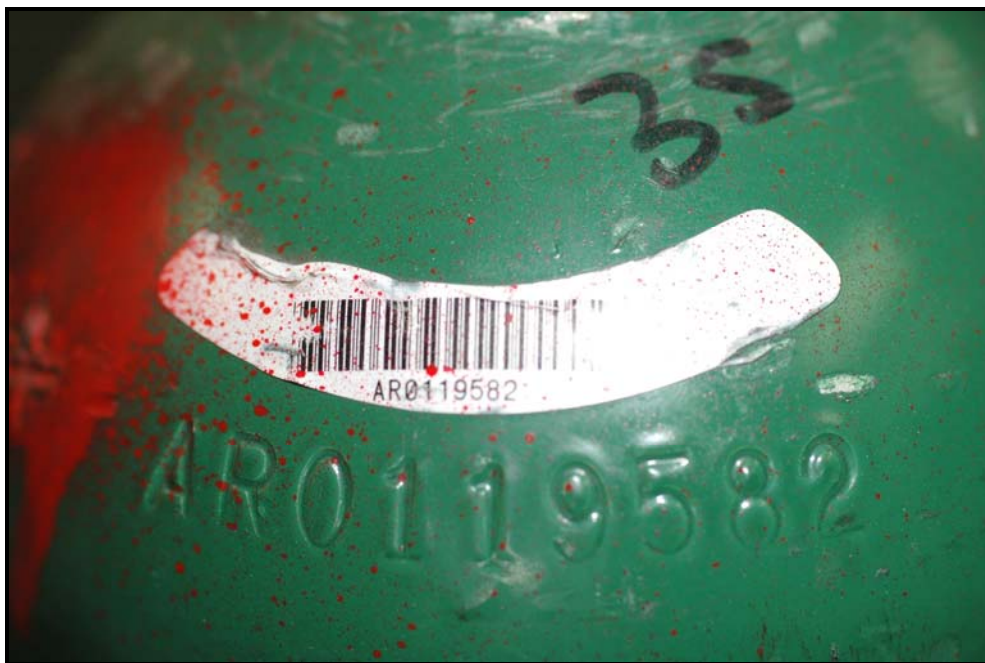
Figure 4: Indented marking on the DOT-3AL cylinder # AR0119582

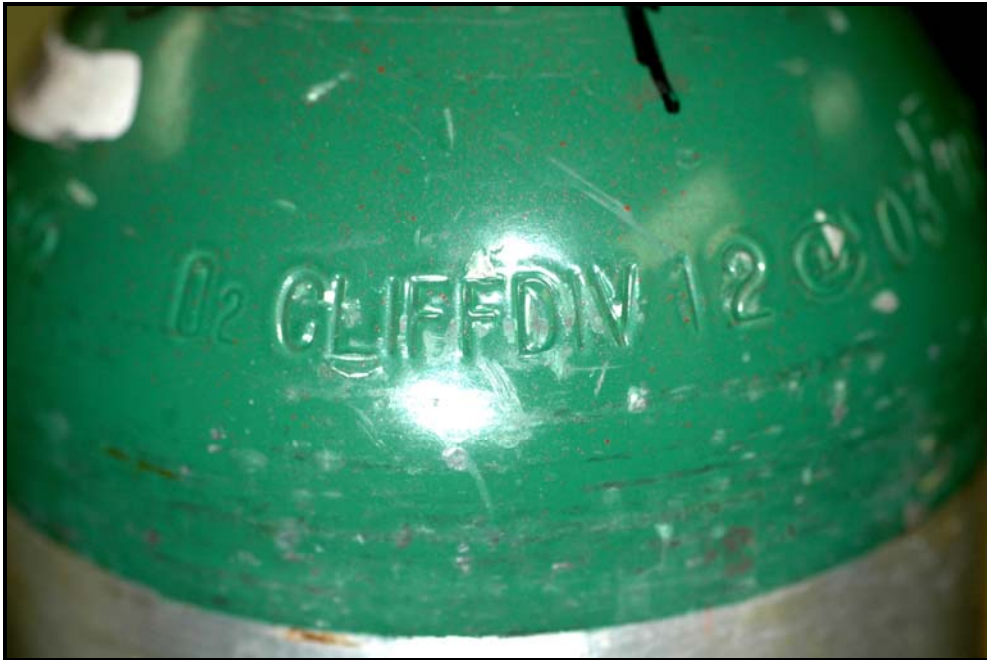
Figure 5: Indented marking on the DOT-3AL cylinder # AR0119582

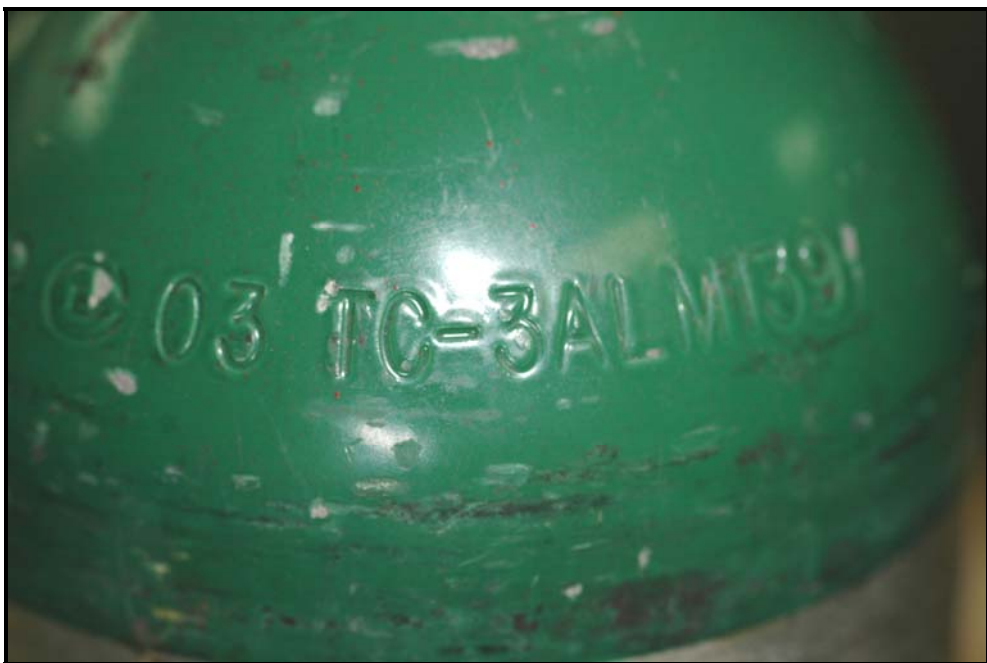
Figure 6: Indented marking on the DOT-3AL cylinder # AR0119582

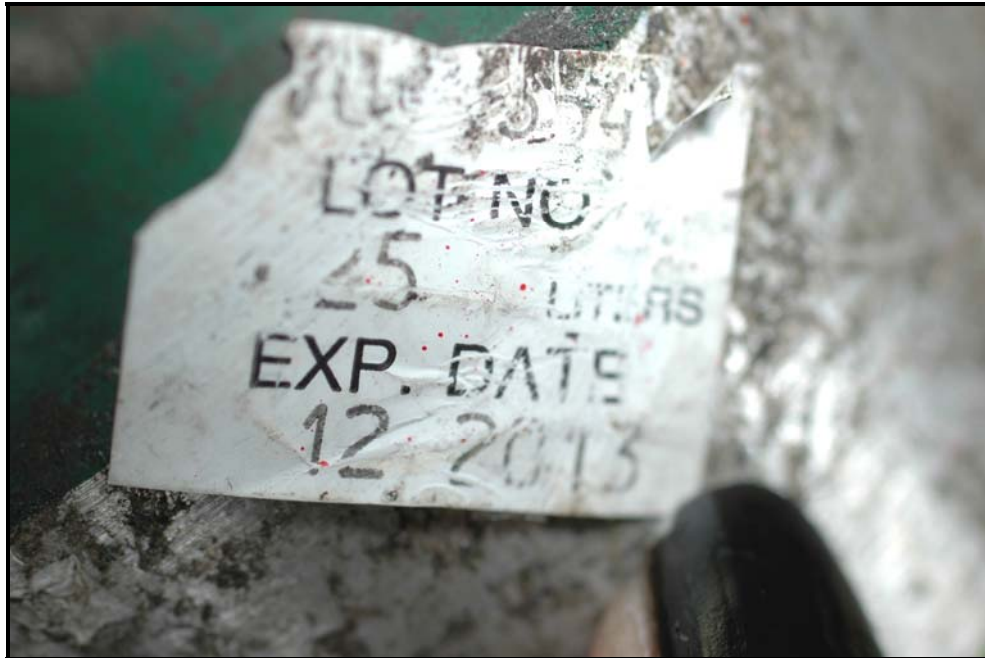
Figure 7: Labels on the DOT-3AL cylinder # AR0119582

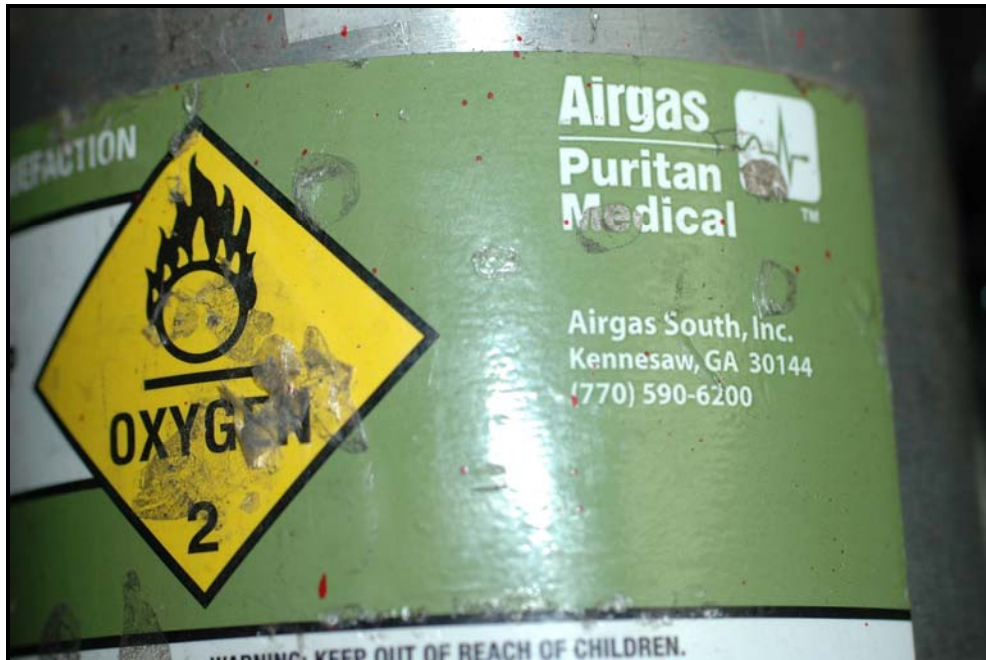
Figure 9: Labels on the DOT-3AL cylinder # AR0119582

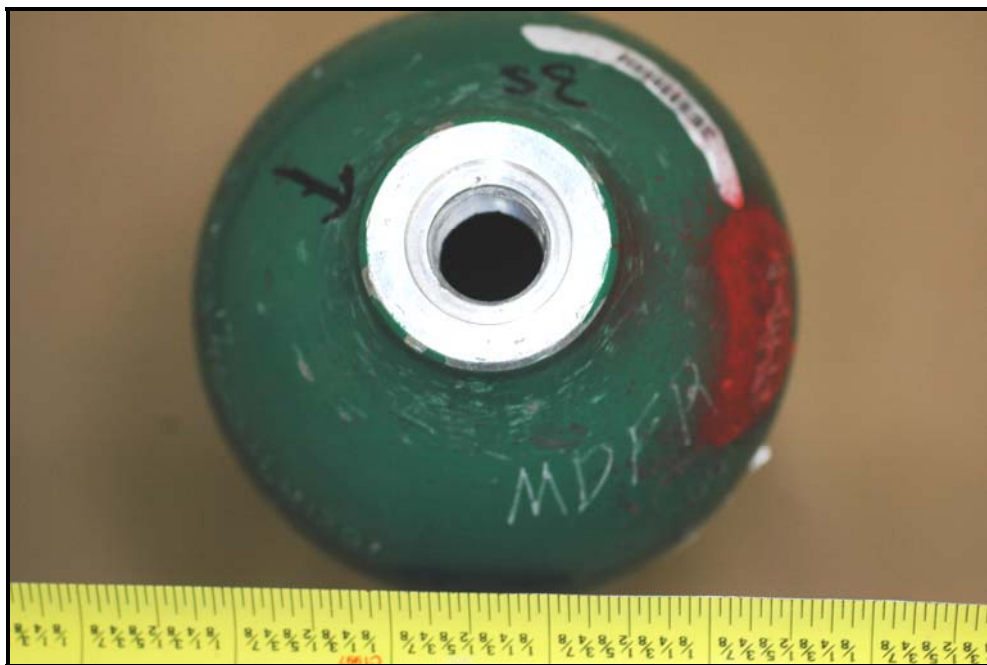
Figure 10: Shows neck and shoulder of DOT-3AL cylinder # AR0119582

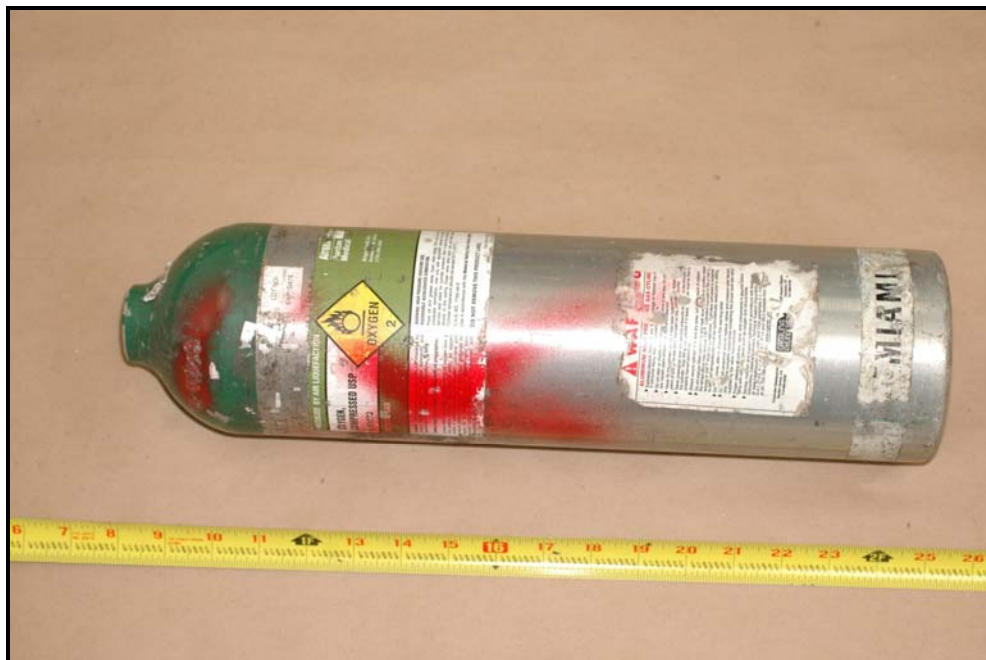
- The cylinder is identified as DOT –XXXAR0118046 O2 Cliff Div 12@O3 TC- 3ALM139.
- Lot # invisible
Capacity: 4.25 liters
Expiration date: 12- 2013
- There were no visible cracks observed on the outer surface of the cylinder. The paint on the cylinder was scratched at several locations.
- Internal observation of the cylinder showed cracks in the shoulder area showed by Figures 28 to 30. The location of cracks is identified in Figures 31 and 32. The cylinder showed no major signs of corrosion on the inside.

Figure 16: Shows the as received DOT-3AL cylinder # AR0118046

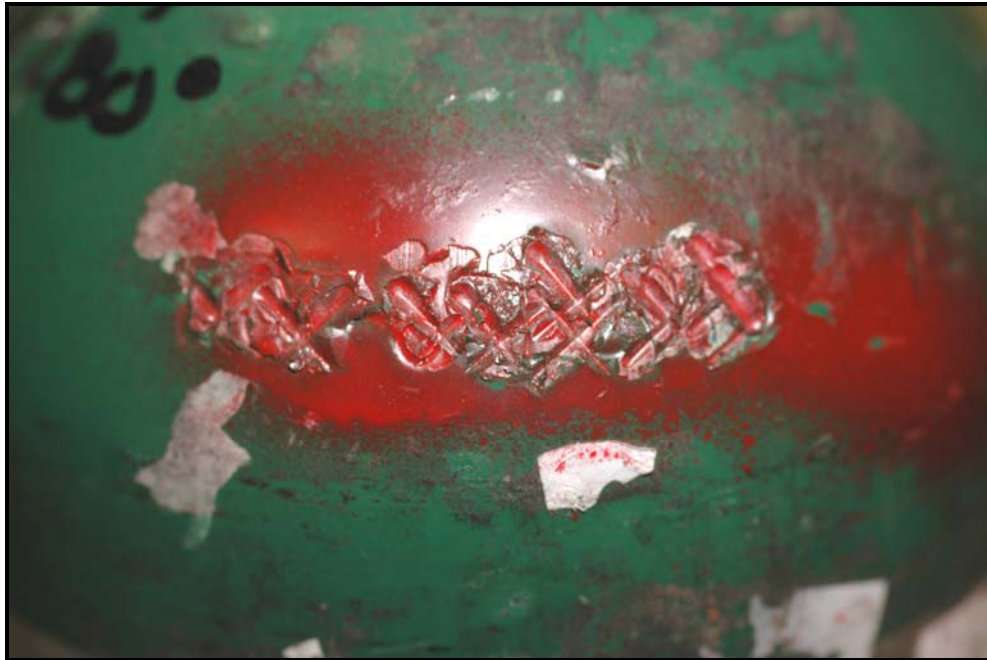
Figure 17: Indented marking on the DOT-3AL cylinder # AR0118046

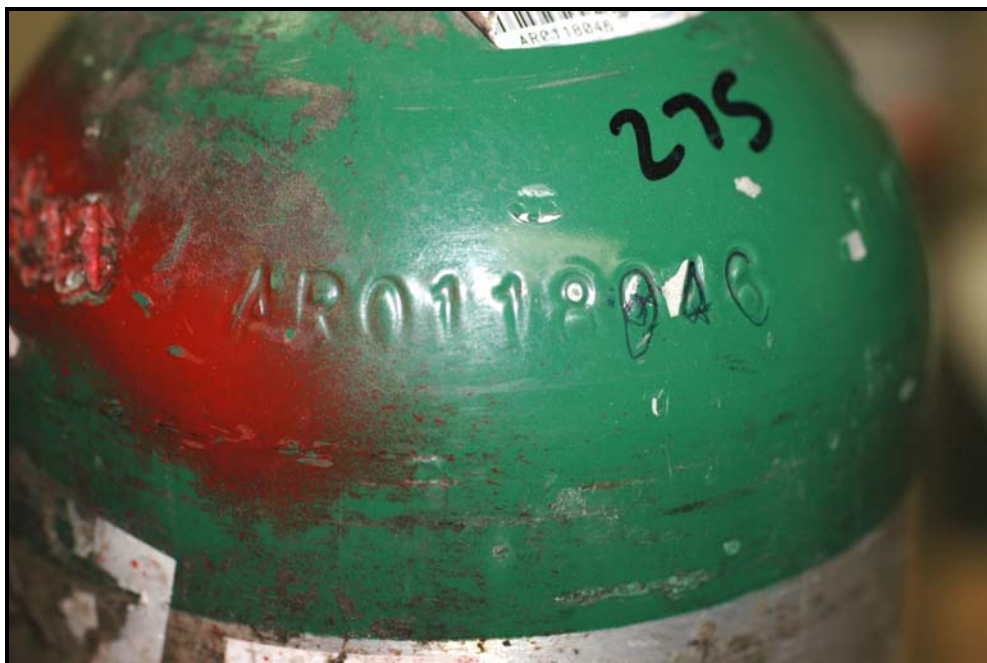
Figure 18: Indented marking on the DOT-3AL cylinder # AR0118046

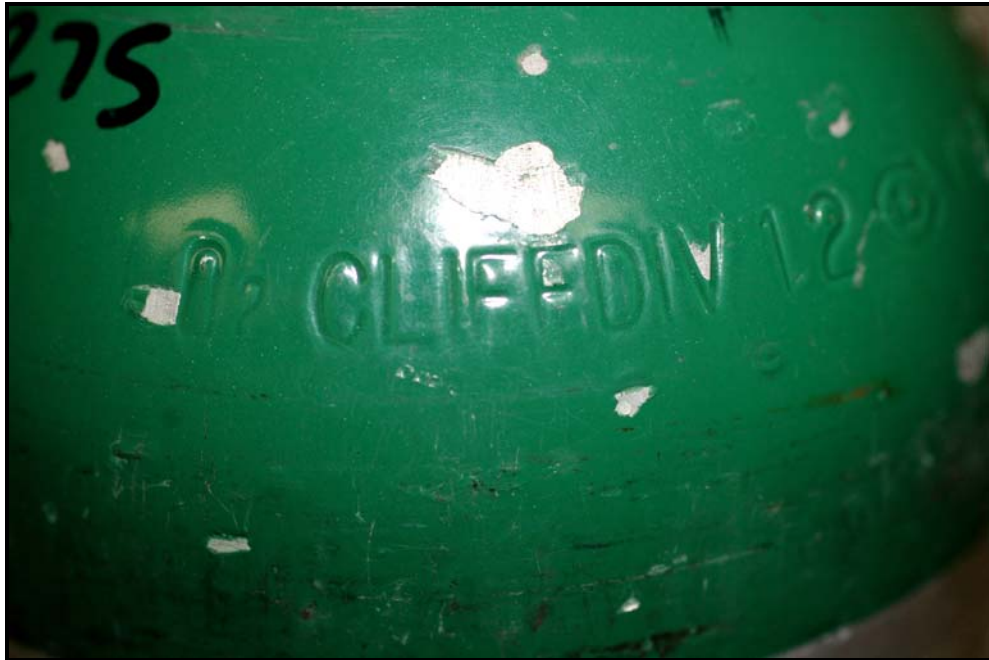
Figure 19: Indented marking on the DOT-3AL cylinder # AR0118046

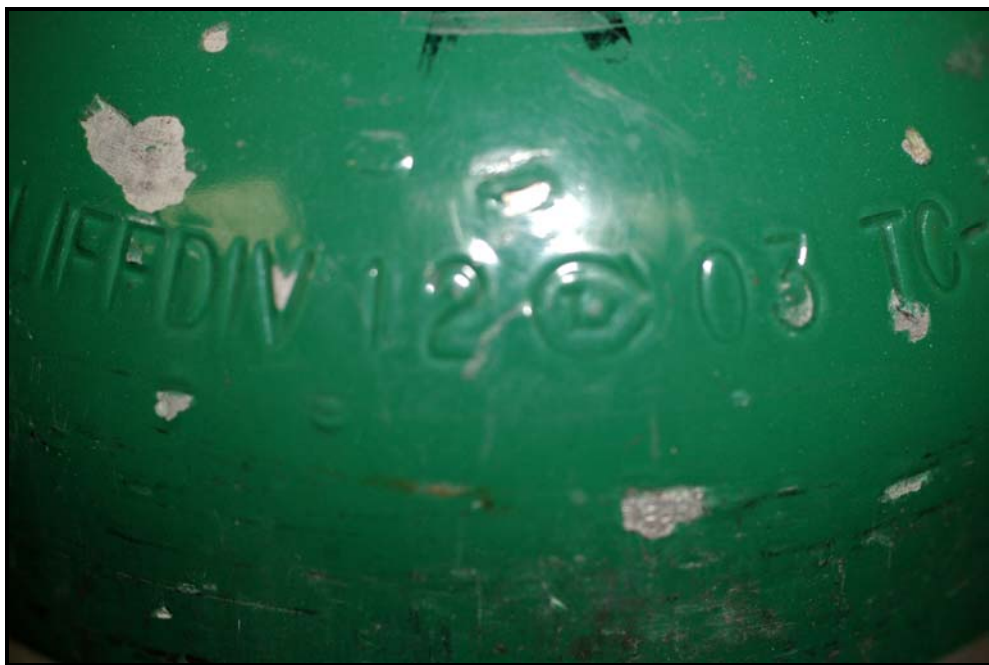
Figure 20: Indented marking on the DOT-3AL cylinder # AR0118046

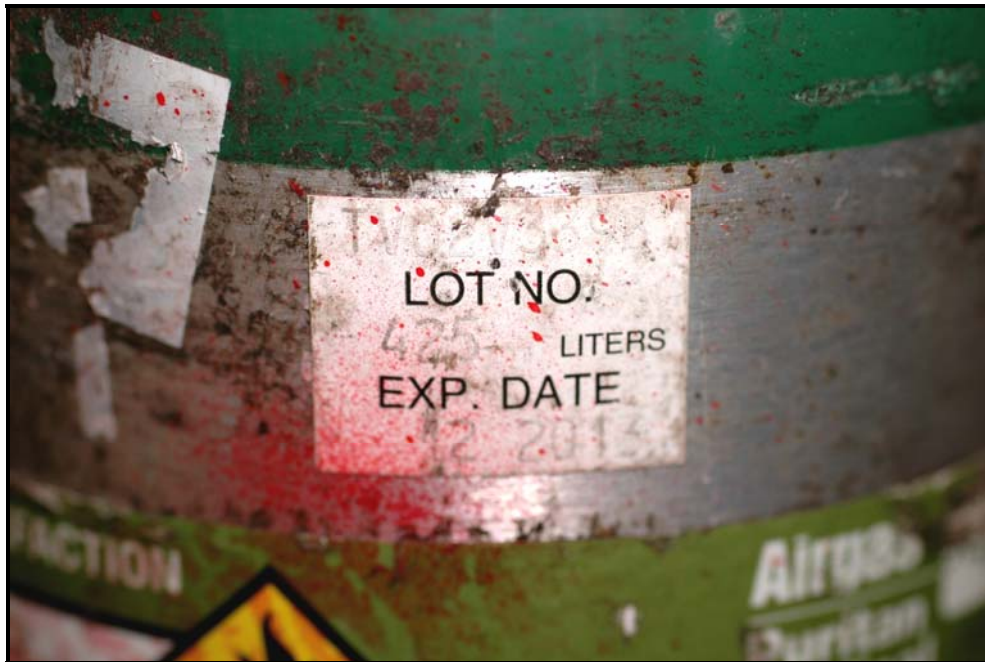
Figure23: Labels on the DOT-3AL cylinder # AR0118046

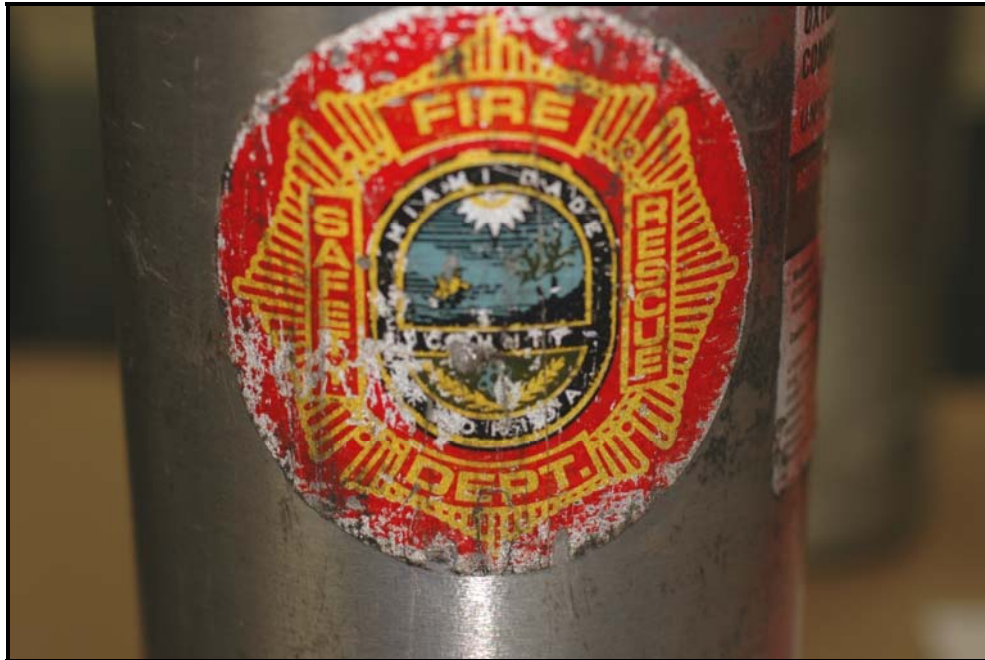
Figure 27: Labels on the DOT-3AL cylinder # AR0118046

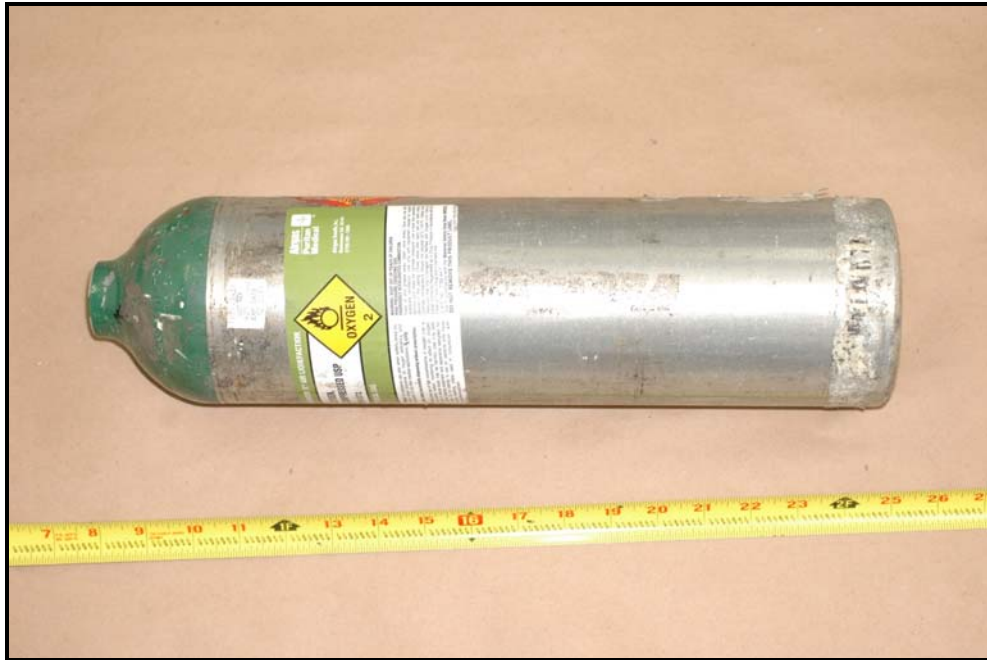
- The cylinder is identified as DOT- XXX AR0116501 O2 CLIFF DIV12 @O3 TC-3ALM139
- It is marked as MDFR
- Lot # TV04V343B
Capacity: 4.25 liters
Expiration date: 12-2013
- There were no visible cracks observed on the outer surface of the cylinder. The paint on the cylinder was scratched at several locations.
- Internal observation of the cylinder showed cracks in the shoulder area showed by Figures 44 to 46. The location of cracks is identified in Figures 47 and 48. The cylinder showed no major signs of corrosion on the inside.

Figure 33: Shows the as received DOT-3AL cylinder # AR0116501

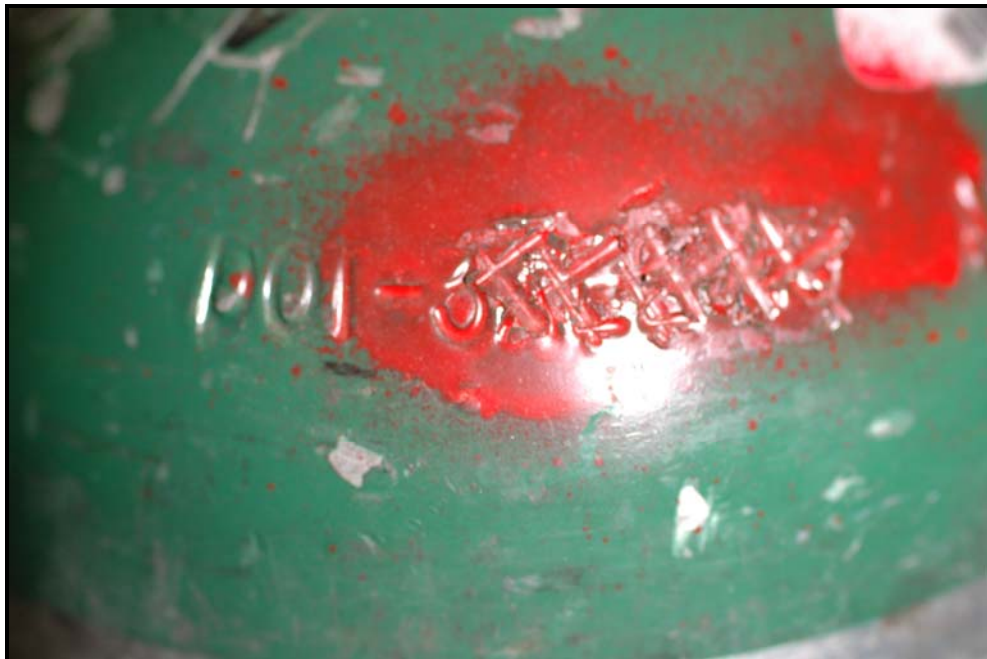
Figure 34: Indented marking on the DOT-3AL cylinder # AR0116501

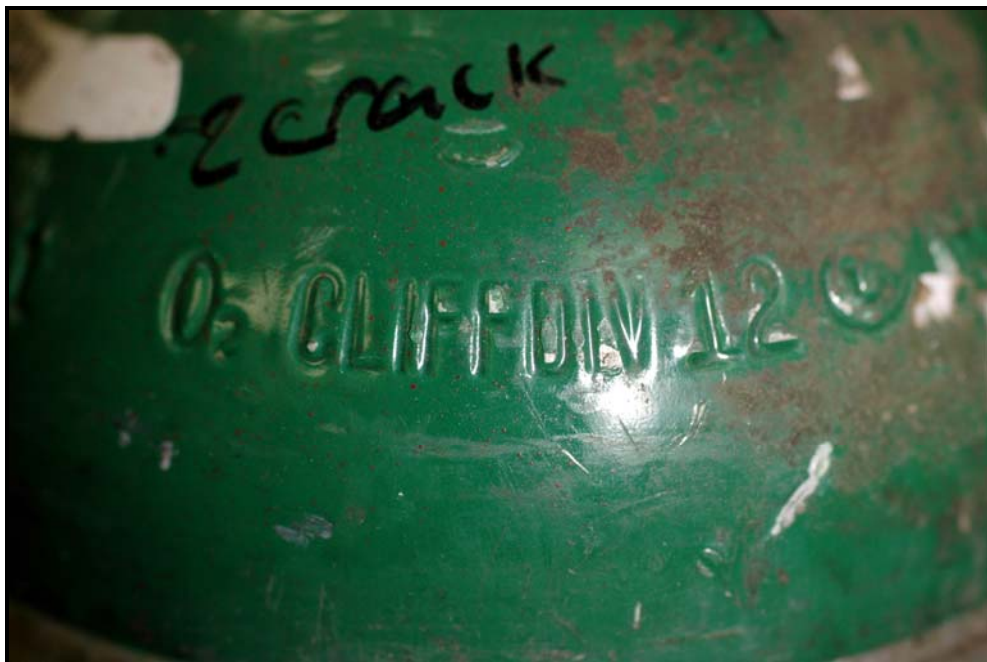
Figure 36: Indented marking on the DOT-3AL cylinder # AR0116501

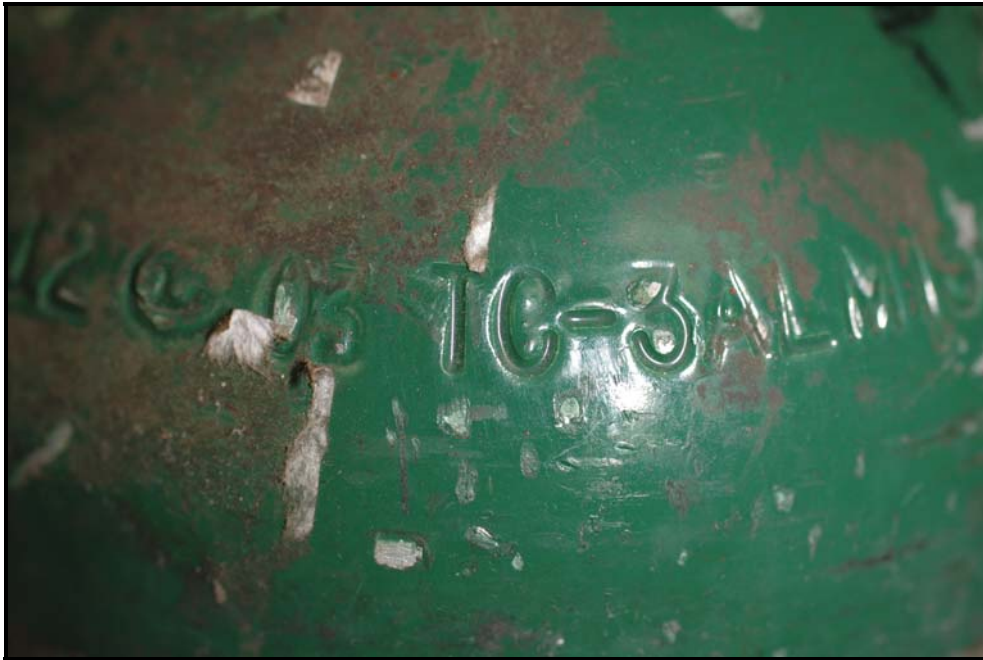
Figure 37: Indented marking on the DOT-3AL cylinder # AR0116501

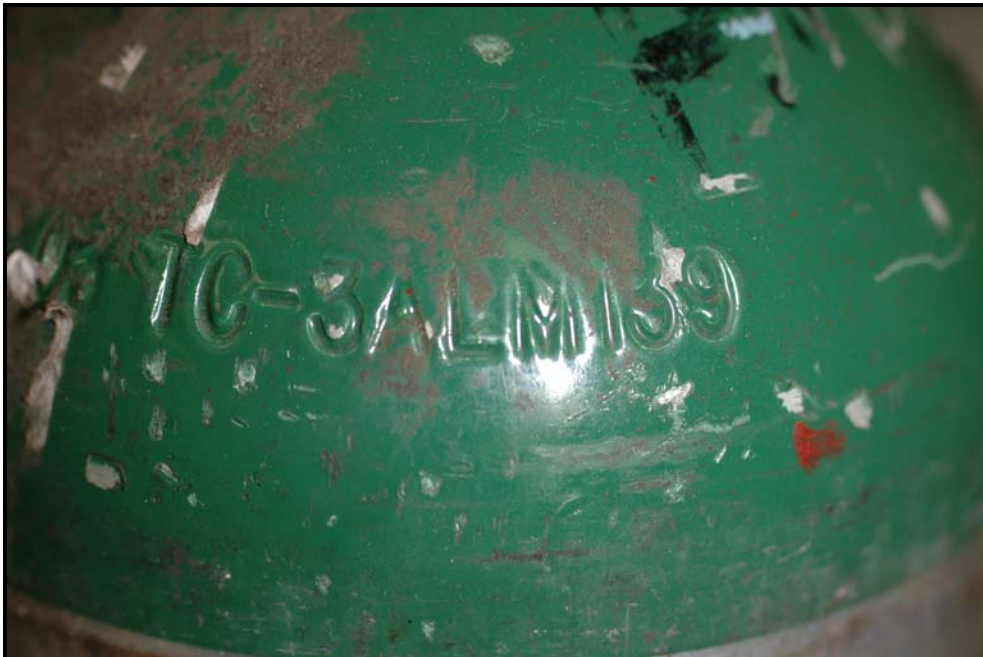
Figure 38: Indented marking on the DOT-3AL cylinder # AR0116501

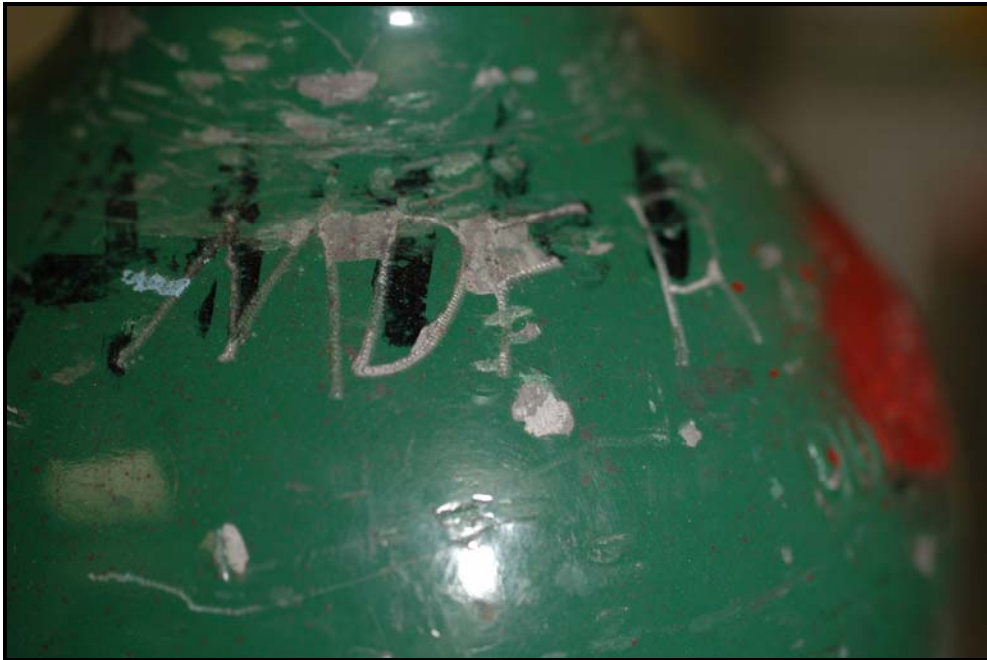
Figure 39: Indented marking on the DOT-3AL cylinder # AR0116501

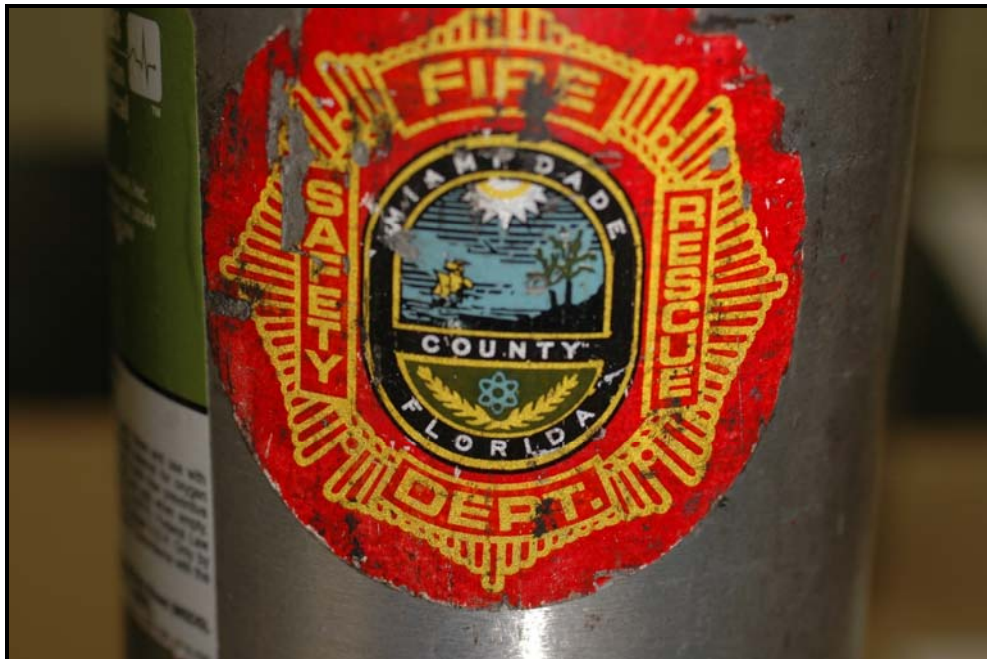
Figure 42: Labels on the DOT-3AL cylinder # AR0116501

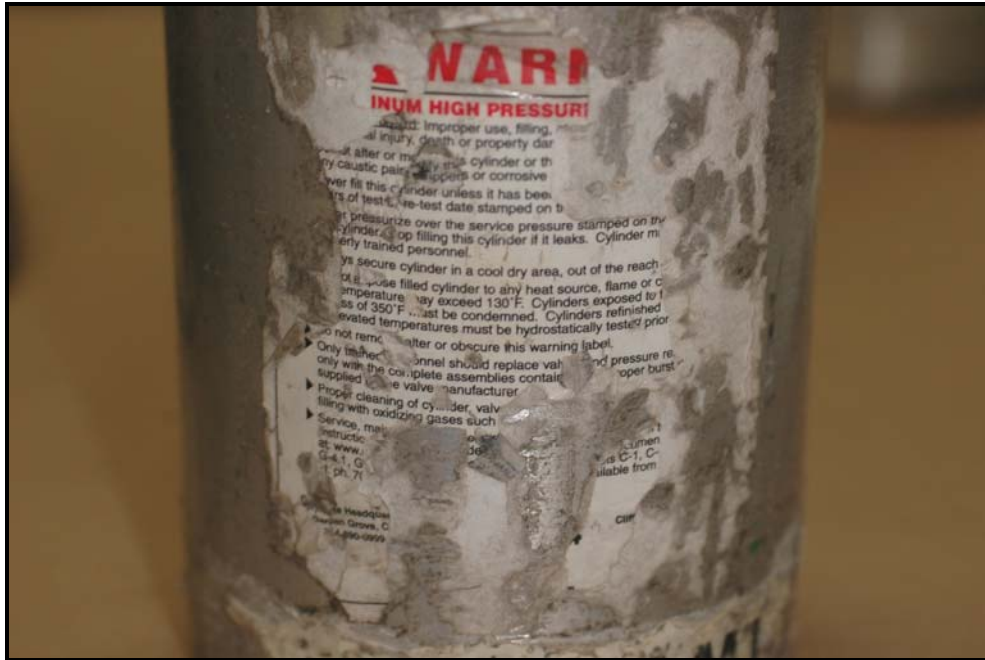
Figure 43: Labels on the DOT-3AL cylinder # AR0116501

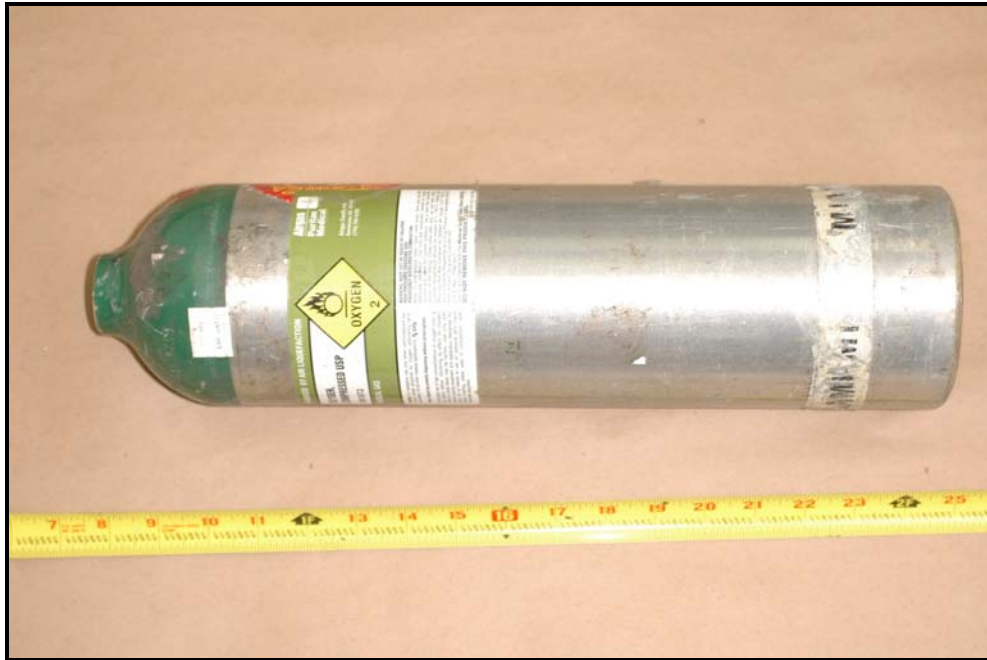
- It is marked as MDFR
- Lot # TV01V309A
Capacity: 4.25 liters
Expiration date: 11-2013
- There were no visible cracks observed on the outer surface of the cylinder. The paint on the cylinder was scratched at several locations.
- Internal observation of the cylinder showed cracks in the shoulder area showed by Figures 60 to 62. The location of cracks is identified in Figures 63 and 64. The cylinder showed no major signs of corrosion on the inside.

Figure 49: Shows the as received DOT-3AL cylinder # AR0118110

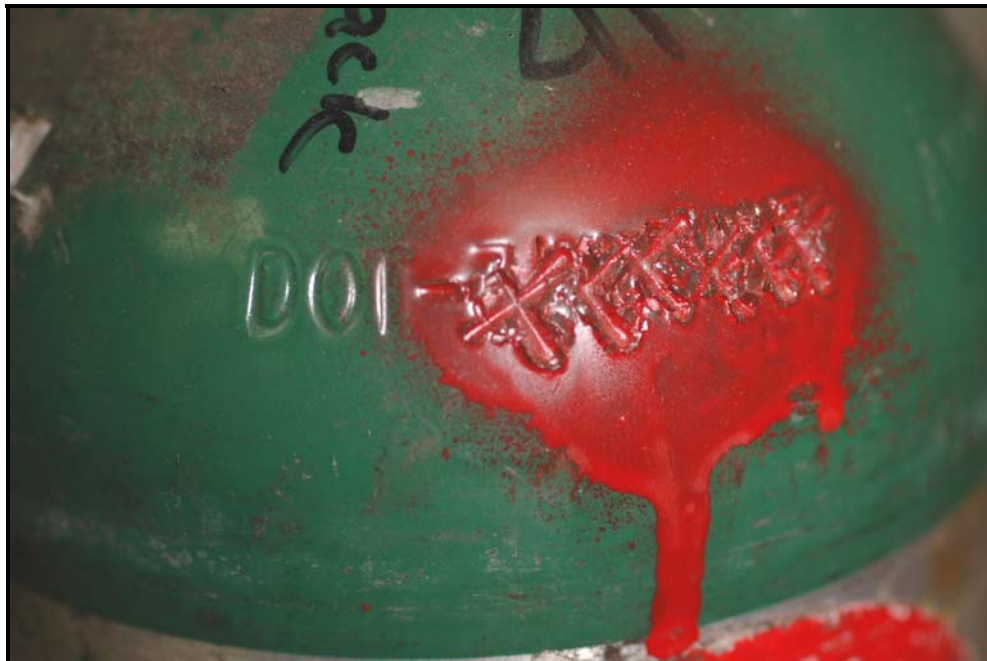
Figure 50: Indented marking on the DOT-3AL cylinder # AR0118110

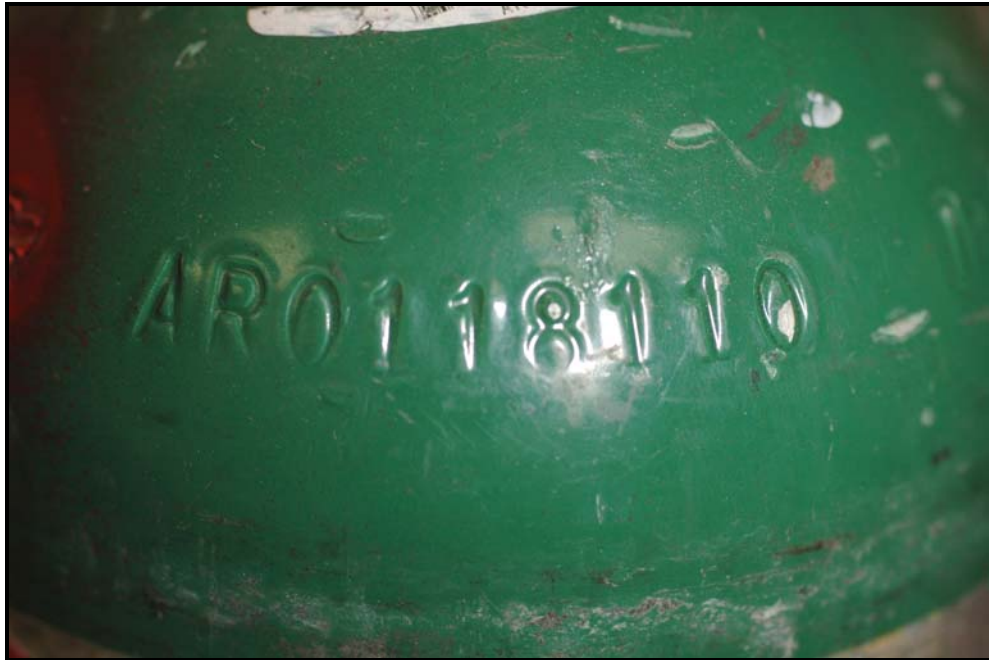
Figure 51: Indented marking on the DOT-3AL cylinder # AR0118110

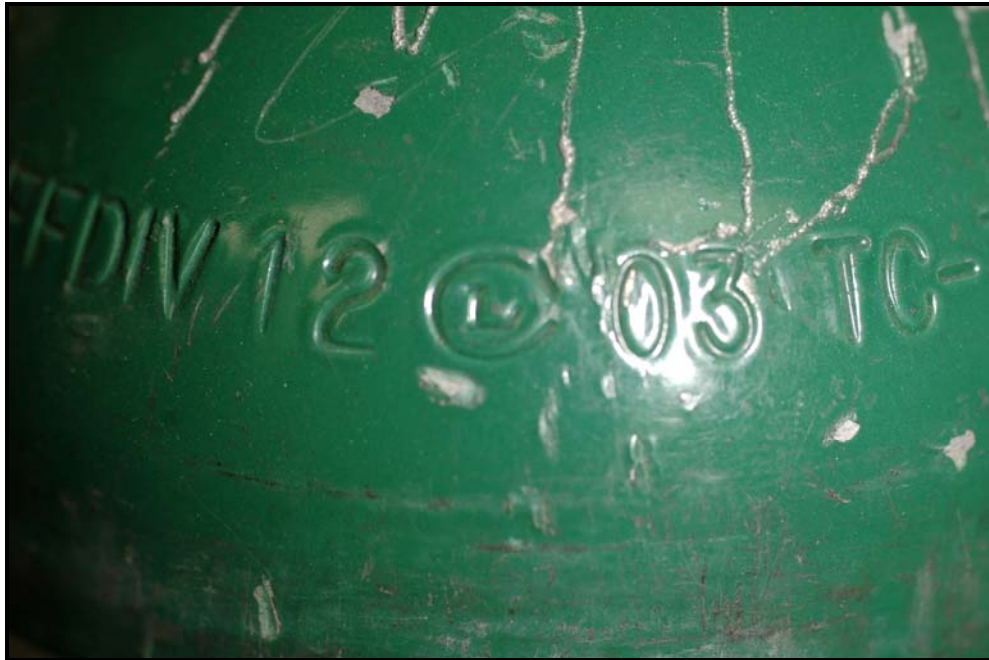
Figure 53: Indented marking on the DOT-3AL cylinder # AR0118110

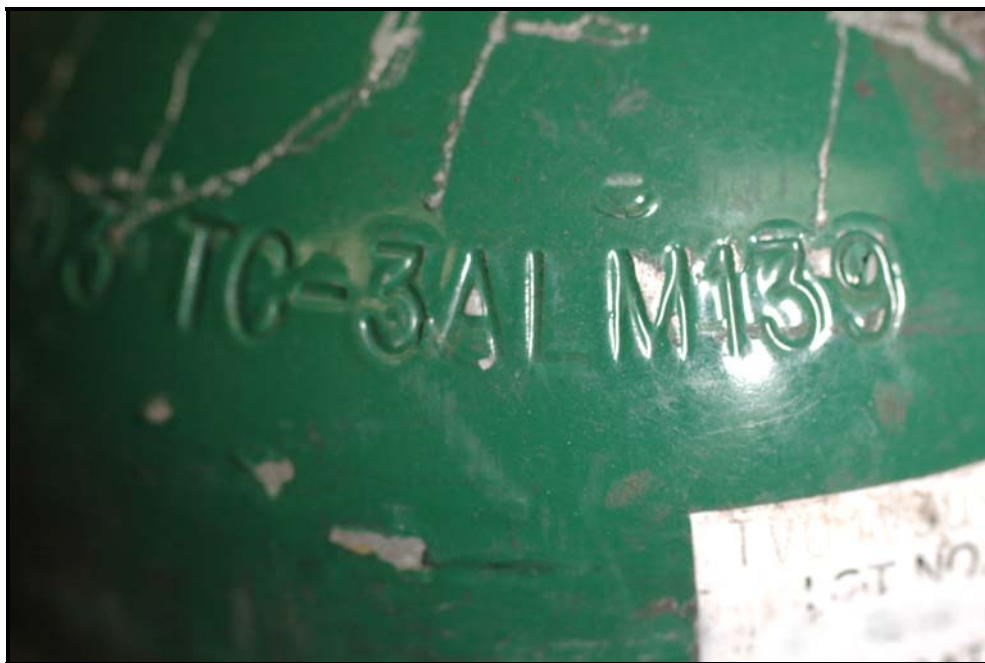
Figure 54: Indented marking on the DOT-3AL cylinder # AR0118110

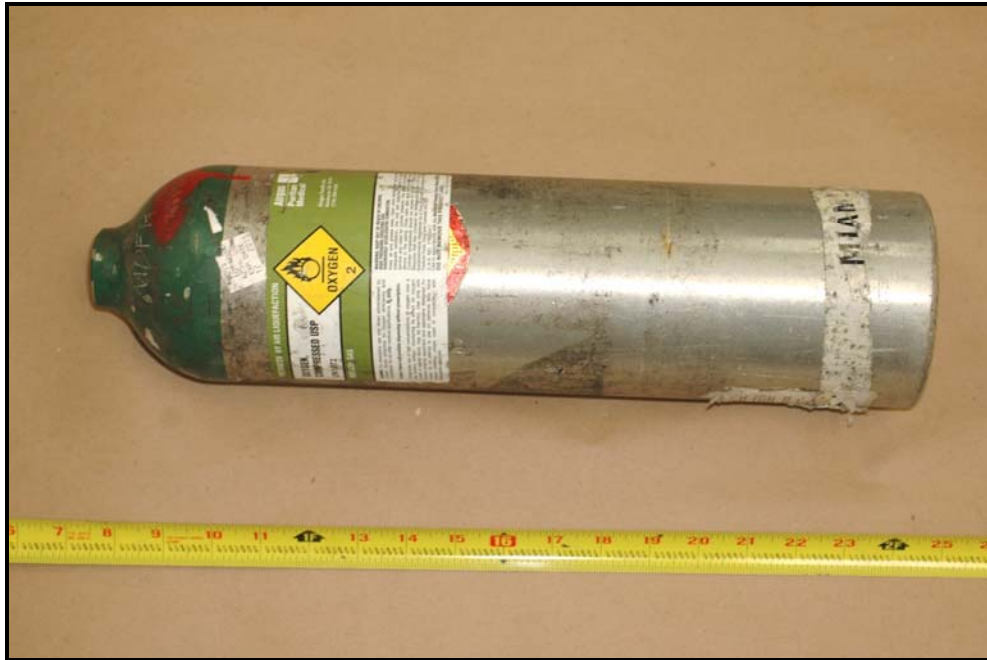
Figure 65: Shows the as received DOT-3AL cylinder # AR0119572

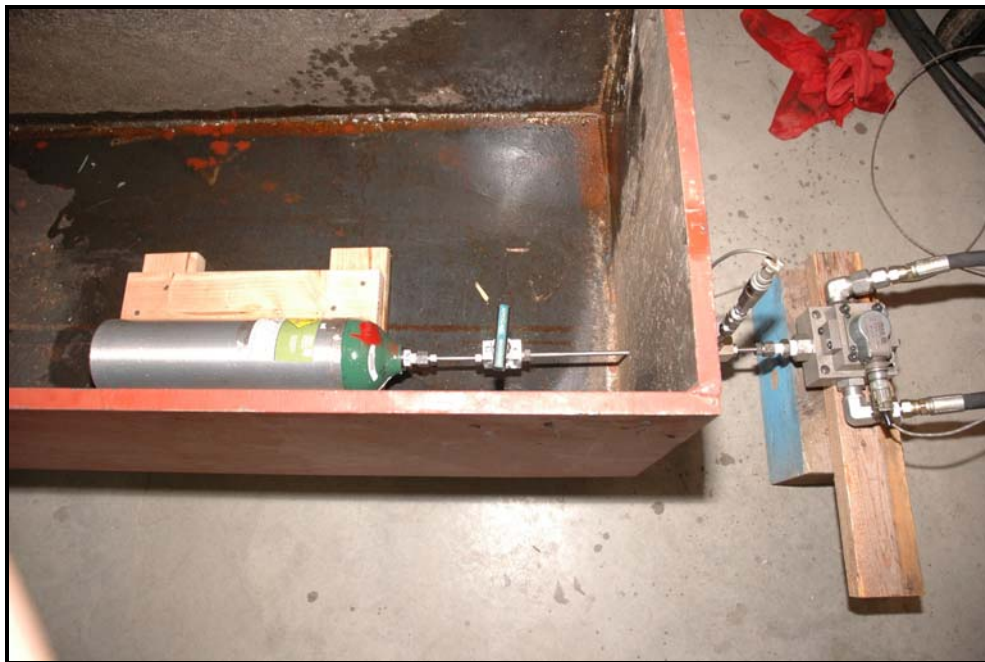
Figure 82: Test set up for pressure cycling DOT-3AL 2015 cylinders up to 12,000 cycles and until failure of the cylinder

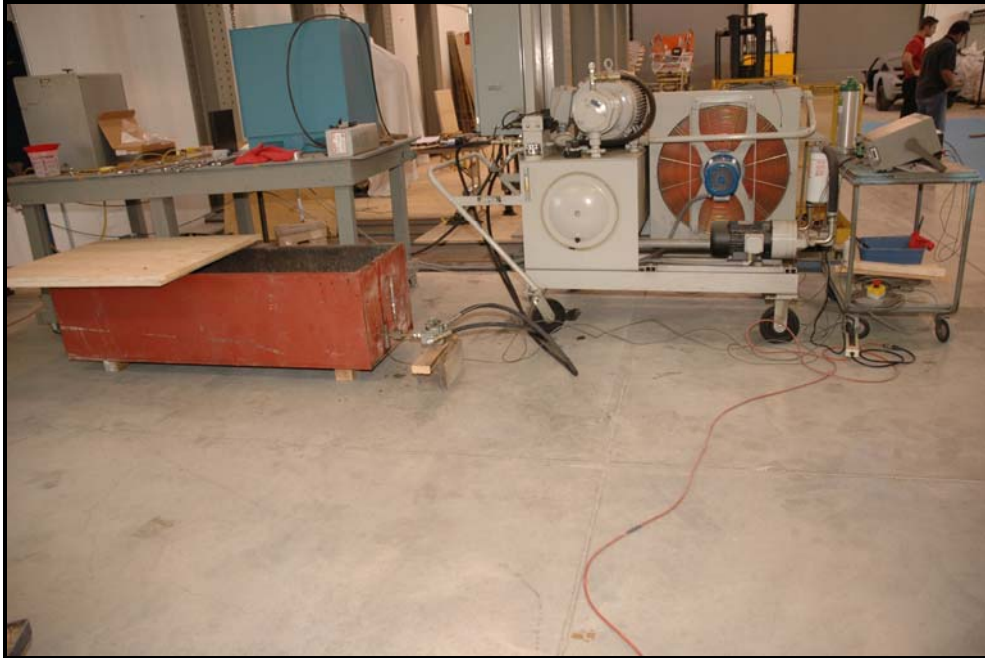
Figure 83: Test set up for pressure cycling DOT-3AL 2015 cylinders up to 12,000 cycles and until failure of the cylinder

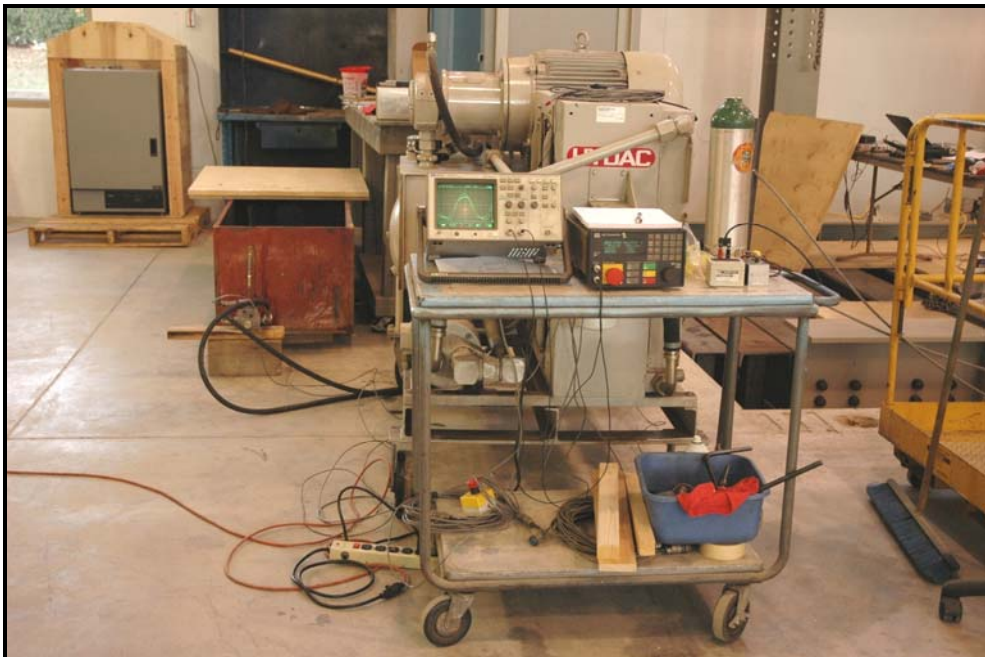
Figure 84: Test set up for pressure cycling DOT-3AL 2015 cylinders up to 12,000 cycles and until failure of the cylinder
