**Hydraulic Pressure Cycling and Performance Evaluation of five DOT-3AL 2015
Cylinders**

FINAL REPORT

Packer Project # 501856

**Prepared for
Mark Toughiry
Office of Hazardous Materials Technology
Pipeline and Hazardous
Materials Safety Administration
U.S. Department of Transportation**

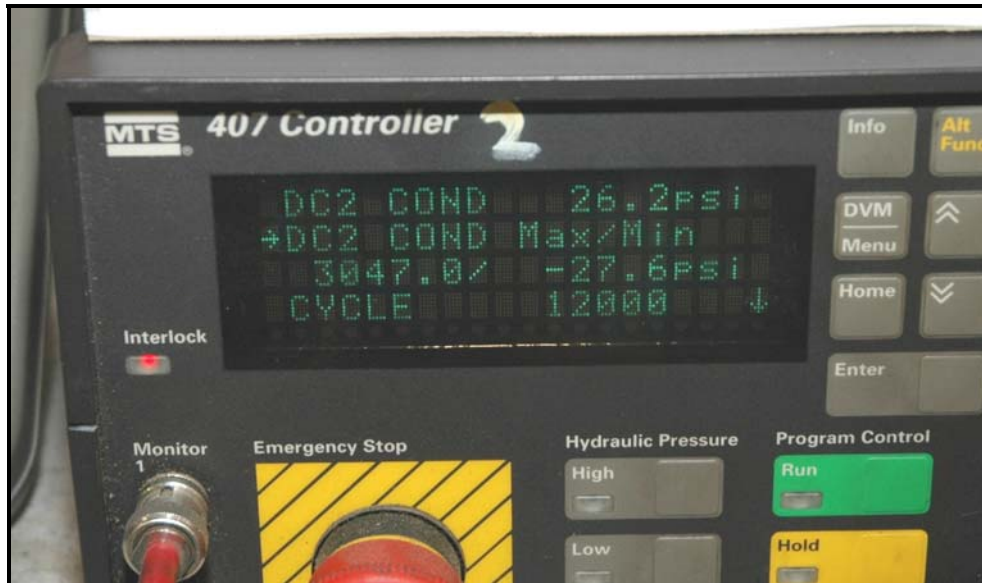
Figure 87: Shows the maximum/minimum pressure and the number of cycles completed during the pressure cyclic testing of the DOT – 3AA cylinder # AR0118046

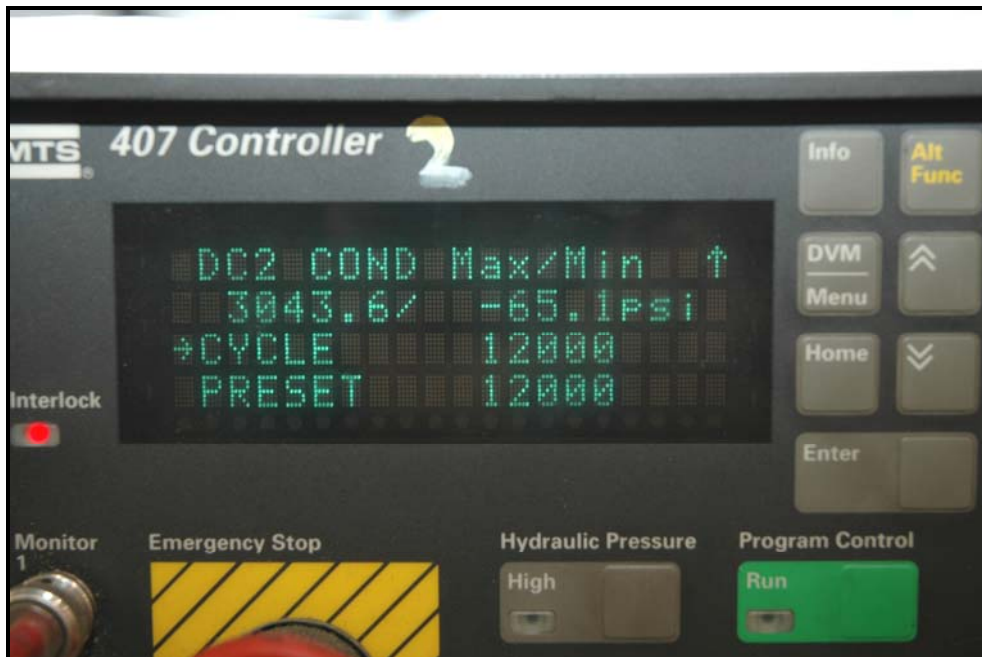
Figure 88: Shows the maximum/minimum pressure and the number of cycles completed during the pressure cyclic testing of the DOT – 3AA cylinder # AR0116501

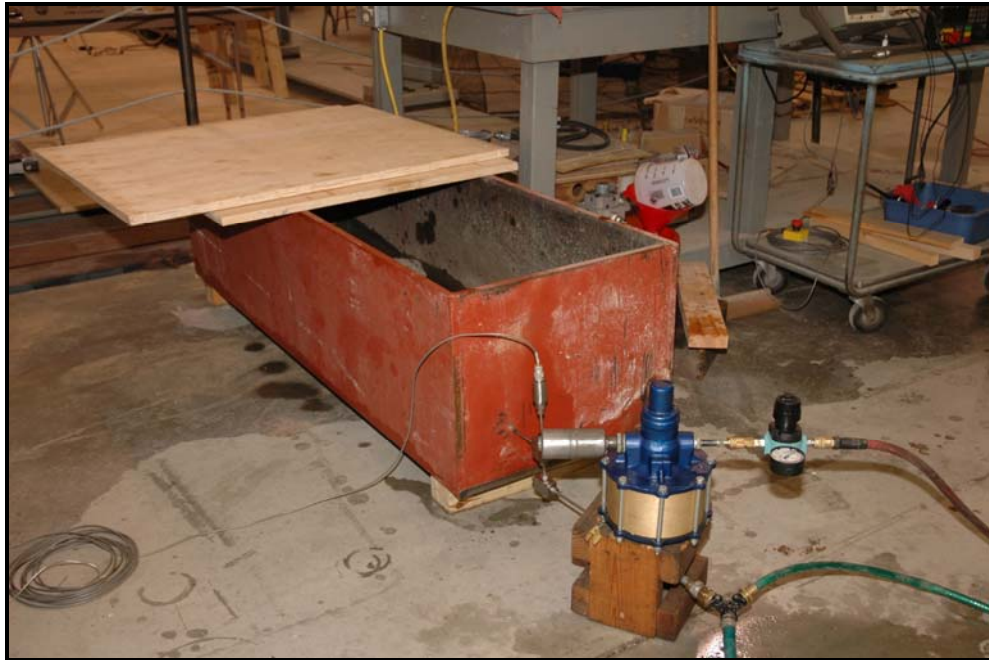
Figure 95: Test set up for hydraulic burst testing of cylinder #AR0119582

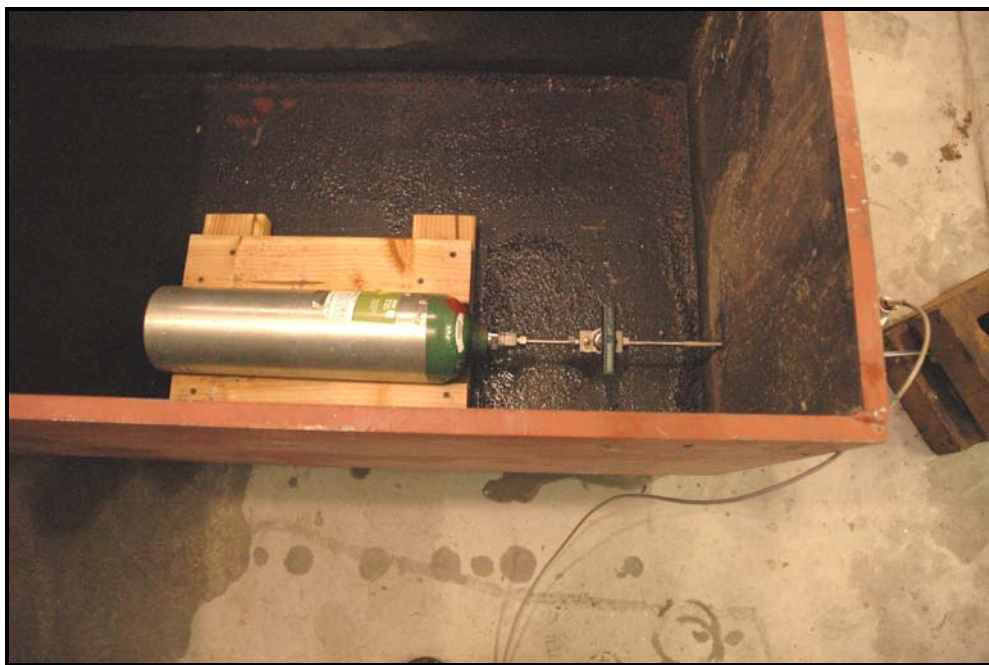
Figure 96: Test set up for hydraulic burst testing of cylinder #AR0119582
