NAPSR

Distribution New Construction

St. Louis, Missouri April 20, 2010

Inspection findings related to Plastic Materials

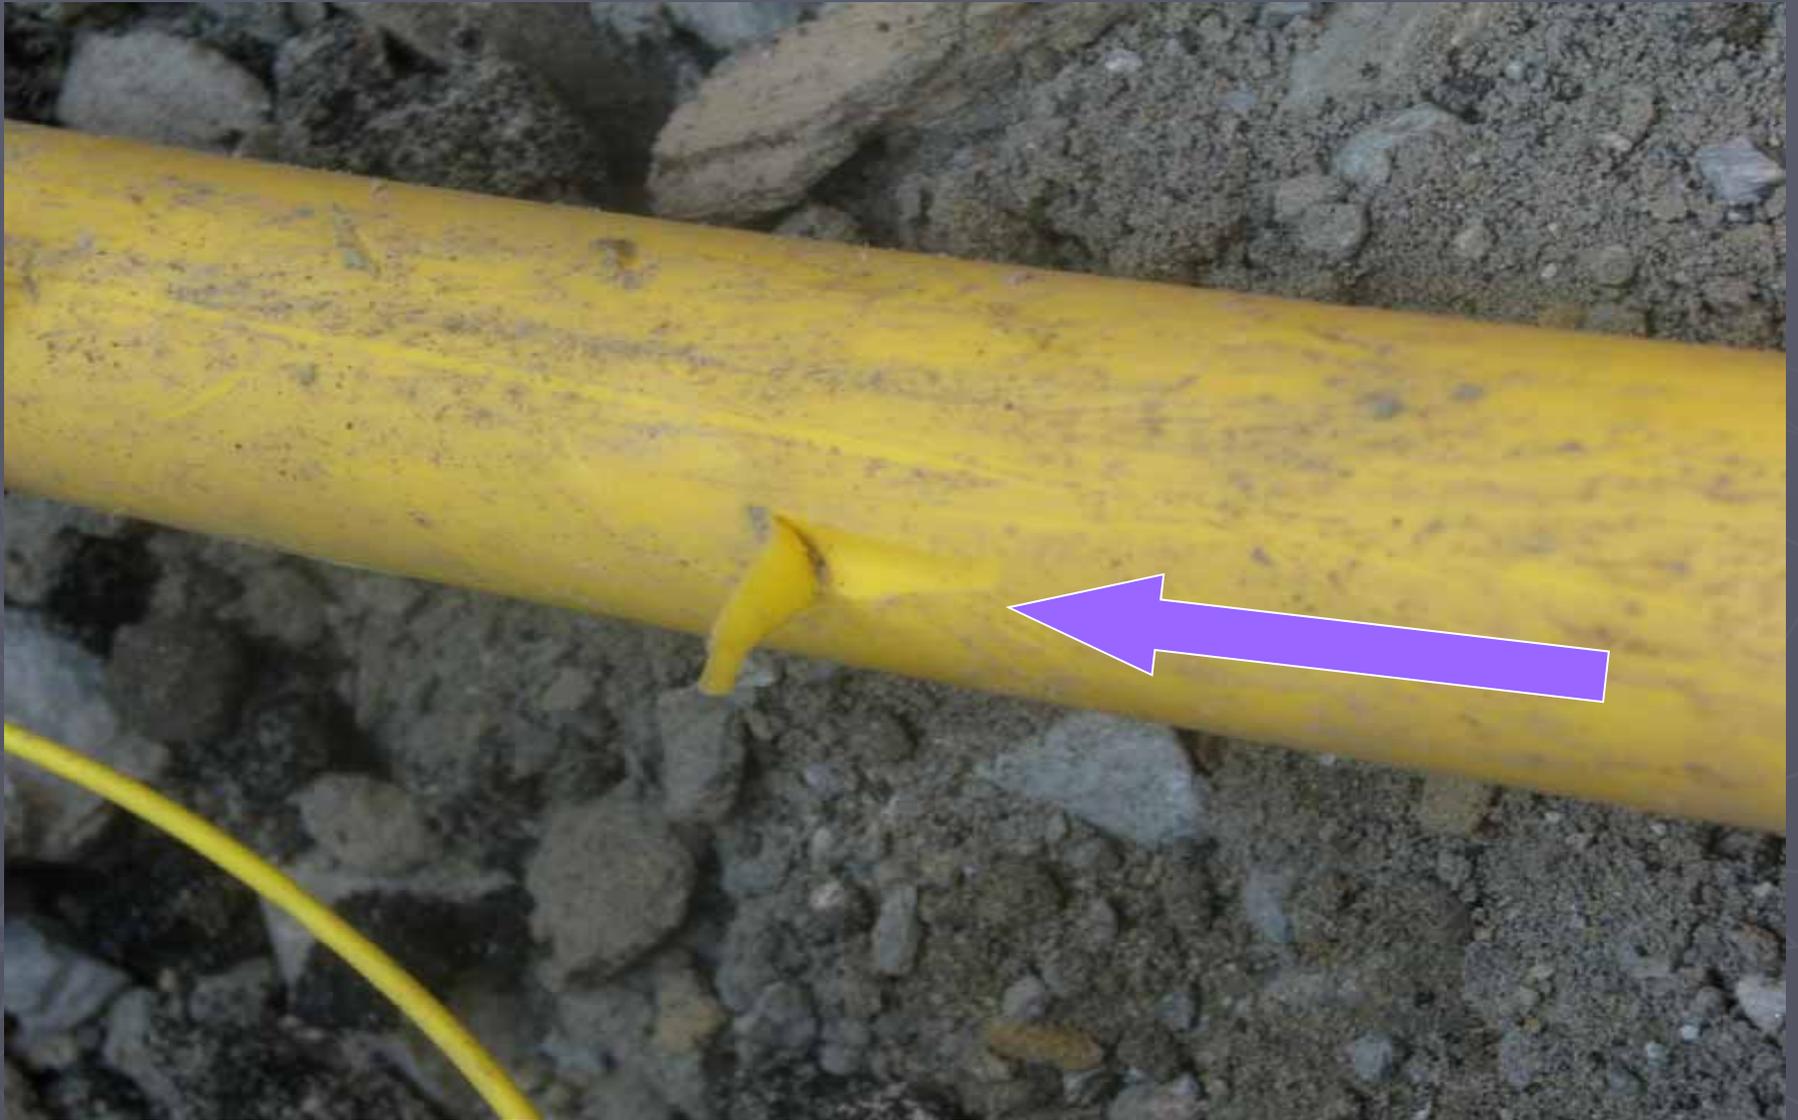
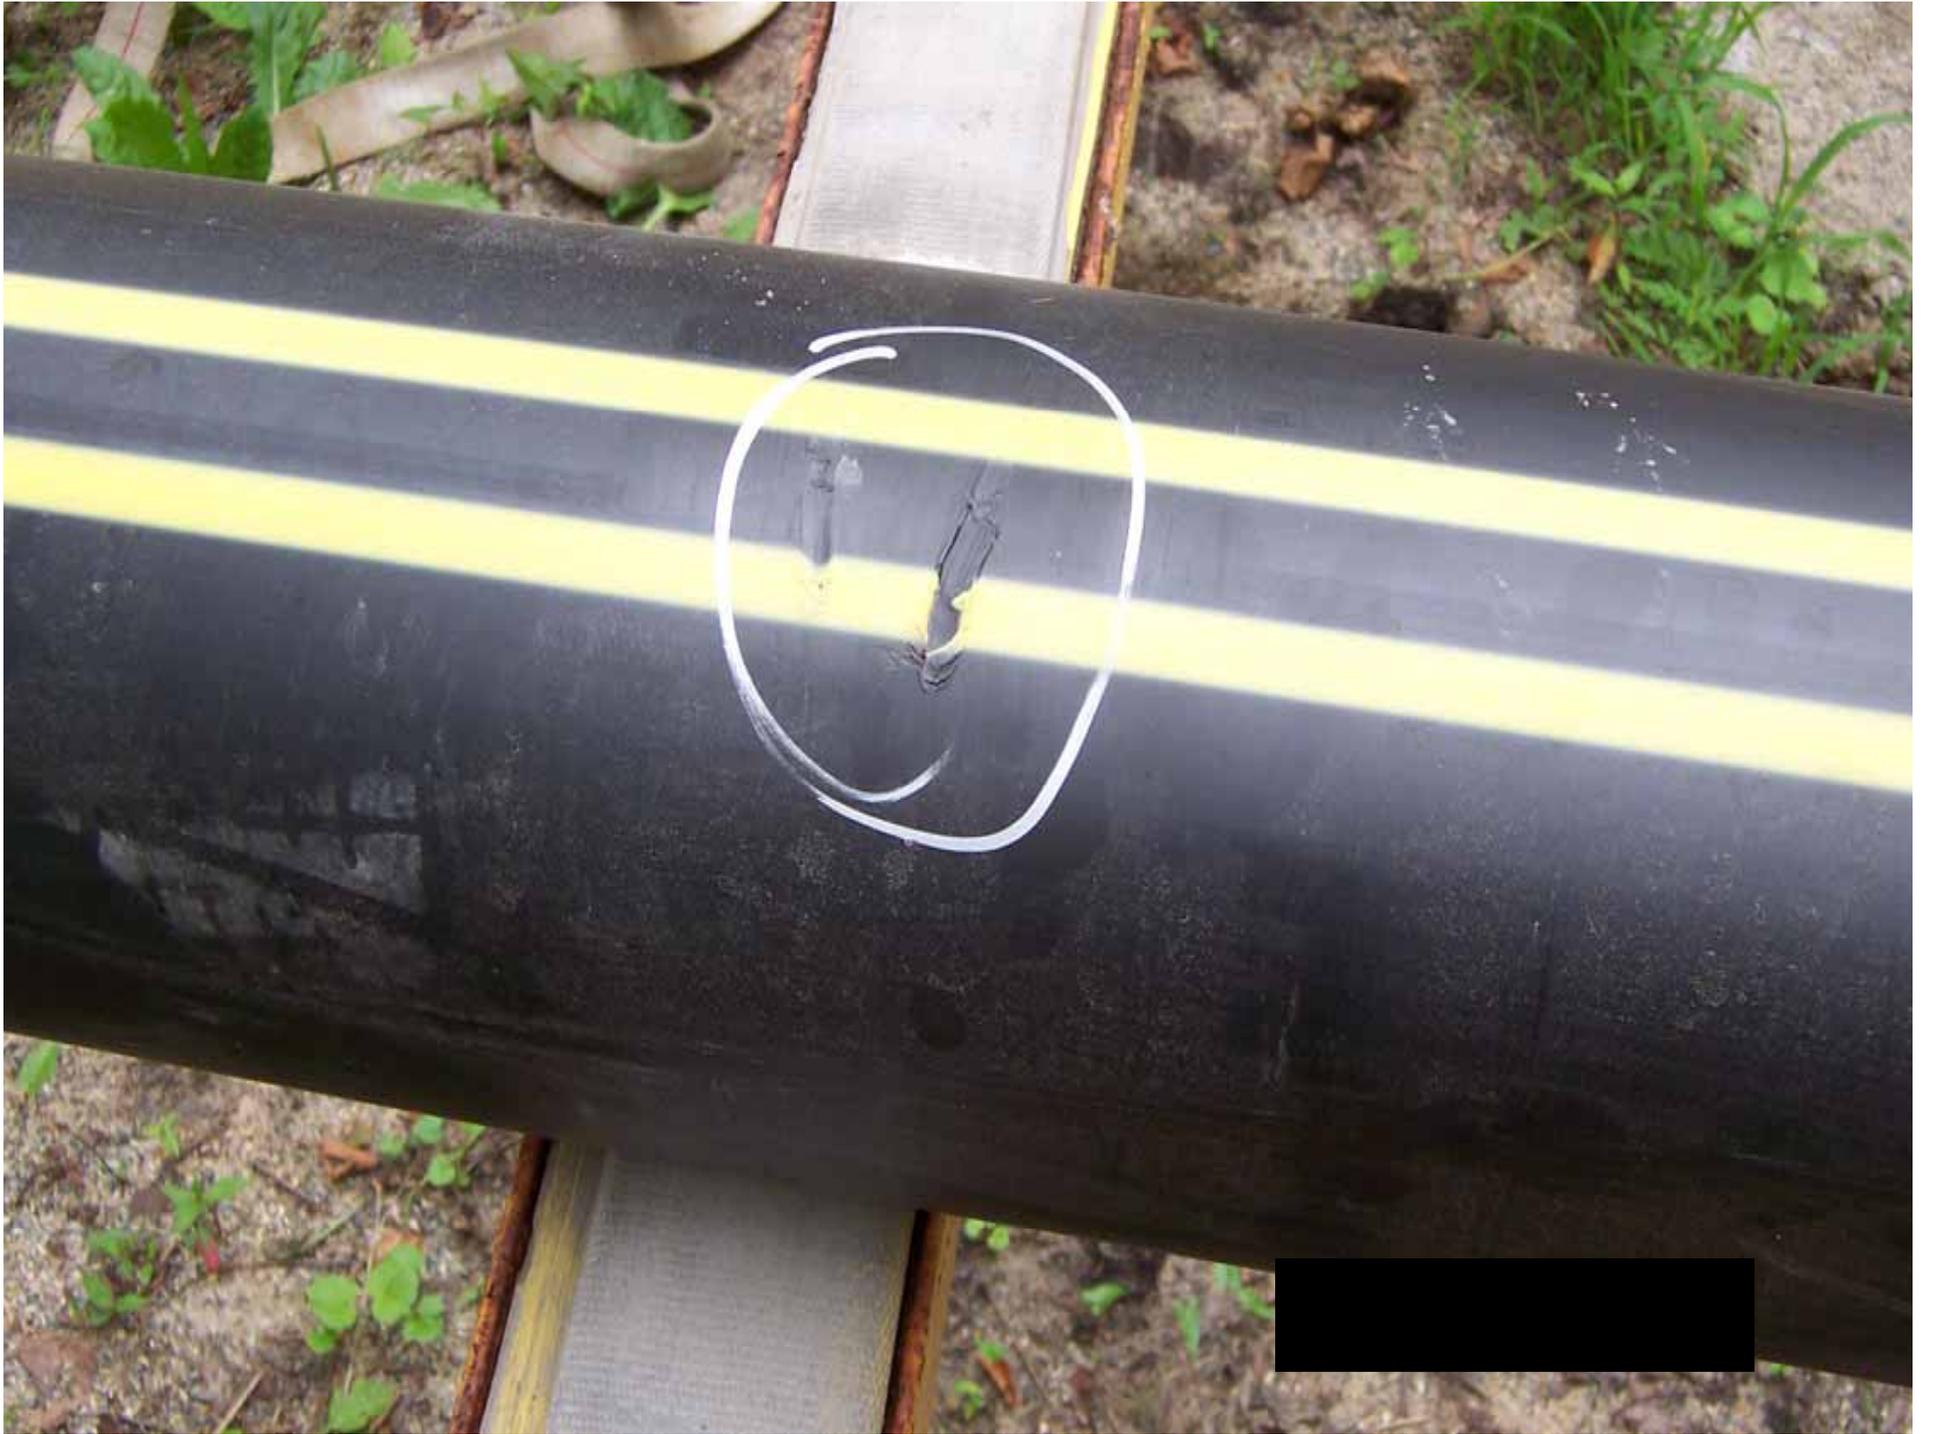
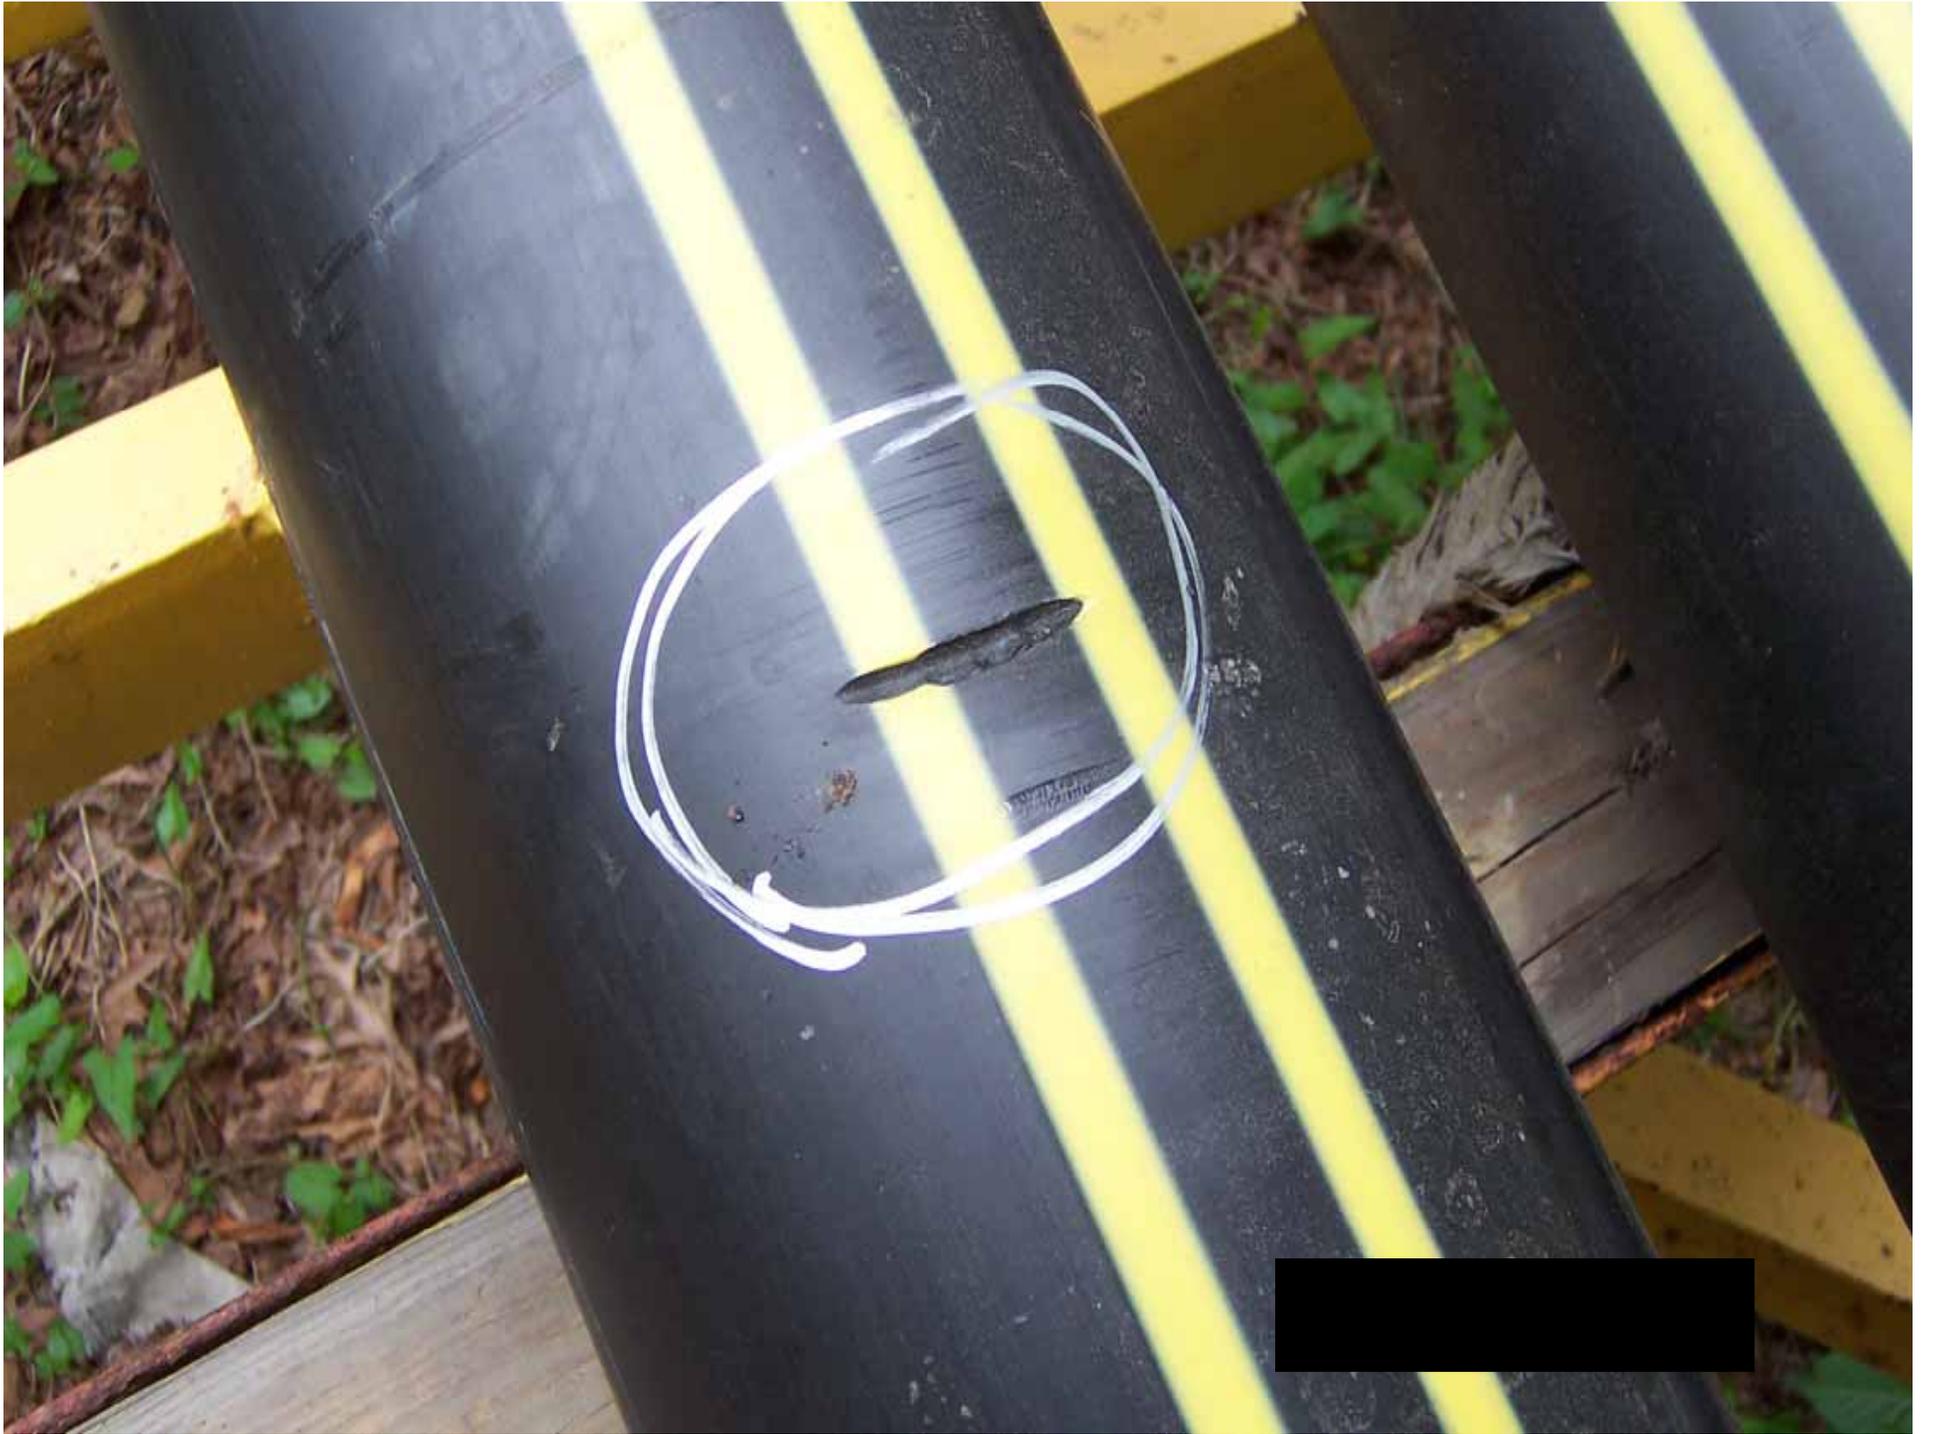
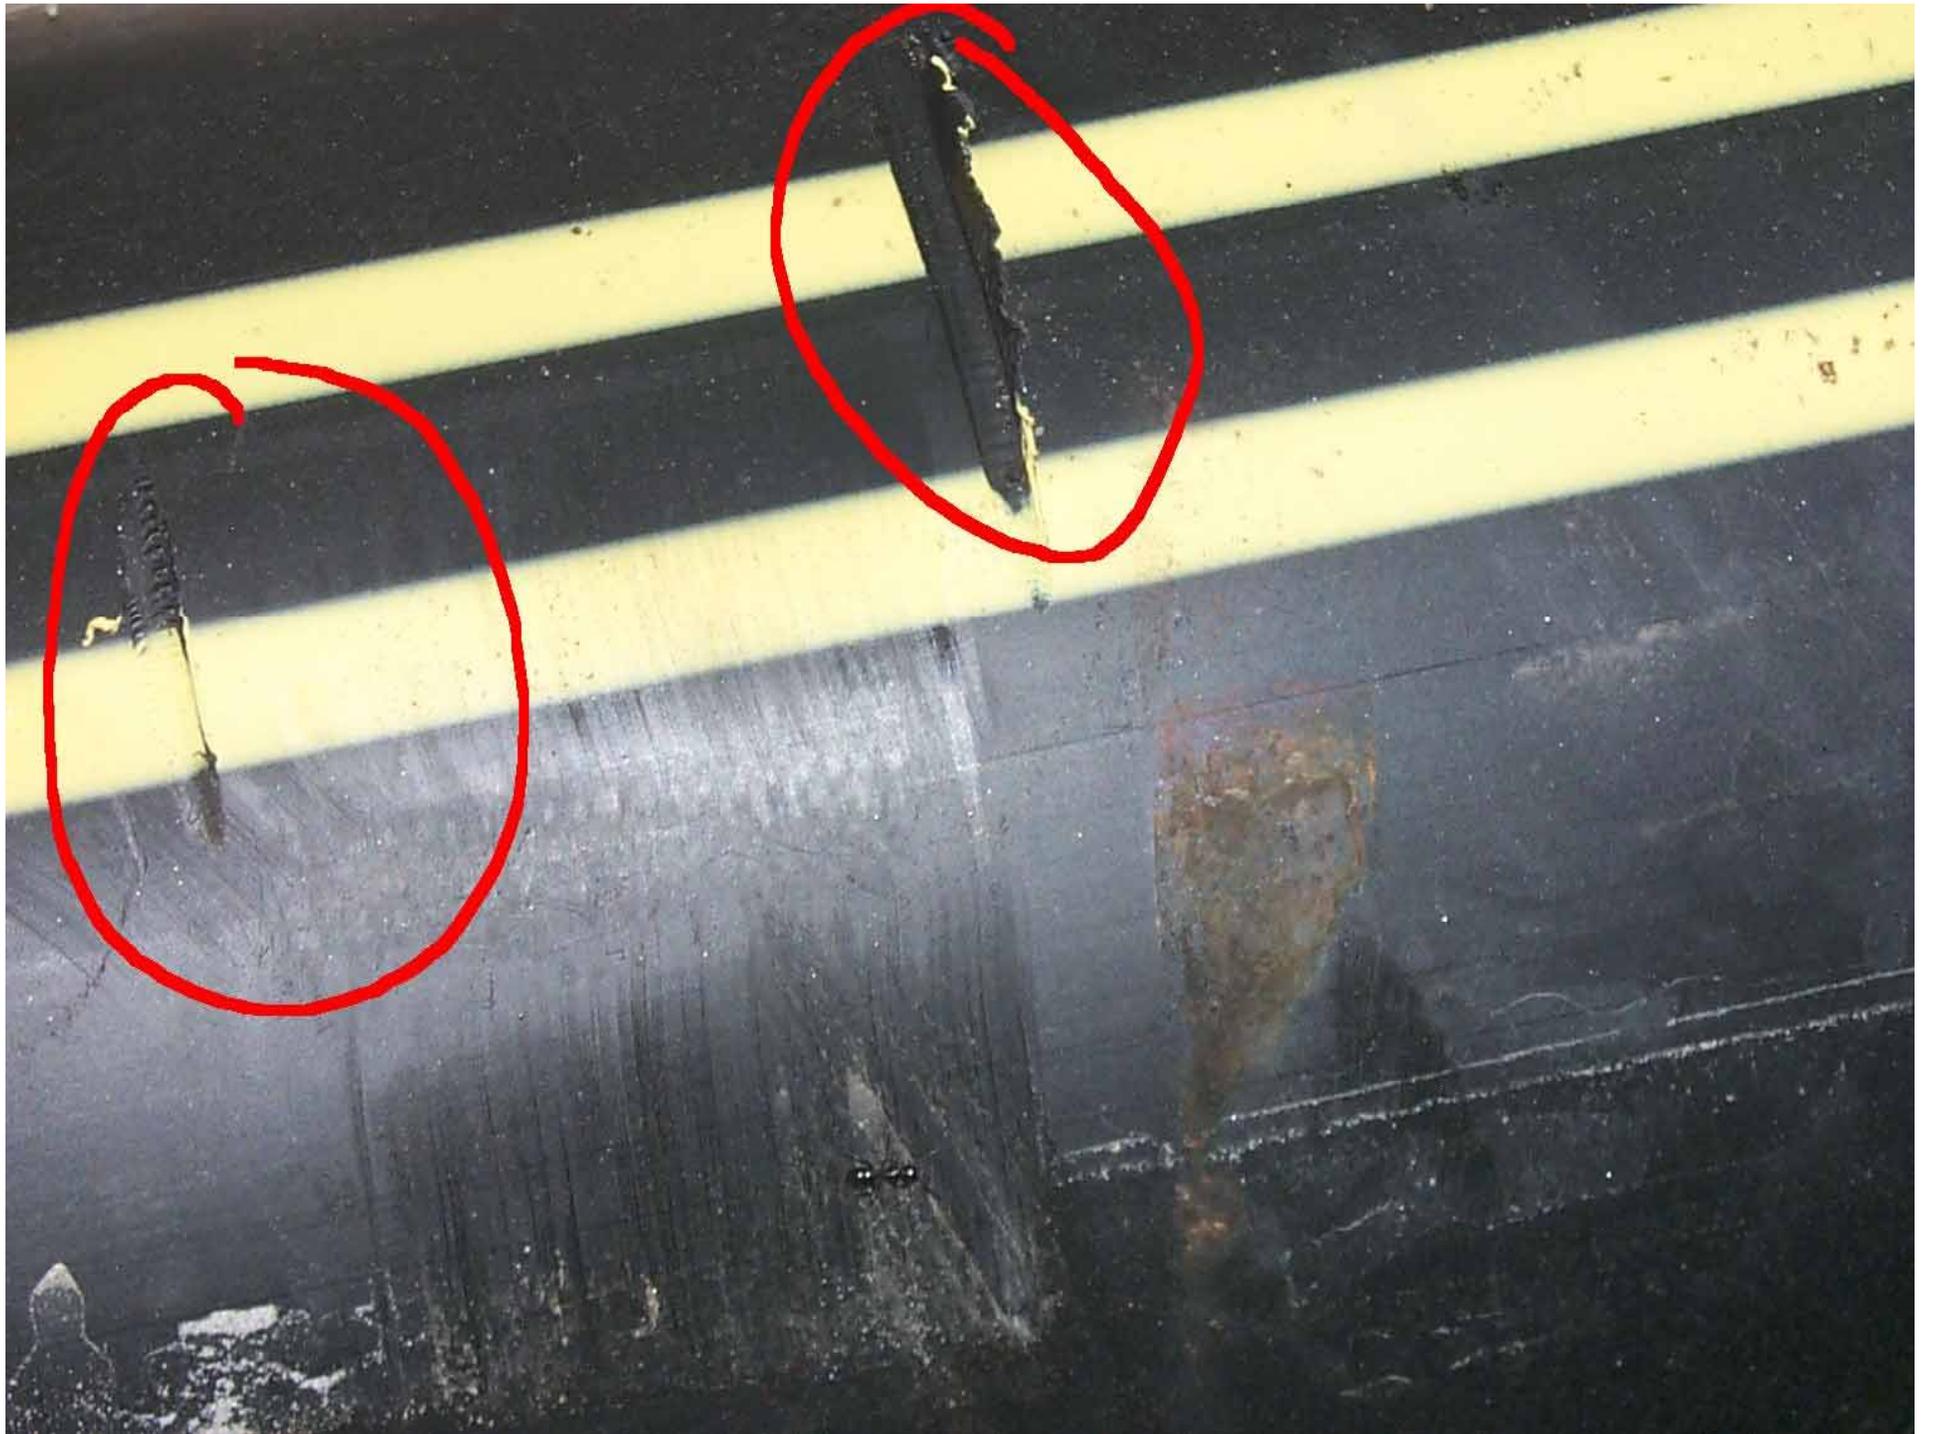
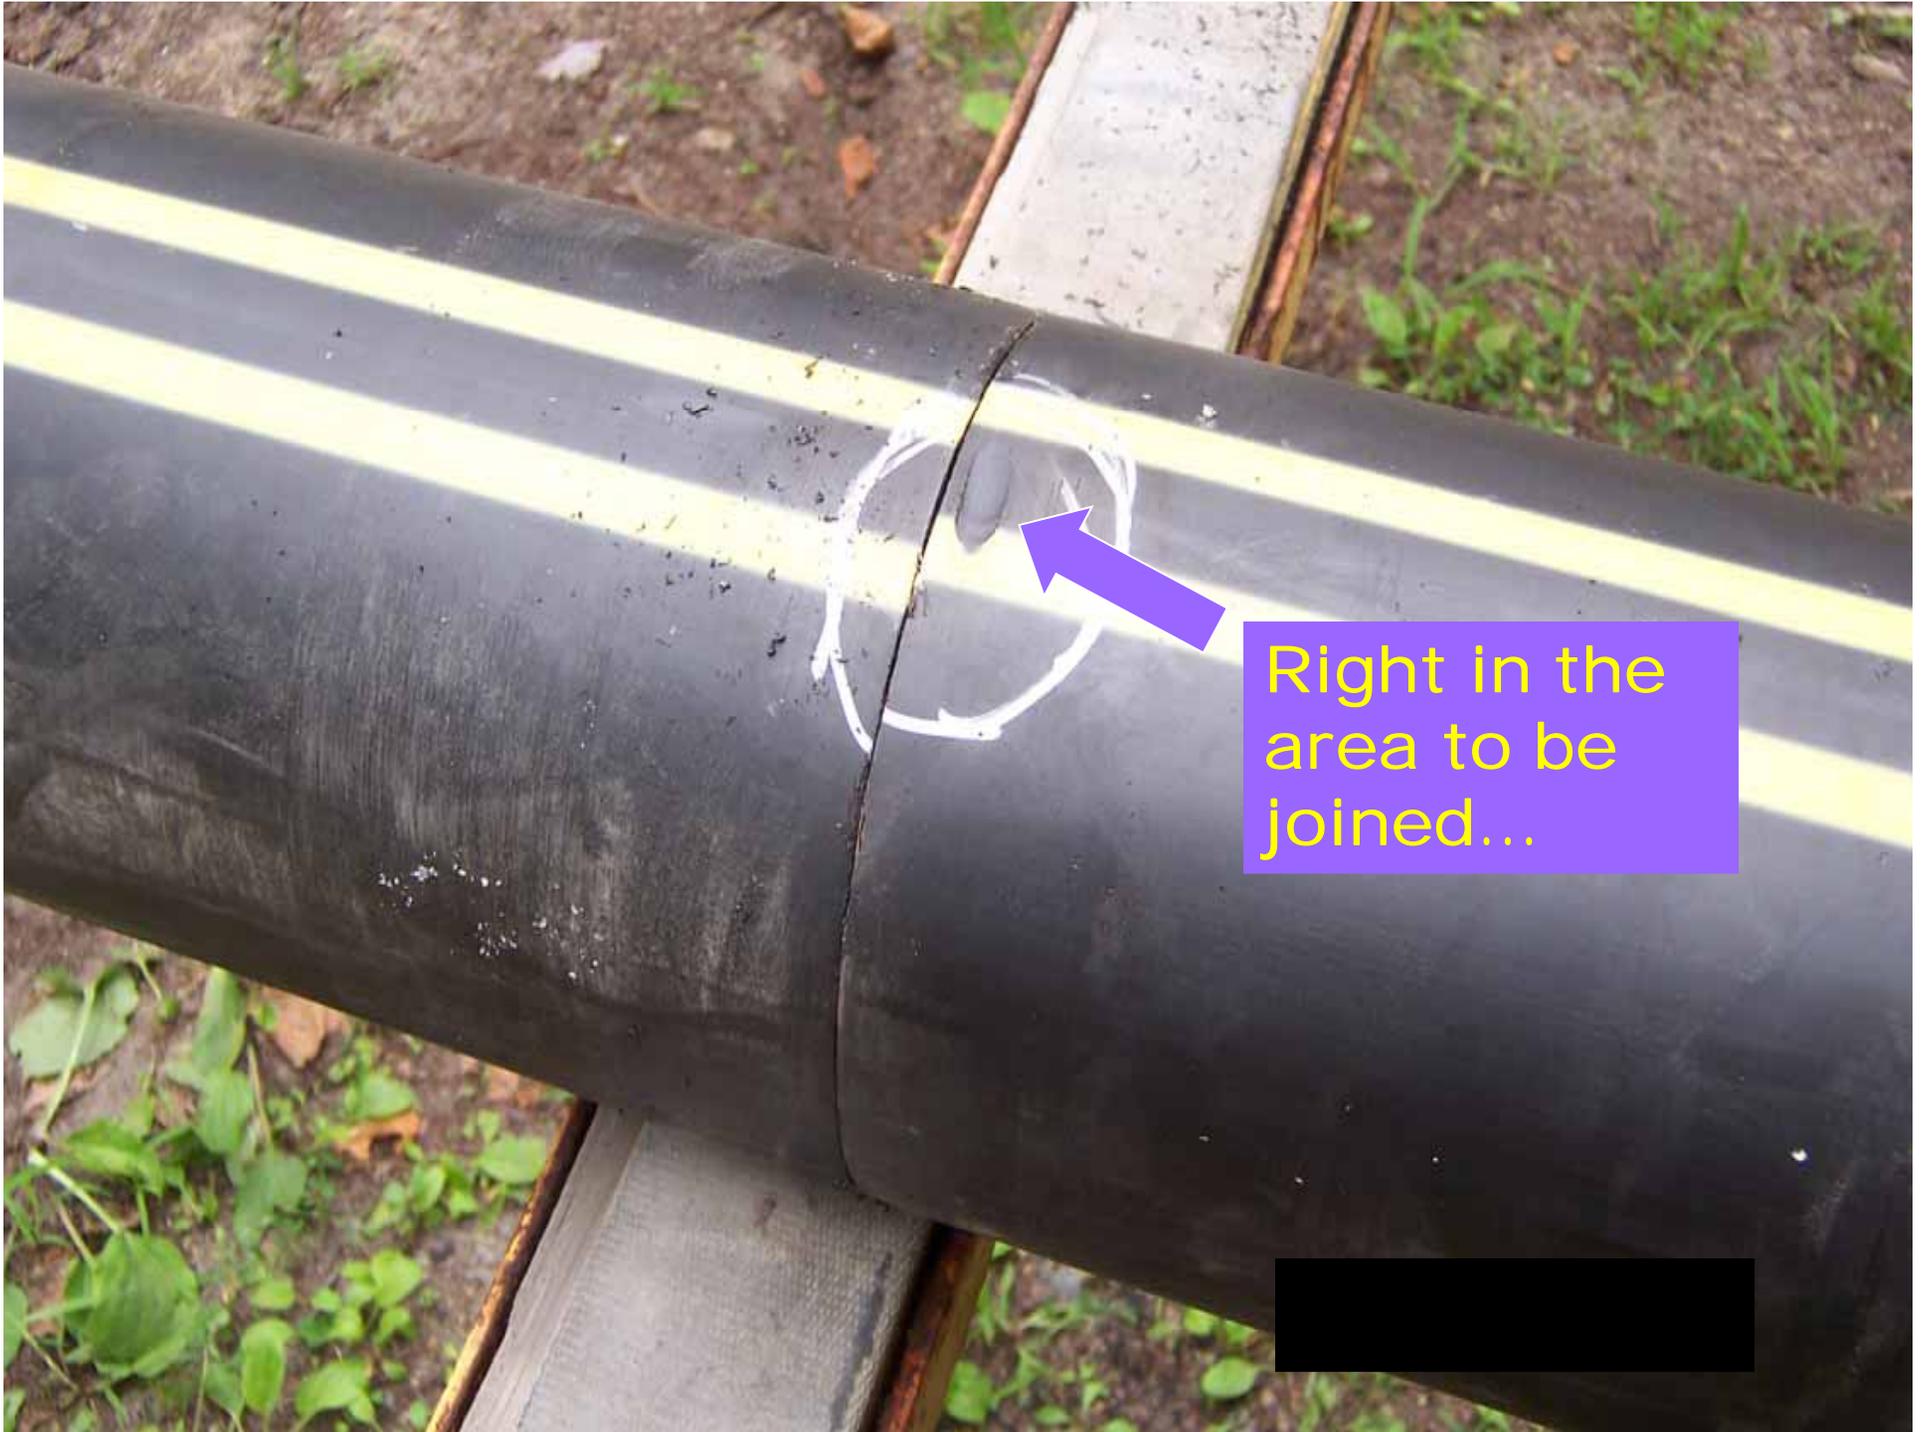
...if it is free of visible defects.

Right in the area to be joined...

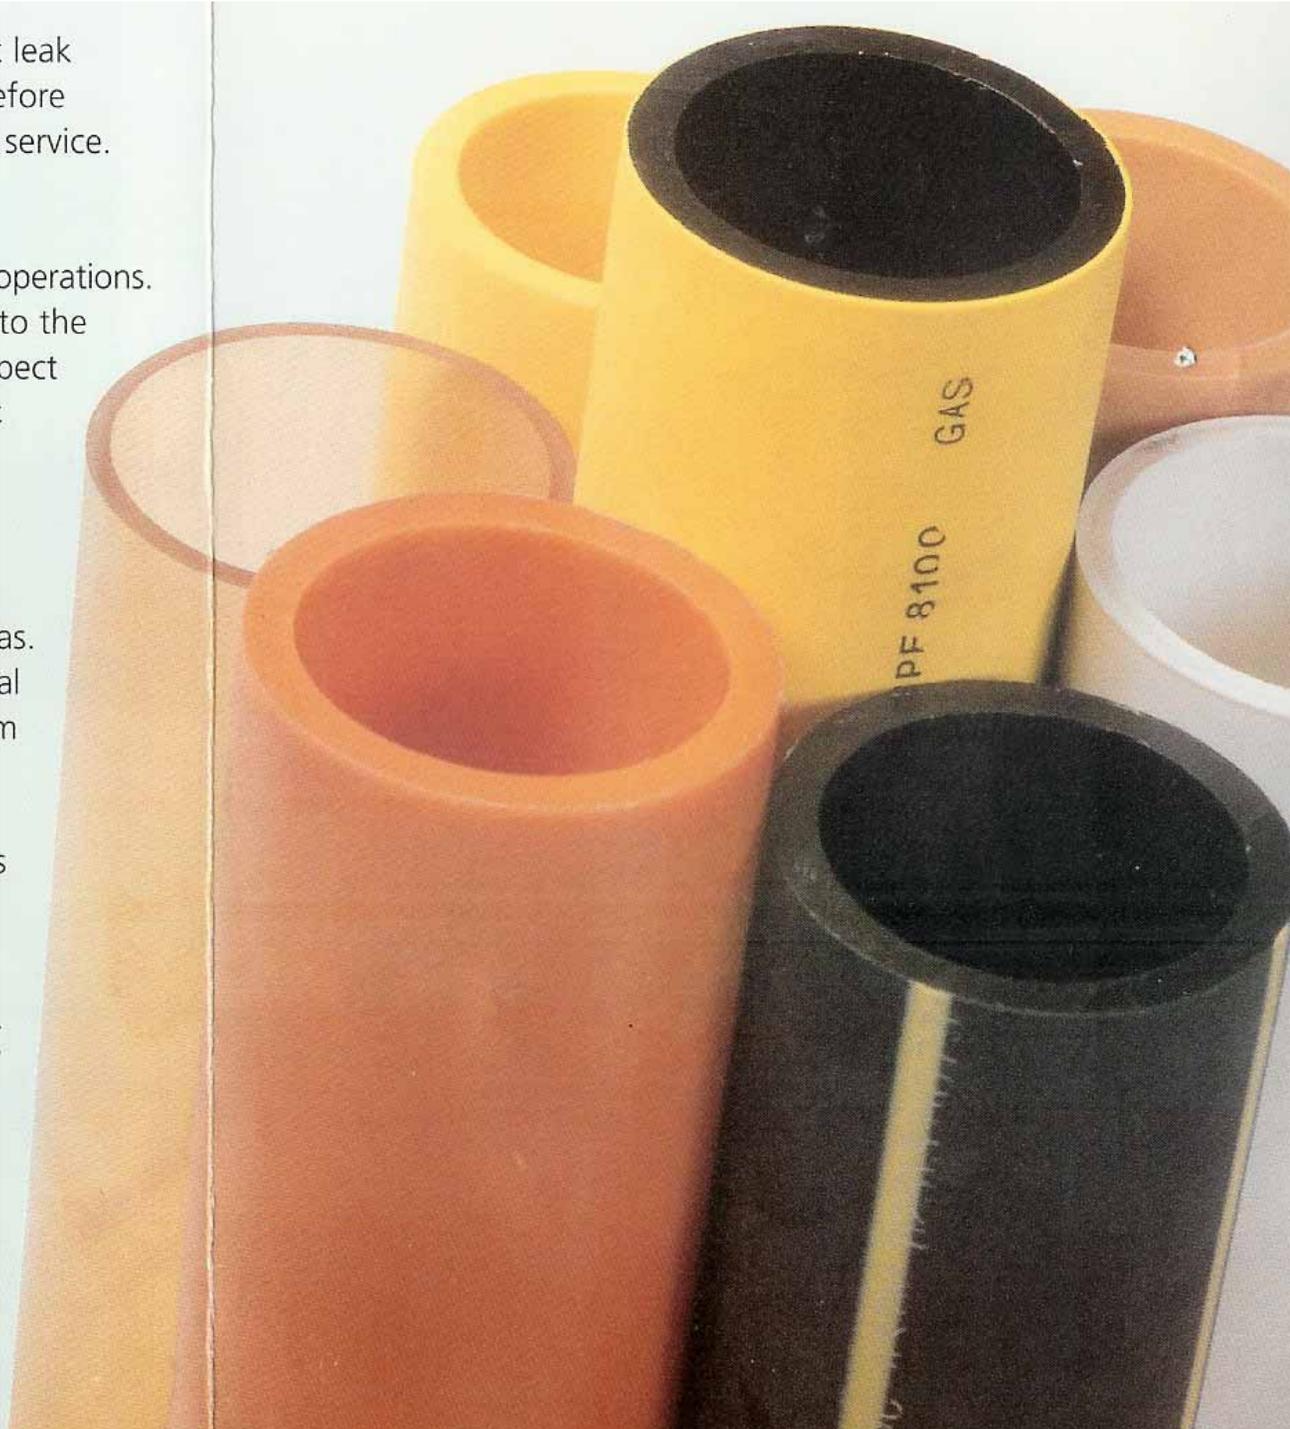
- ▶ The Operator installed a 2" plastic with a gouge greater than 10% wall loss, the Operator did not know how to measure the defect nor did he have any equipment to measure the defect.

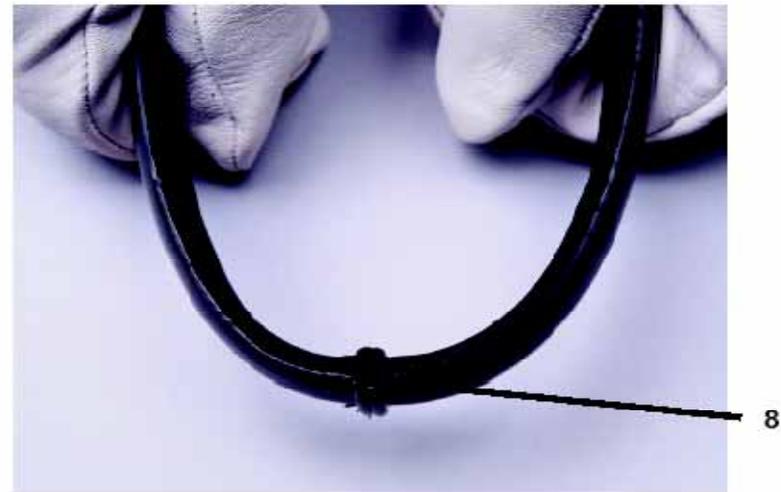
8. No gaps or voids when bent

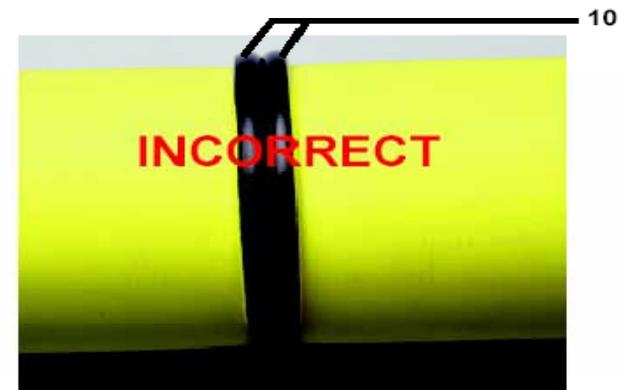
10. Excessive heat time or pressure applied during heating; melt bead too large

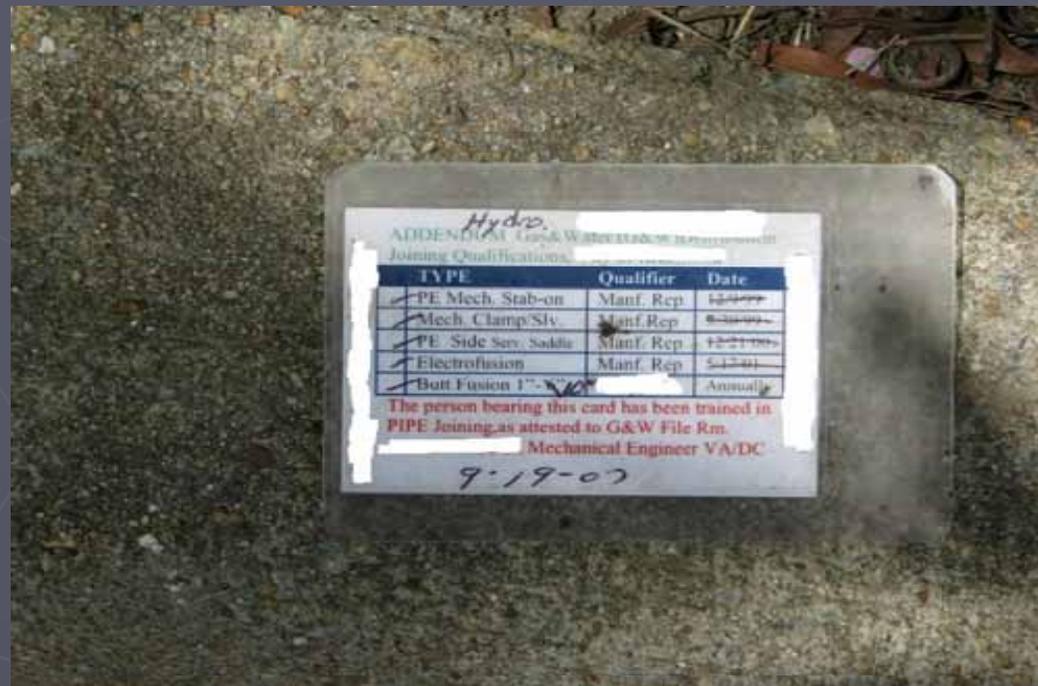
- ▶ The Operator's contractor performing heat fusion had an expired joining card.

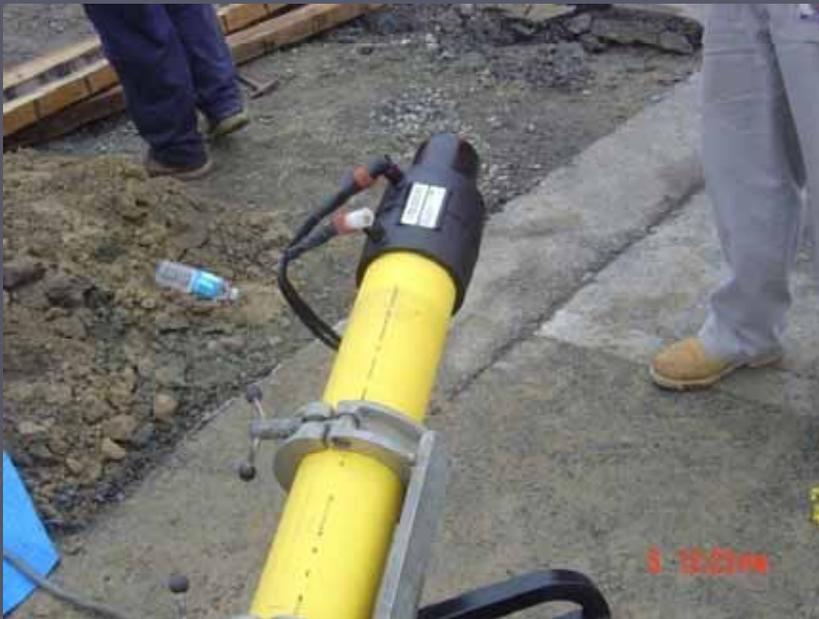
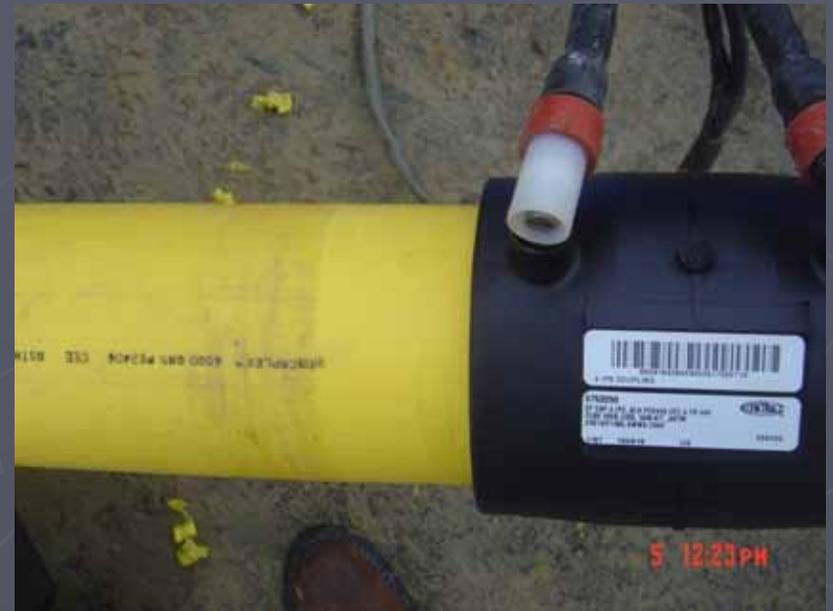
The Operator did not mark the proper stab depth before performing an electrofusion.

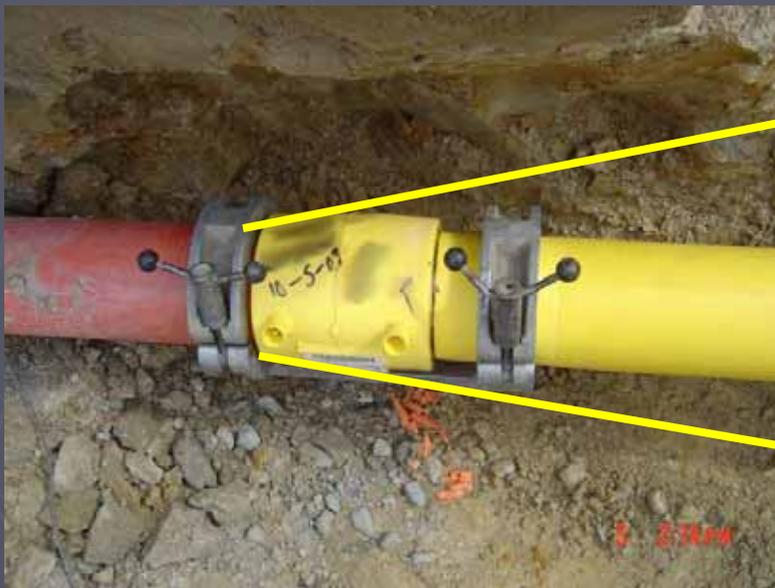
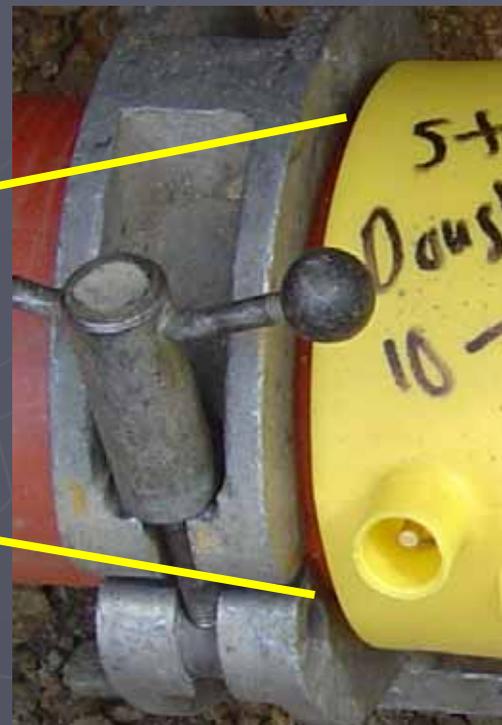
Another example of not marking the proper stab depth before performing an electrofusion.

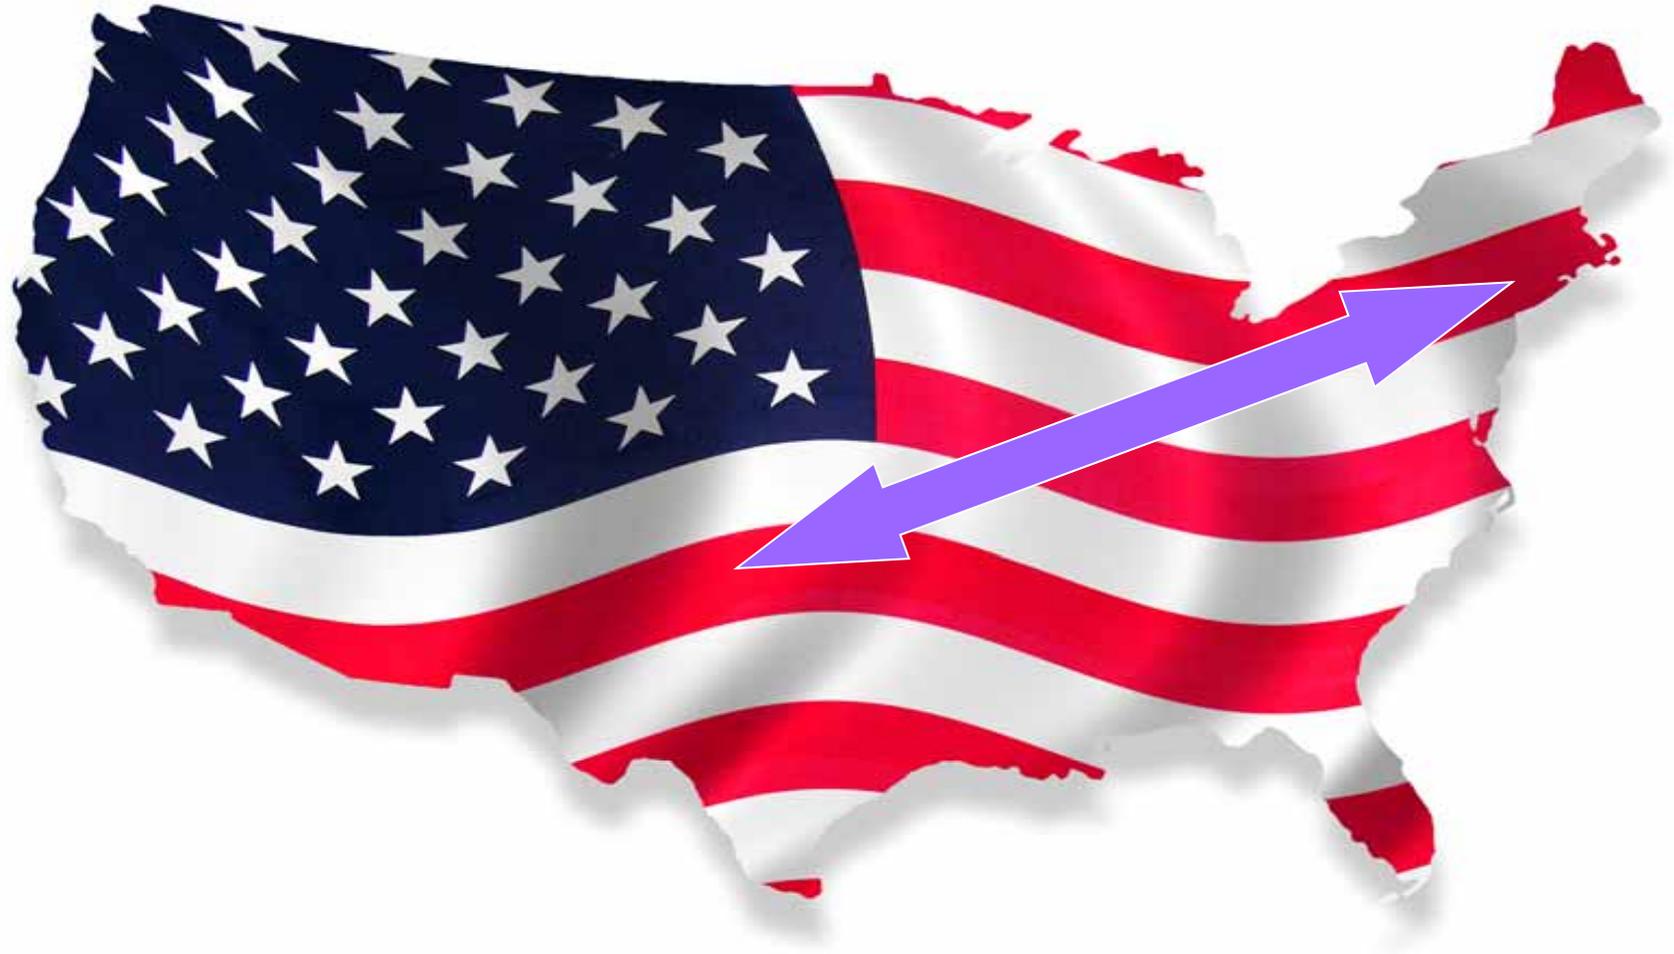
Pipe Dated
March 7, 2010

Pipe is 11 days old from the factory?

Delivered cross country in 11 days!

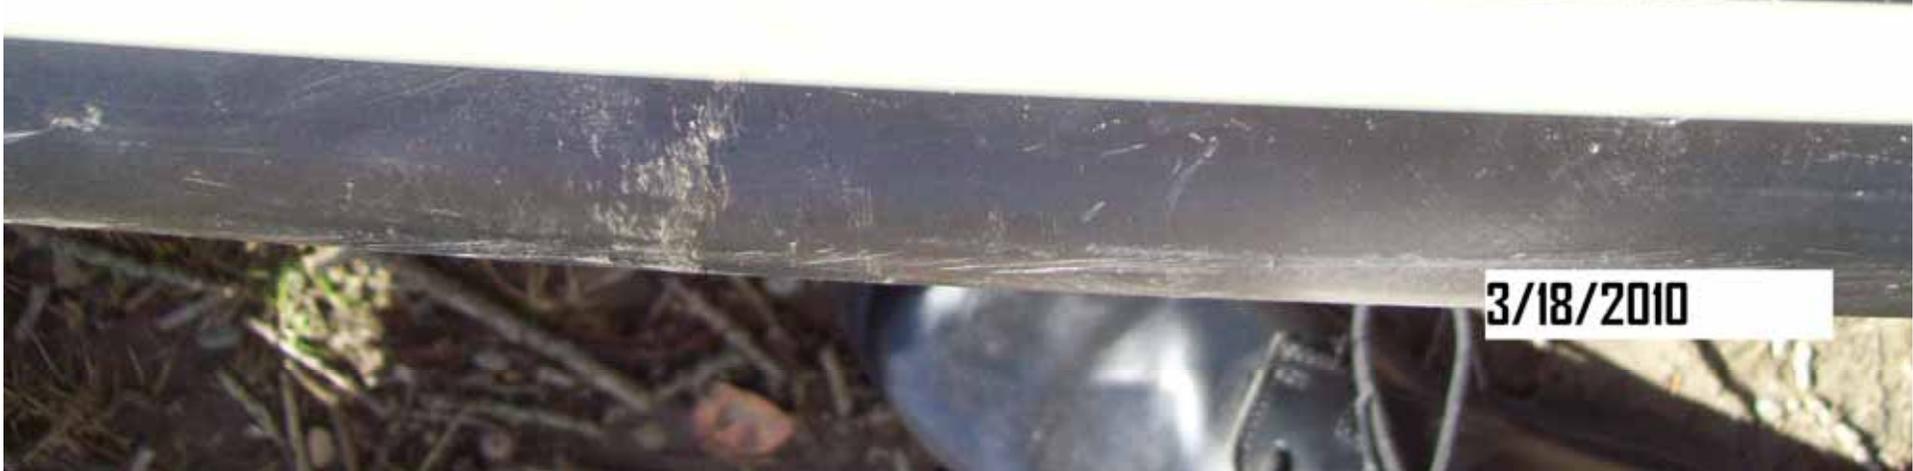
Pipe Dated
Feb. 6, 2008

...Older than 2 years!

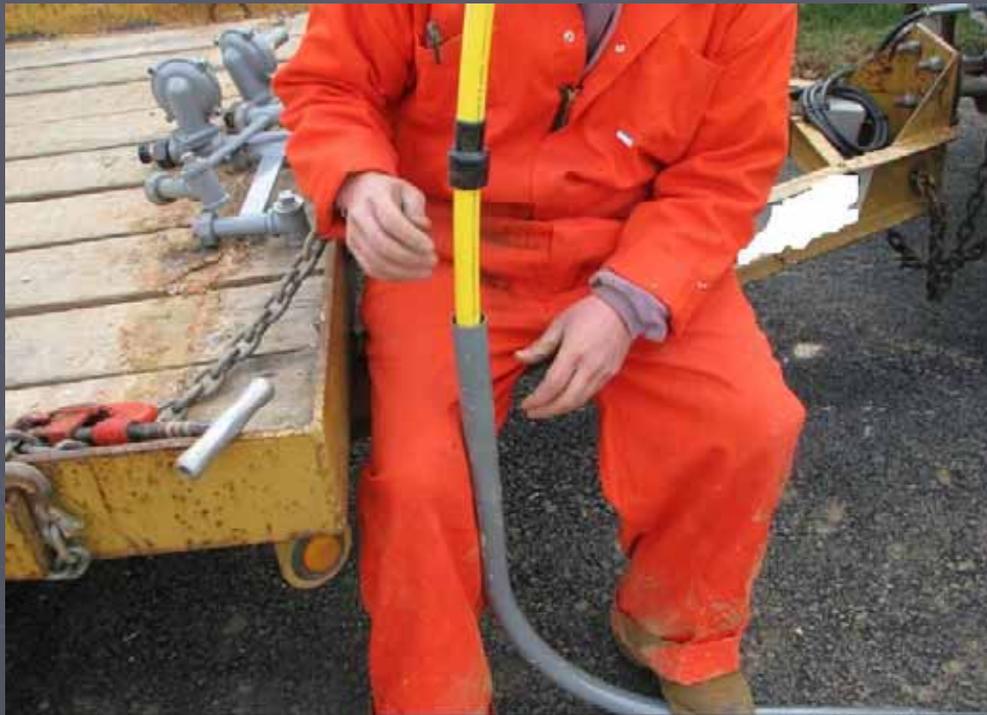
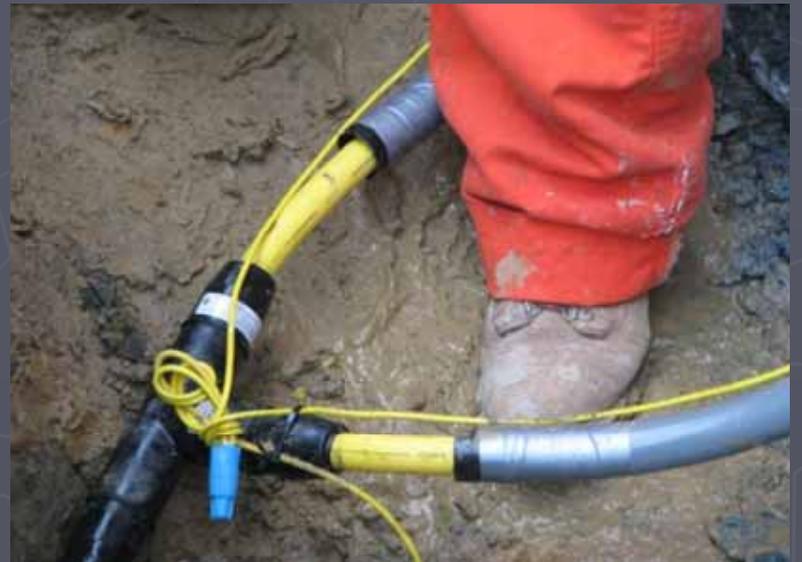
- ▶ The Operator's contractor performing a branch service installation shortened two anodeless risers. There was no procedure for this activity.
