NAPSR

Distribution New Construction

St. Louis, Missouri April 20, 2010

Inspection findings related to Plastic Materials

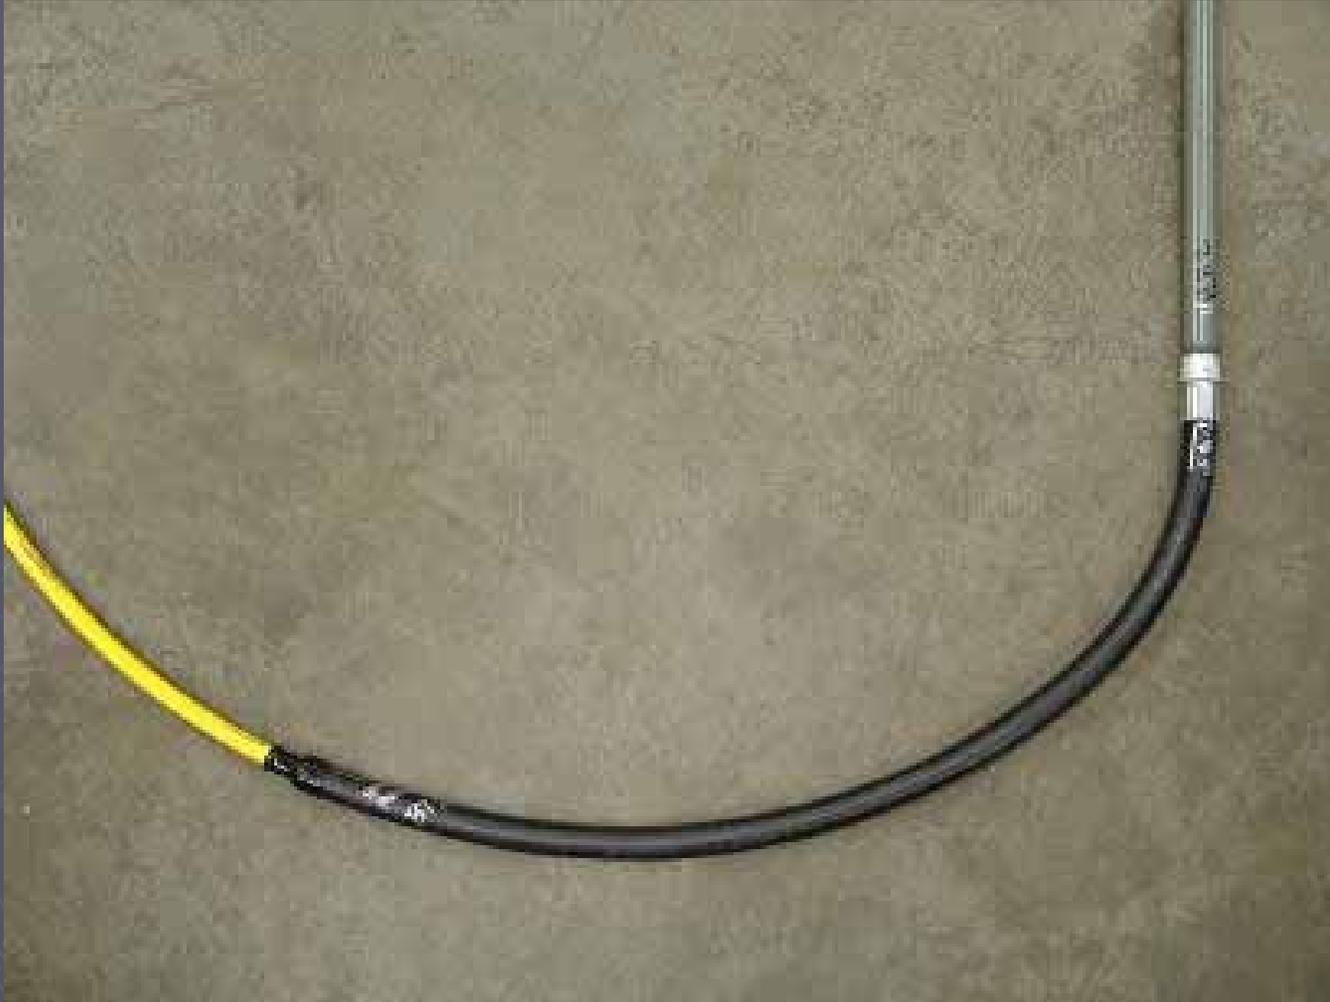
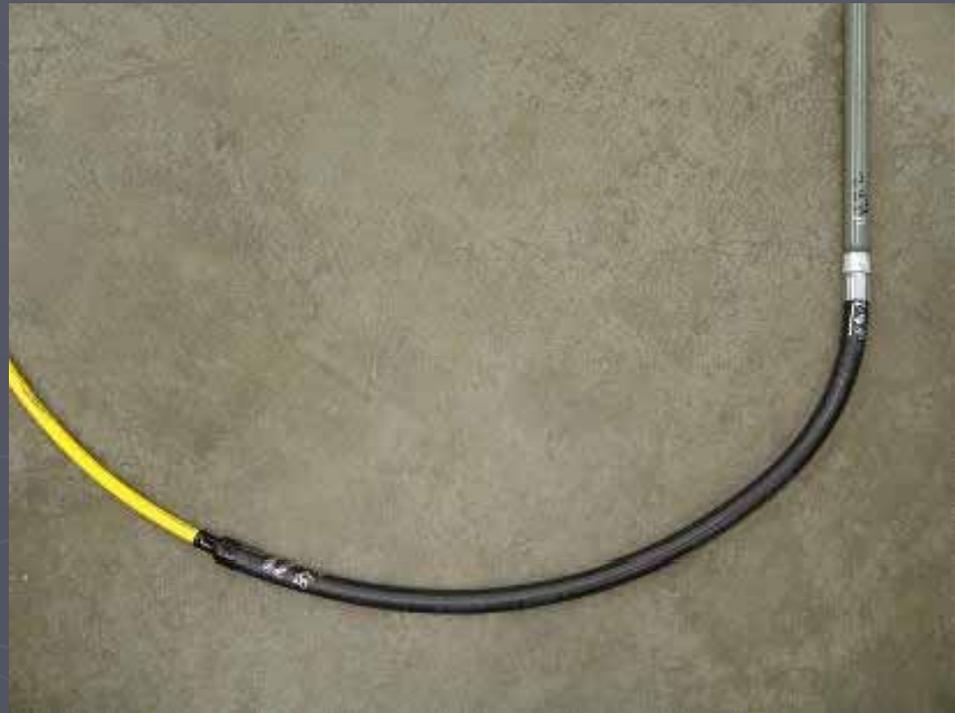
- ▶ This time the Operator had a written procedure to assemble anodeless risers but unfortunately the parts supplied were leading to on site failures.

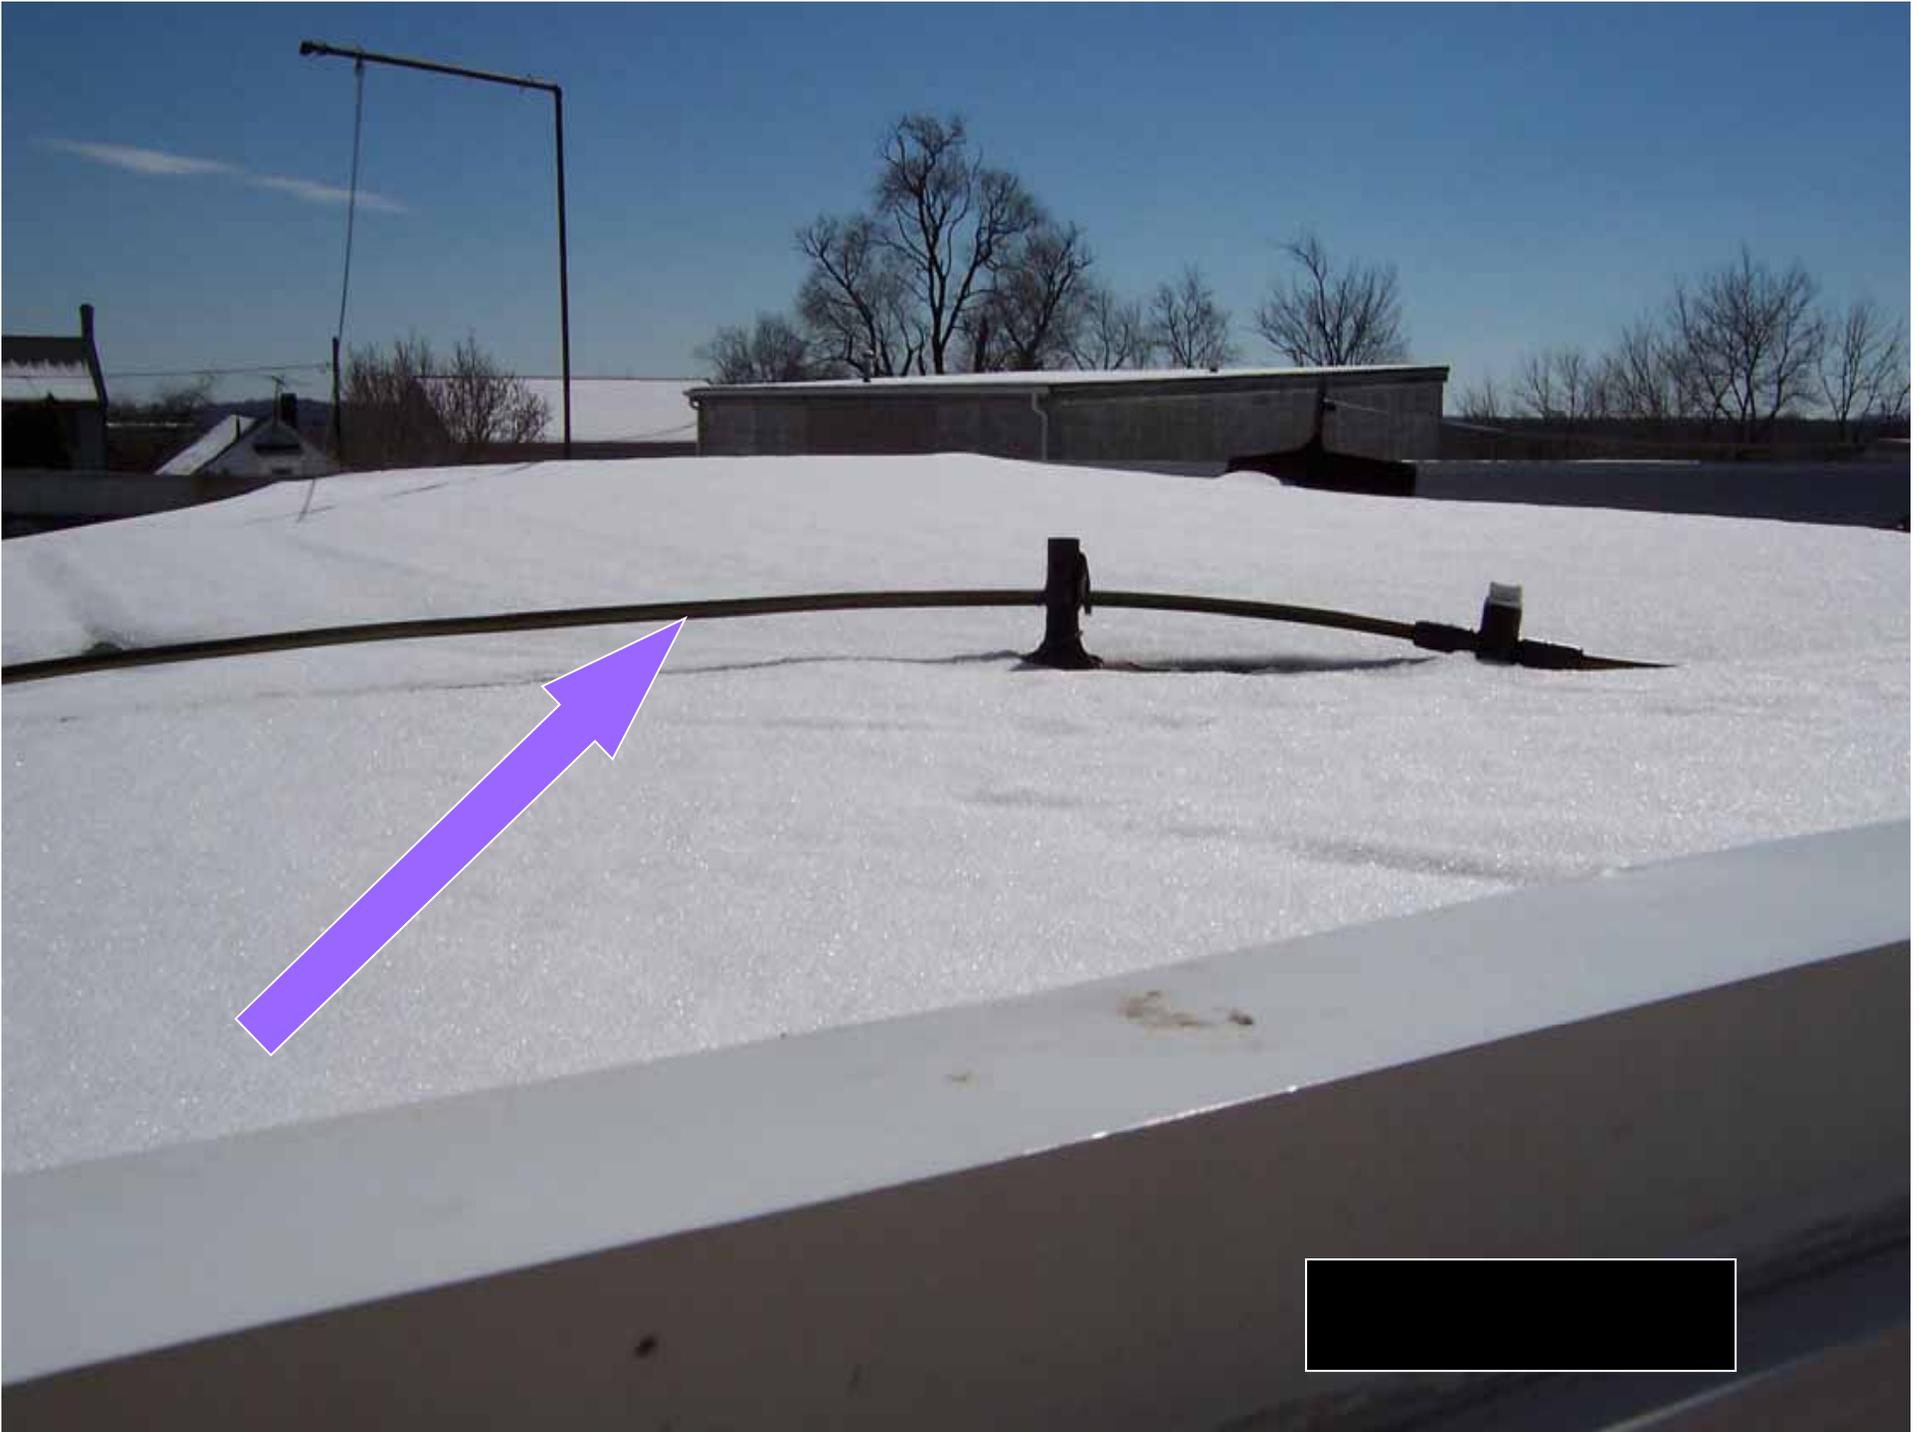
- ▶ The Operator installed a temporary gas service above ground over a garage.

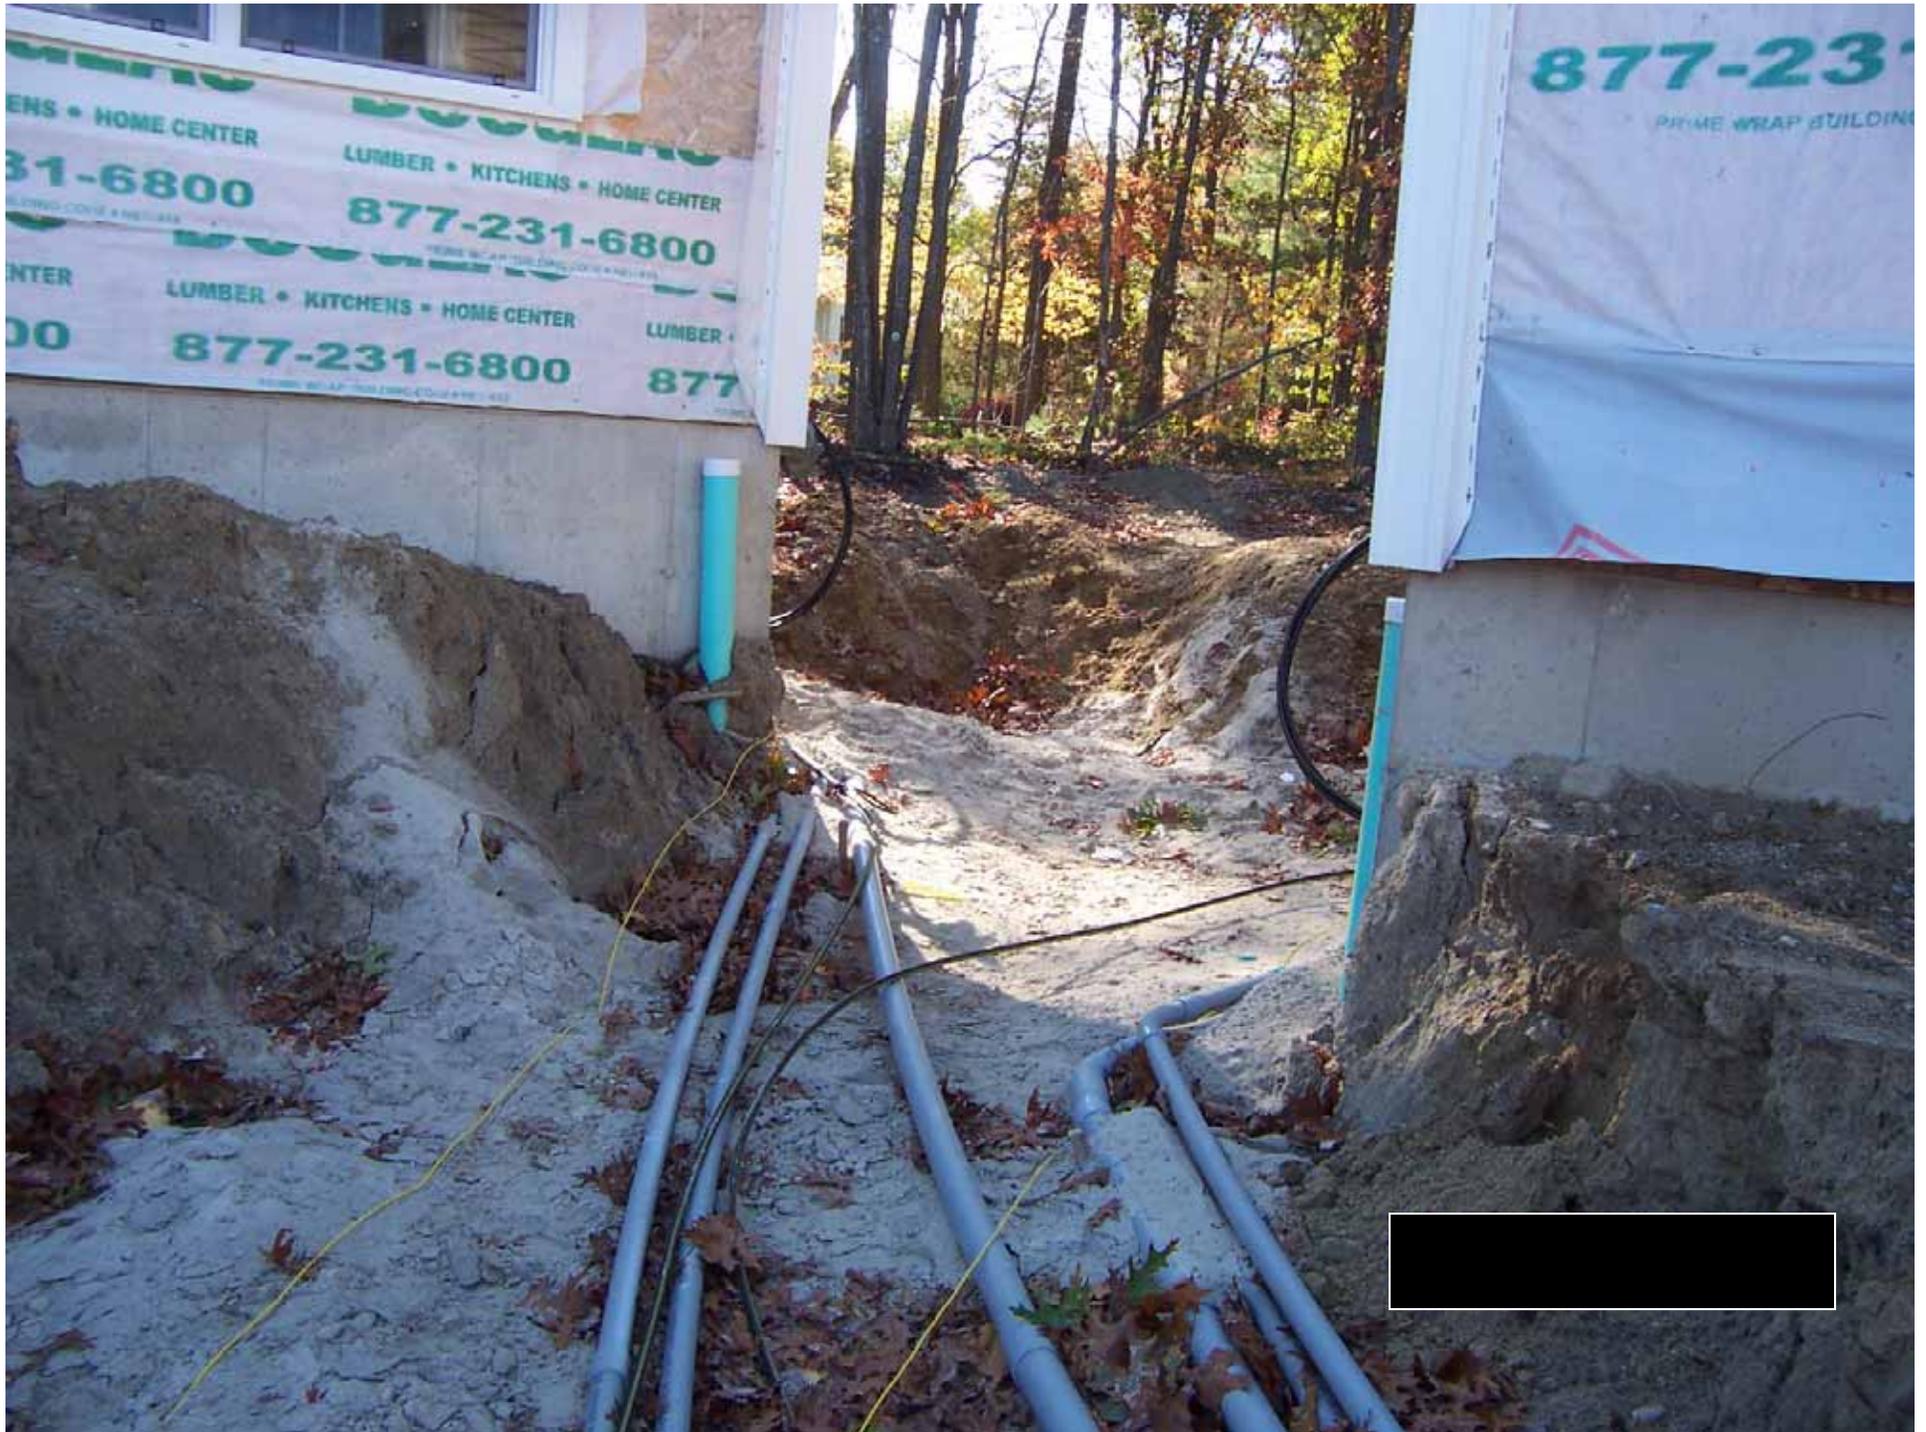
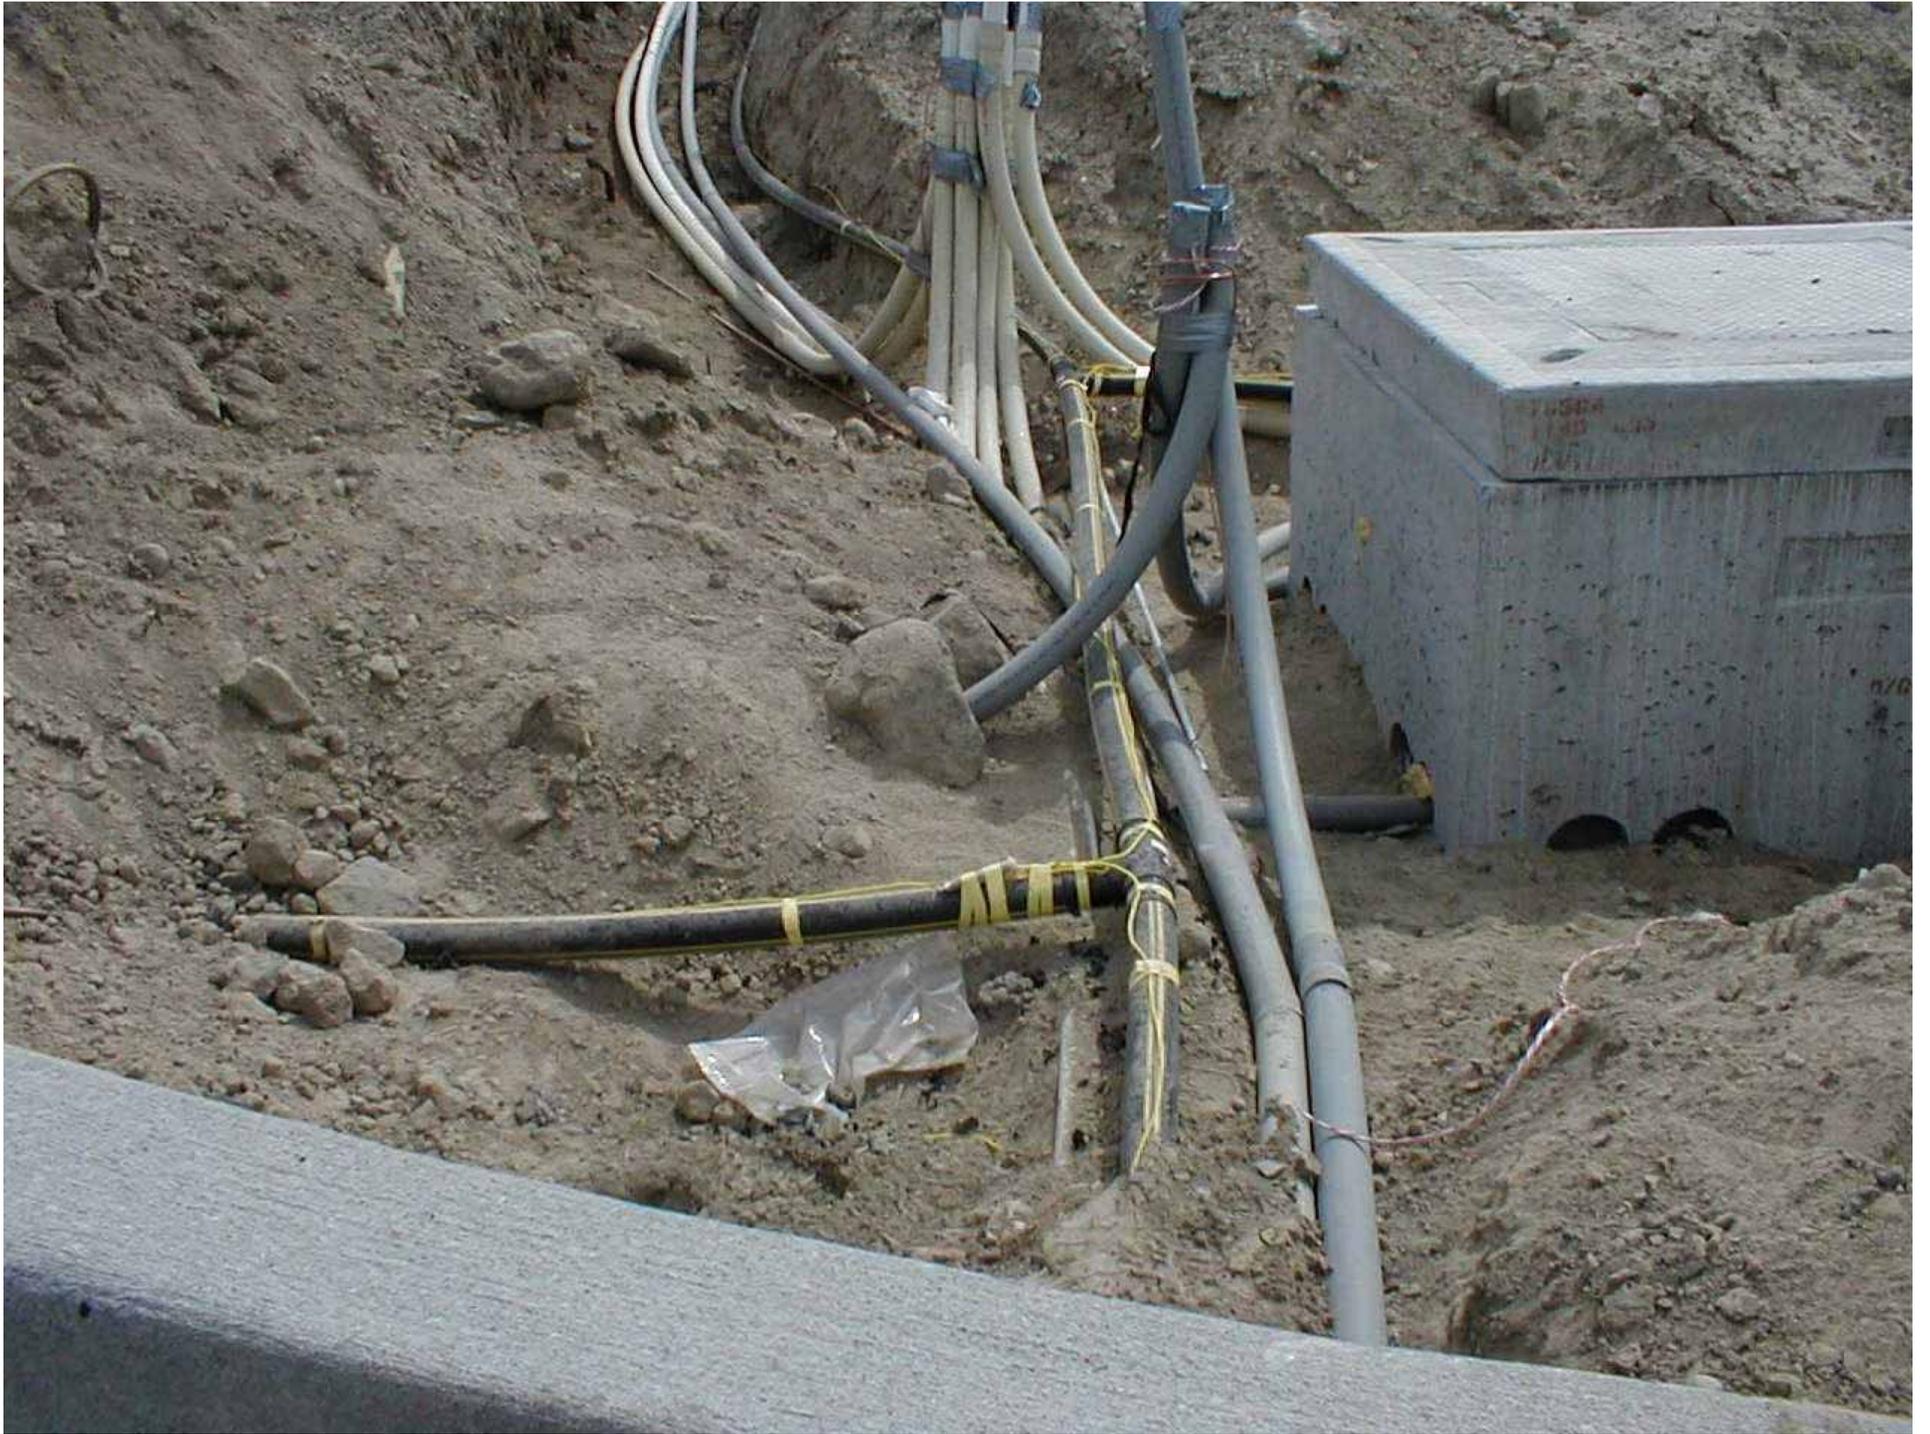
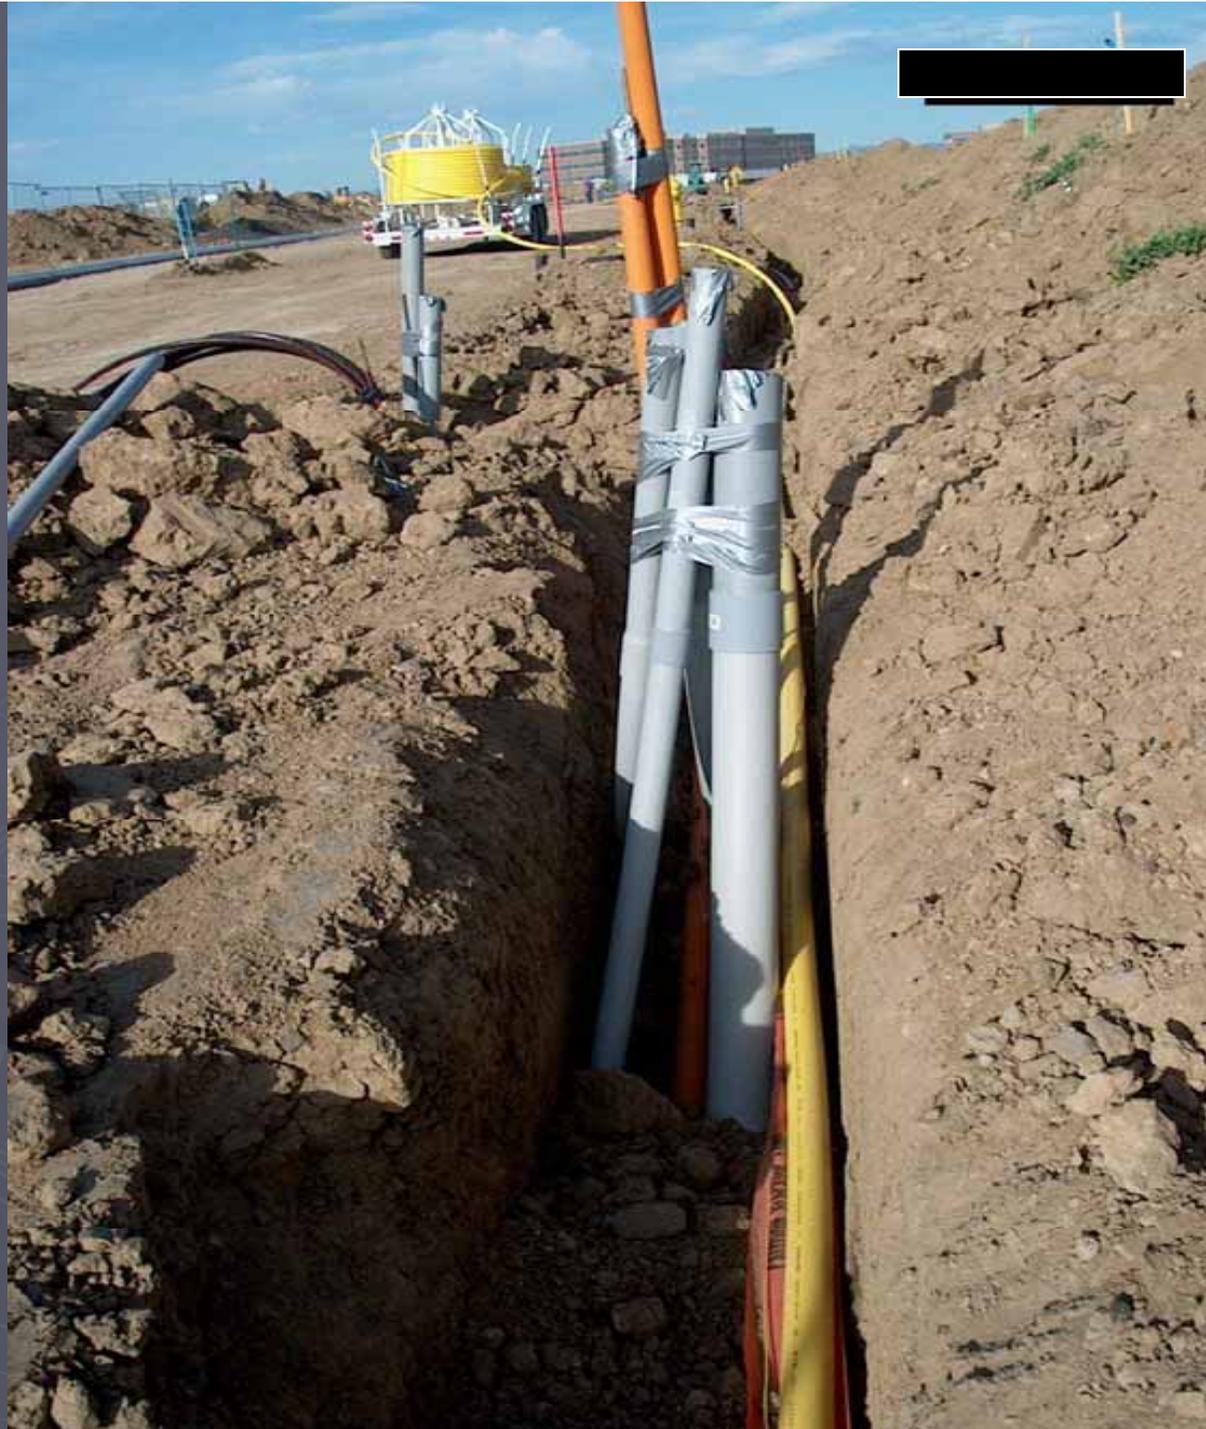
§192.325(b) - Failure to install a main with enough clearance from any other underground structure to allow for proper maintenance

Electric Line

Sewer Line

2" Plastic Gas Main

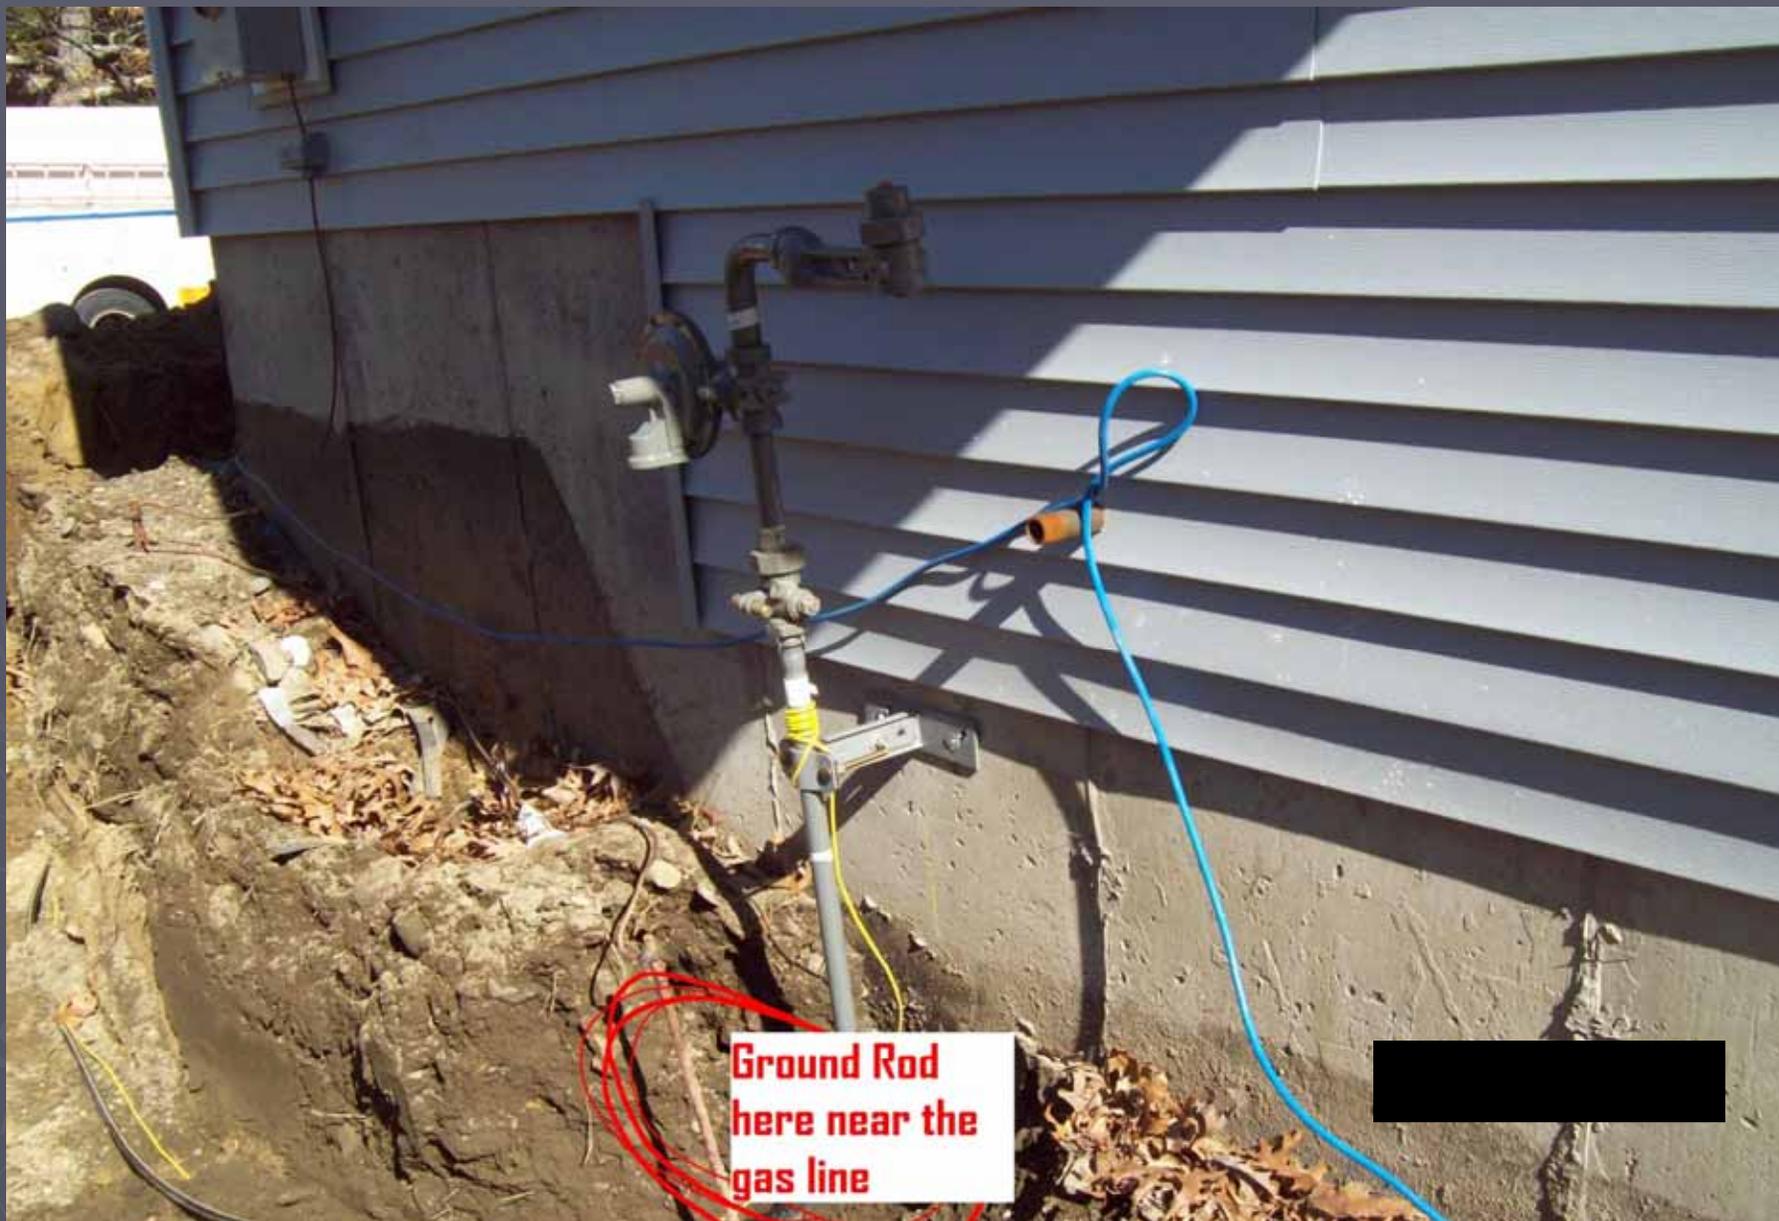
Grounding rod right next to the service
