NAPSR

Distribution New Construction

St. Louis, Missouri April 20, 2010

Inspection findings related to Plastic Materials

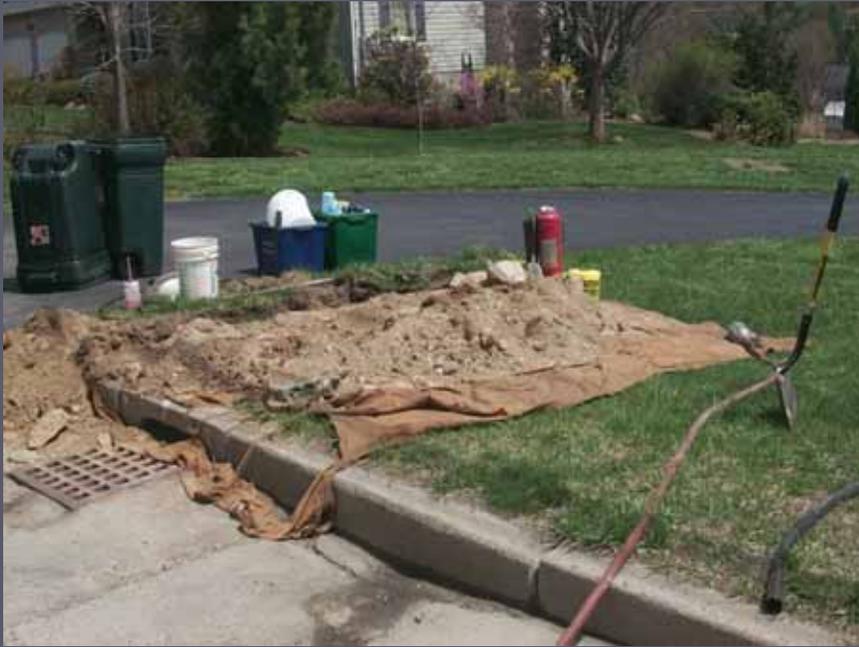
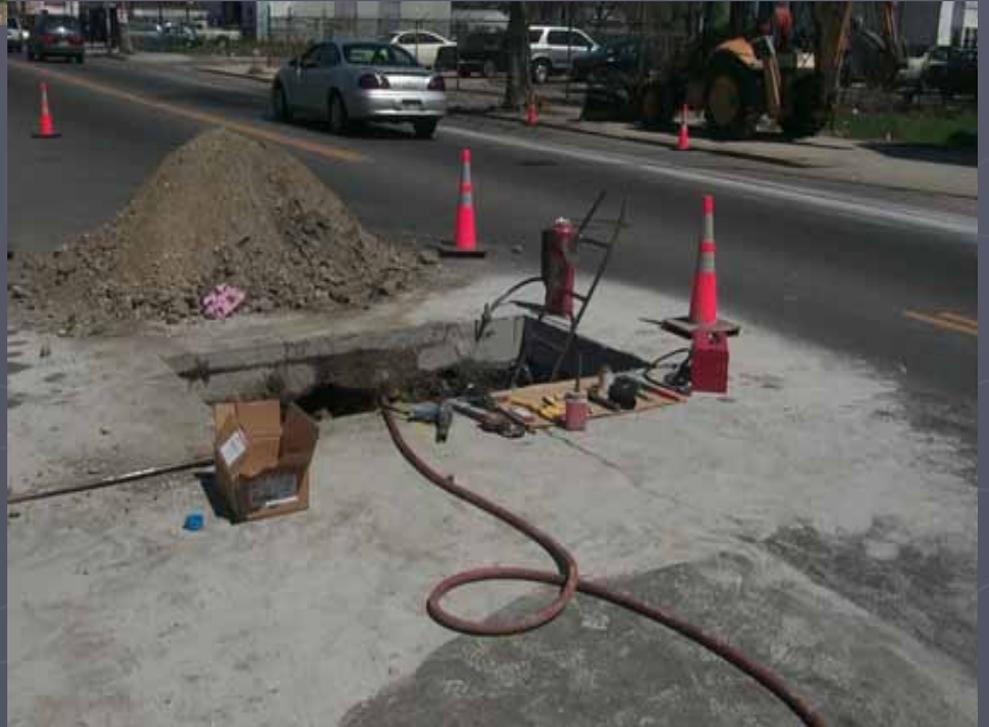
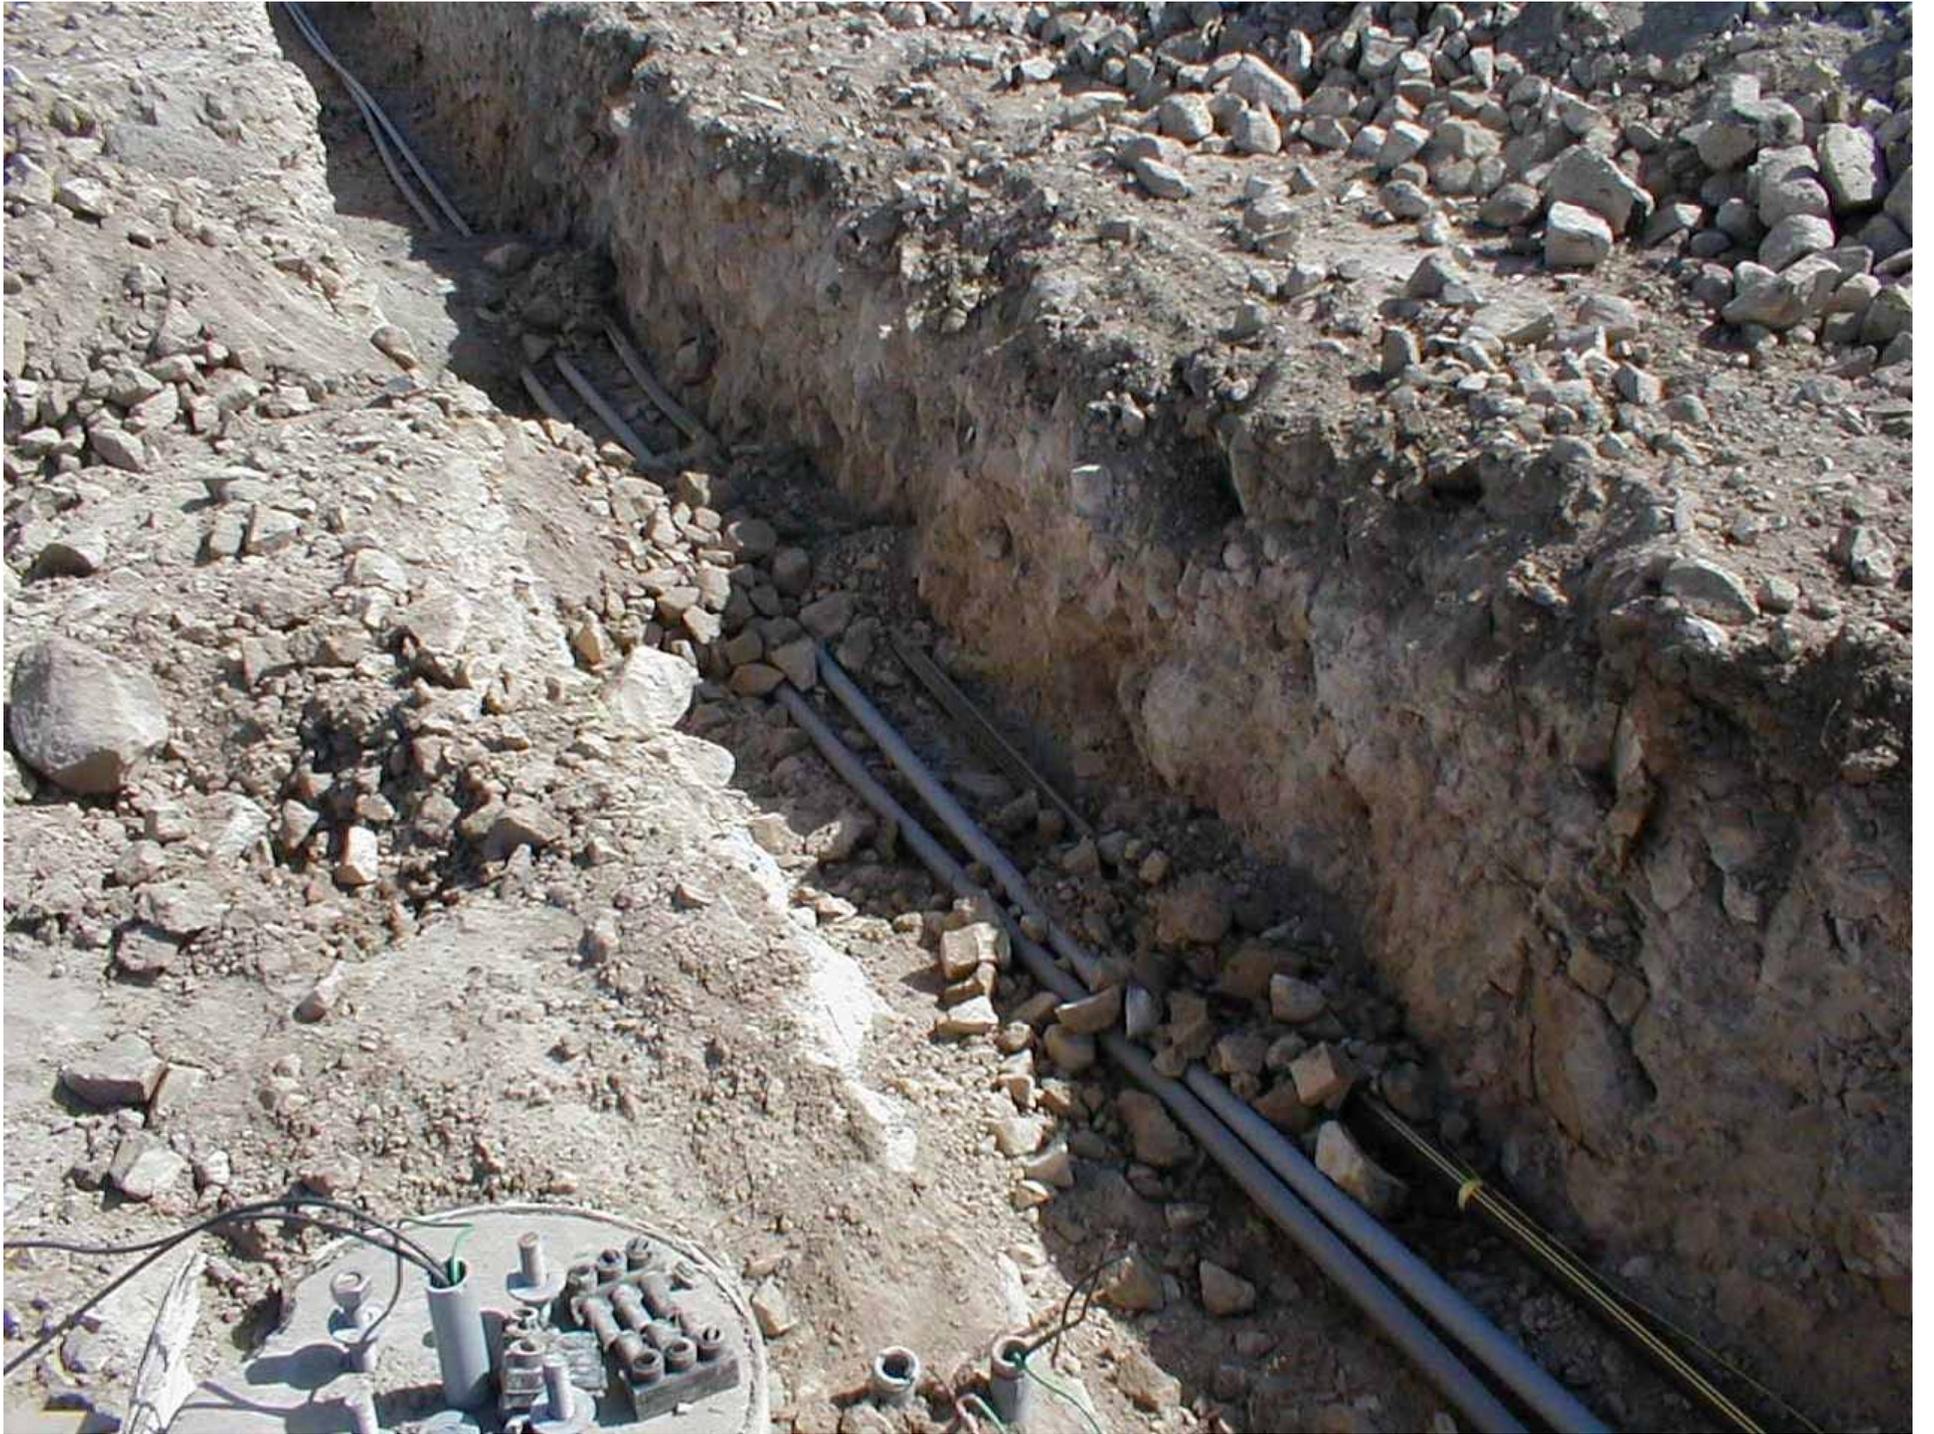
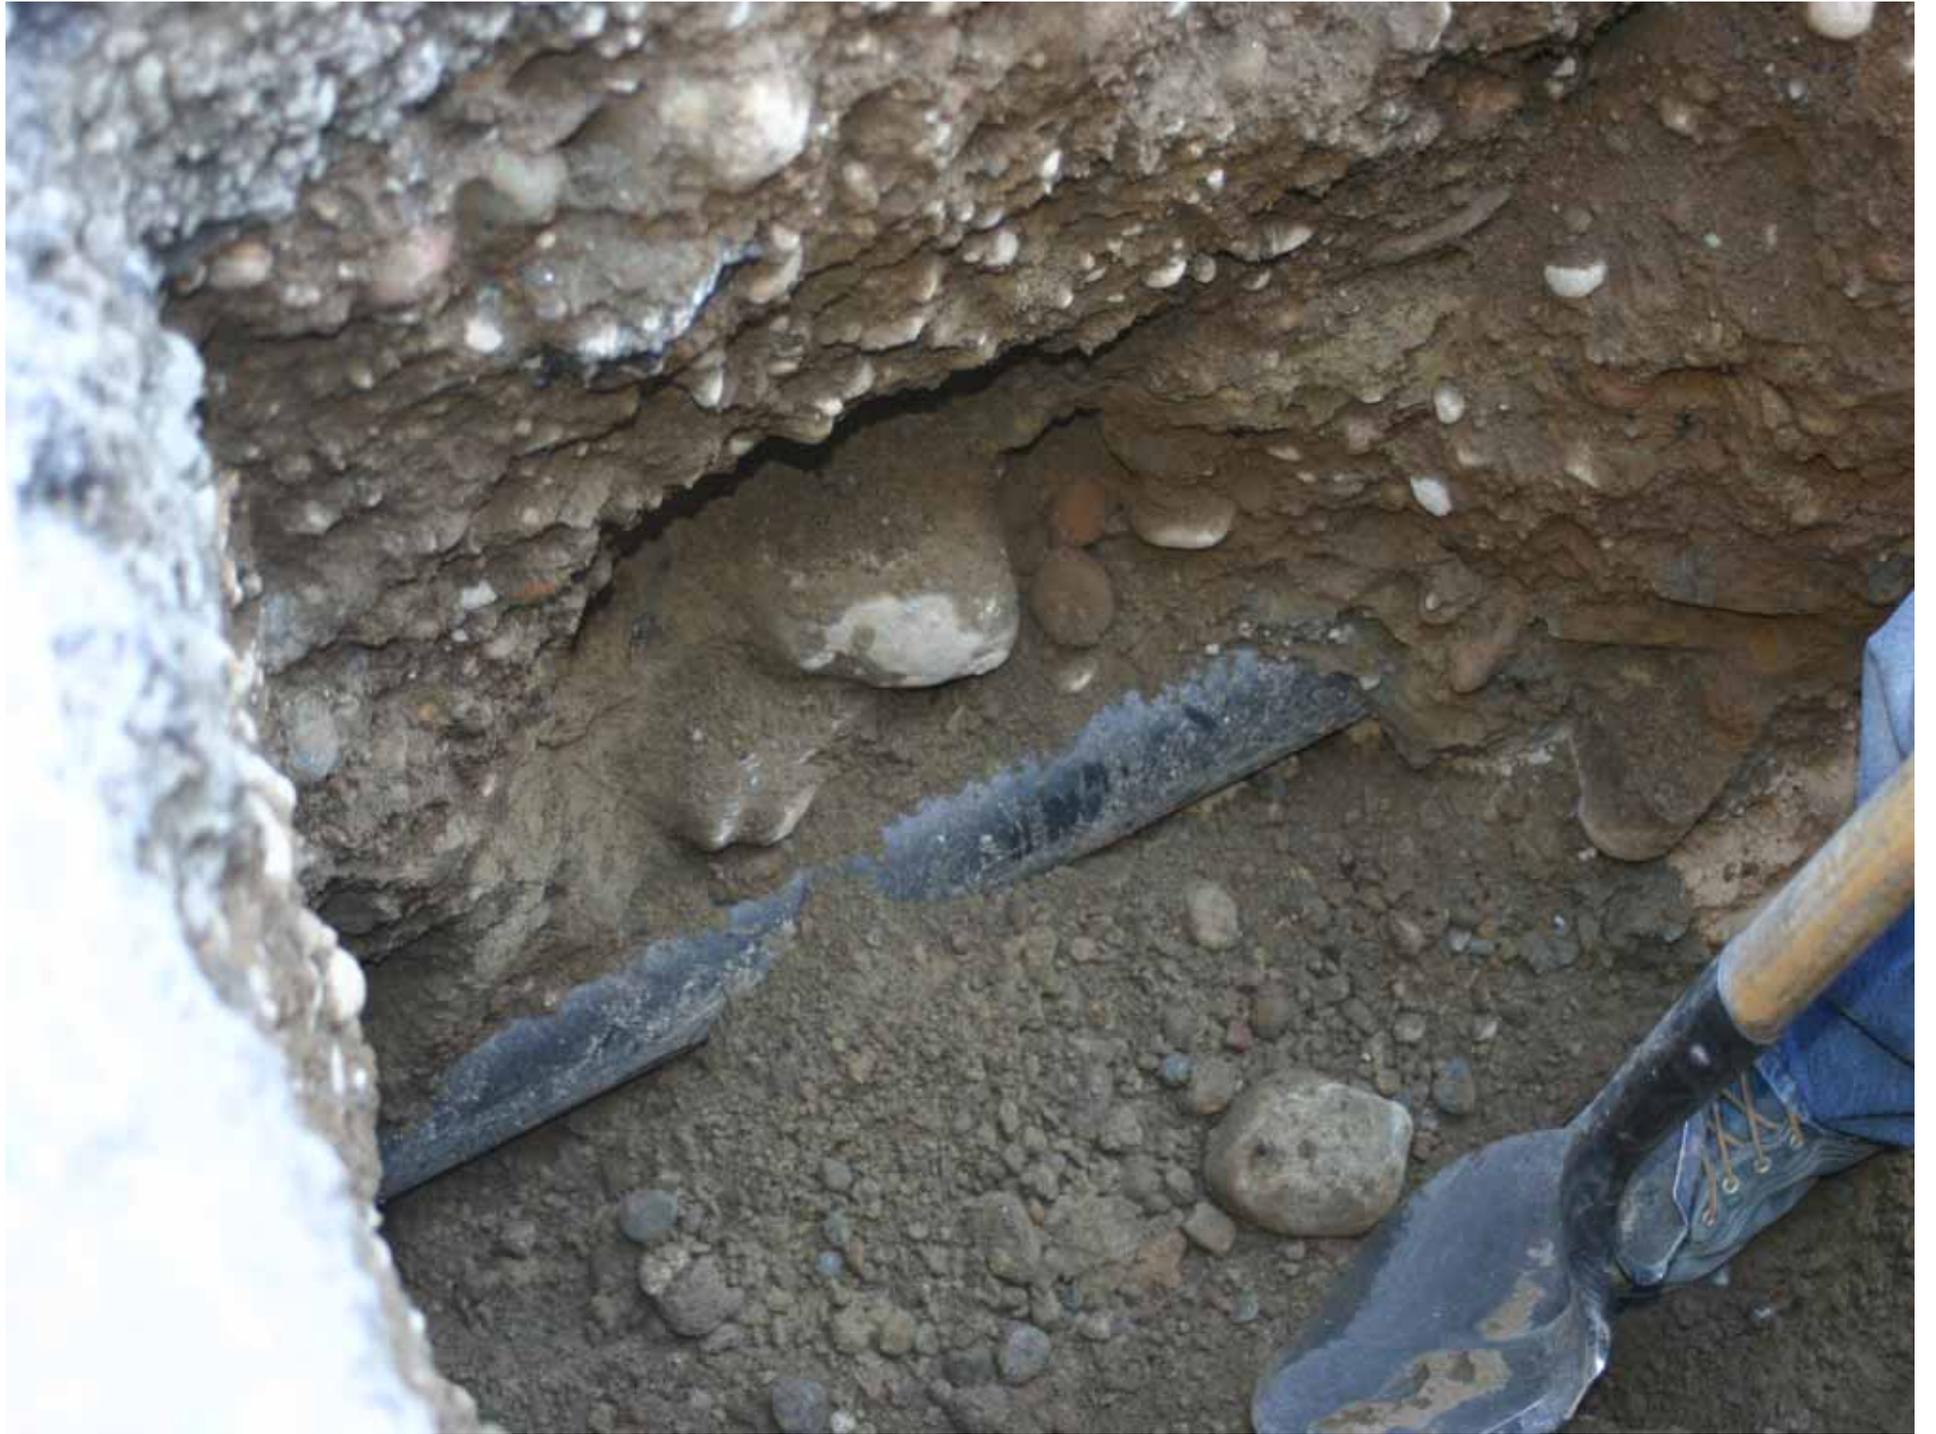
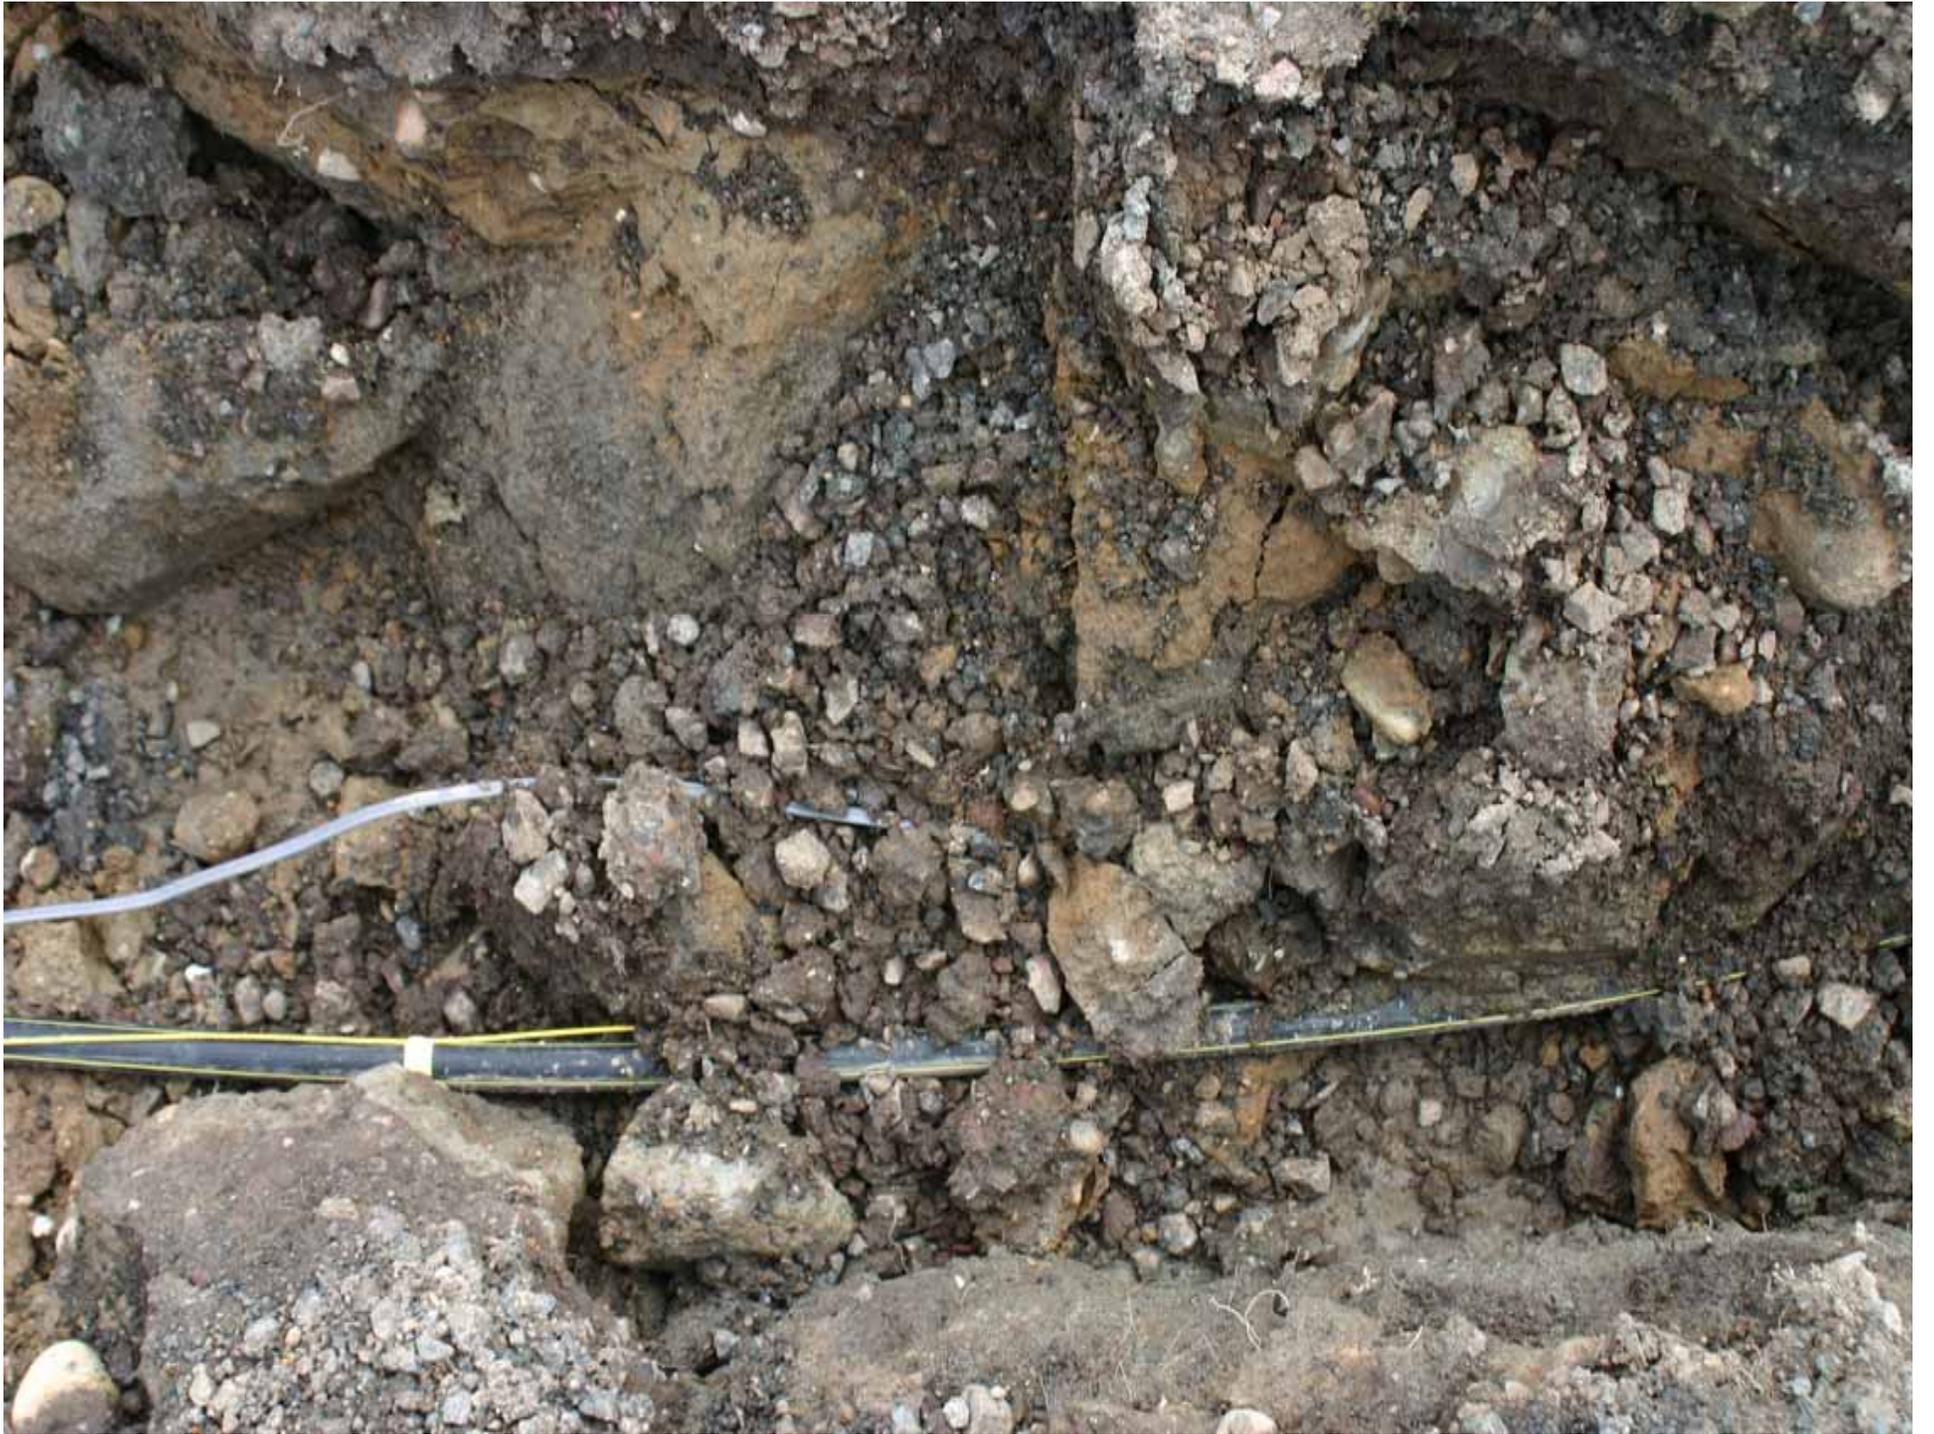
- ▶ The Operator's contractor installed a 4" plastic main with improper backfill material. About 2500' (about a ½ mile) of the newly installed 4" gas main was replaced and select backfill was brought in.

§192.319(b)(2) - Backfill in a manner that prevents damage to the pipe from the backfill material.

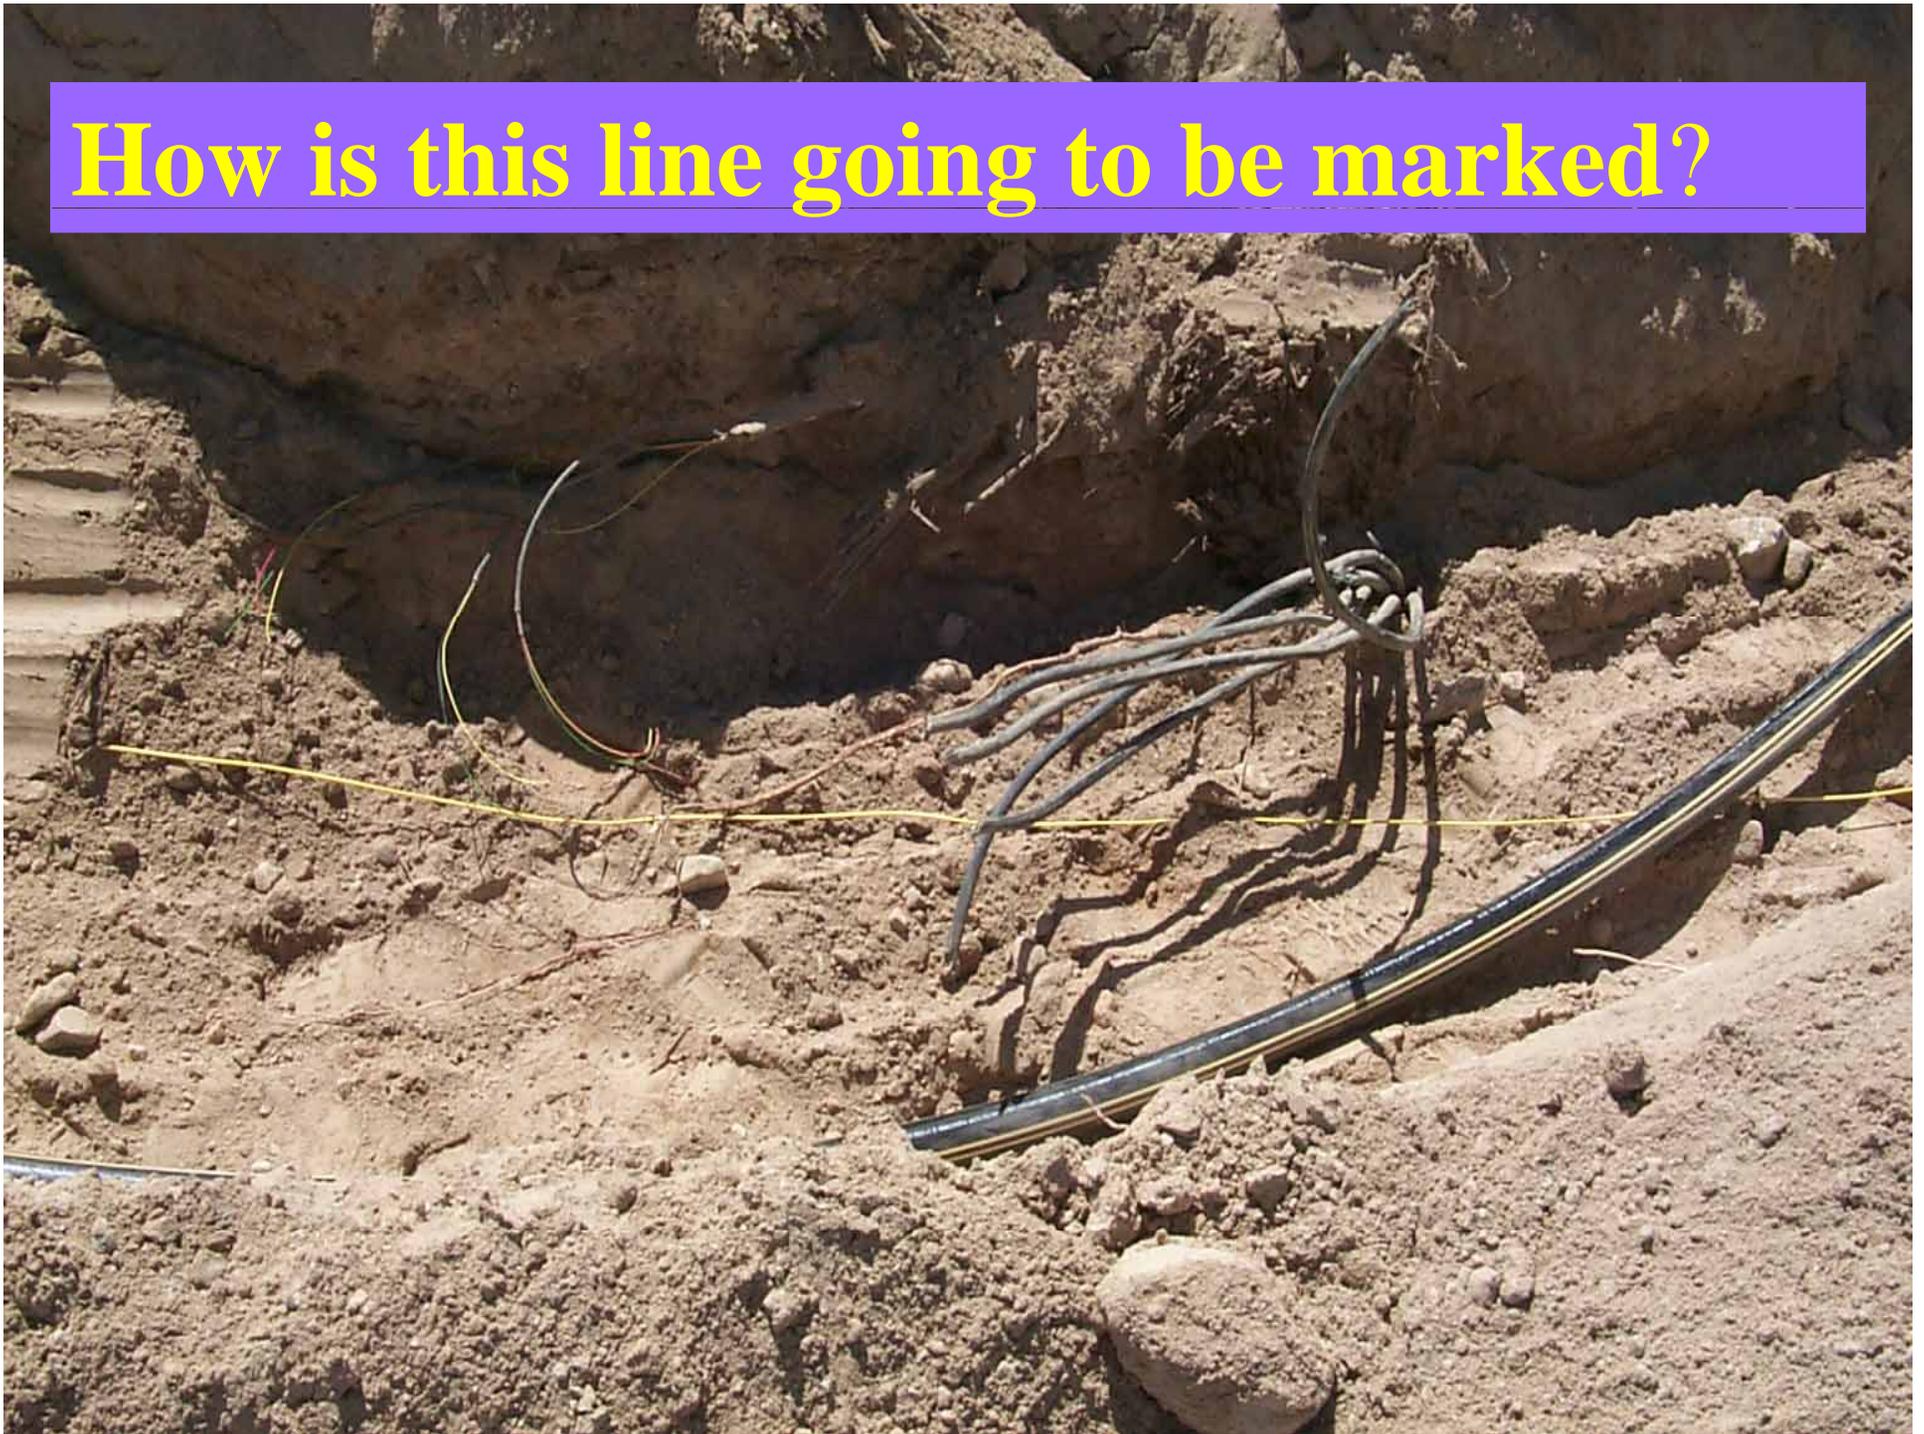
§192.327(b) - Failure to install a main with at least 24 inches of cover.
